Case Study: Class 390 Train Management System (TMS) Upgrade

Situation and nature of failure mode

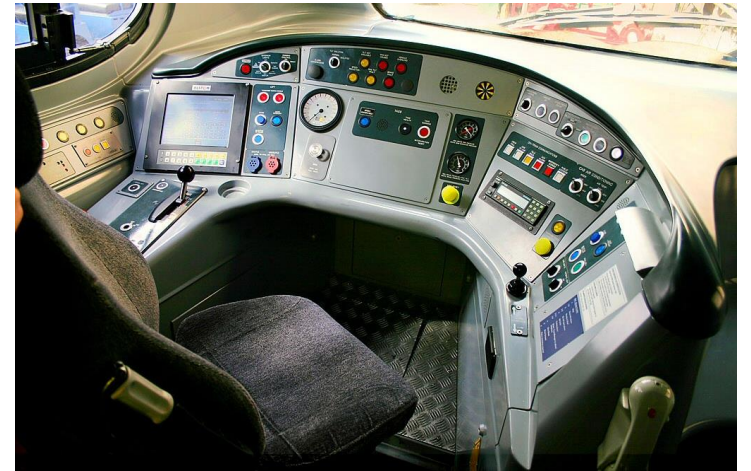
- A software update was planned to the Class 390 TMS software to upgrade five system functions
- Regression testing was performed on the manufacturer's test facility and functionality testing was performed
- The software was initially tested on a small number of trains and performed satisfactorily
- The upgrade was then rolled-out to the whole fleet
- During operation it was noted that on some trains it was not possible to reset the Vacuum Circuit Breaker (VCB) after a neutral section resulting in half-power
- The only way to overcome this fault was to perform a system reset

- Initial analysis suggested it was processor overload due to the 'random' appearance of the fault
- Further investigation identified the fault only occurred on certain trains (head codes*) at certain locations/direction and on certain routes
- The root cause of the fault was traced back to the number of stations within the diagram and a counter overflowing
- It took one year to fully understand the issue involving an interim TMS version with improved fault logs; it was then possible to recreate the event in order to confirm the fault
- The fault was fully fixed when a new version of software was installed to address the problem

The software design and testing should consider the full range of credible operating conditions that could be experienced in service including operating time e.g. a one-off test is not reflective of 24 hours operation in service
