## Case Study: Class 755 wheel slide protection and sanding systems

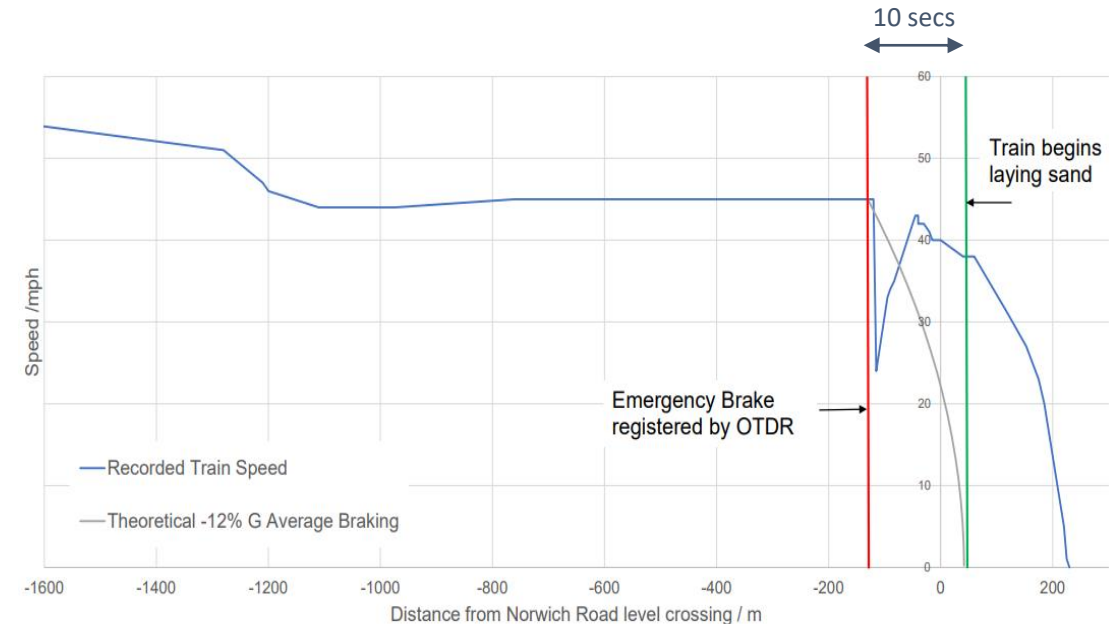
- During the Norwich Road level crossing incident on 24 November 2019, while not a contributory factor, it was observed that when the driver applied the emergency brake, there was a ten second delay between the wheel slide protection (WSP) system detecting axles sliding and the 'axles sliding' signal being transmitted over the Controller Area Network (CAN) bus to the Vehicle Control Unit (VCU). Once the 'axles sliding' signal is received by the VCU, sanding is deployed.
- At the design stage the train manufacturer's type testing had been undertaken to confirm that when the 'axles sliding' signal was received by the VCU that sanding was initiated. This was performed and the results deemed positive, but during the test it was missed that the signal was not immediately coming when it would be expected.

- The WSP system manufacturer believed that the 'axles sliding' signal was to be used exclusively for diagnostic purposes, and the delay had been included to avoid excessive wheel slide warning on the train management system, as was the case on other vehicle fleets without sanding equipment fitted.
- Type testing had been undertaken to confirm that when the 'axles sliding' signal was received by the VCU that sanding was initiated but this did not include an integrated test with the WSP system.
- The engineering change to remove the ten second delay has now been completed across the train fleet.
