Loss of safety critical signalling data on the Cambrian Coast line

The information to produce these slides has been taken from this RAIB report

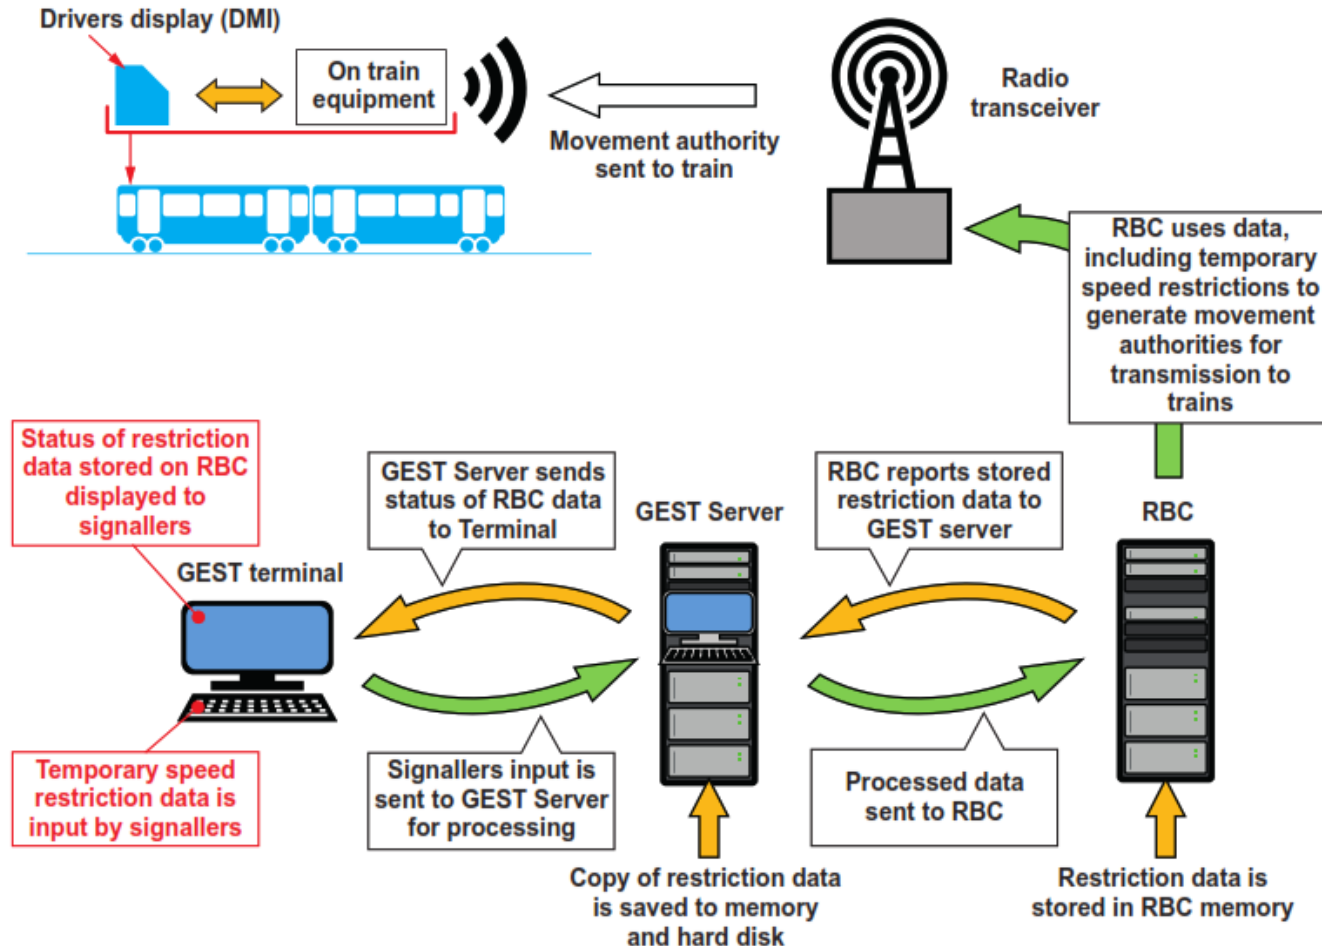
Figure 6: Simplified arrangement of GEST and signalling control system interface

The ERTMS signalling system was returned to service following an Radio Block Centre (RBC) software automatic reset, known as a 'rollover', without temporary speed restriction information for transmission to trains.

- Temporary speed restriction data was not uploaded to the RBC after a software rollover because the GEST sub-system had entered a fault condition, probably due to a corrupted database.

- No indication that the system had failed was provided to signallers.
- The memory used for storing temporary speed restrictions in the RBC was volatile, allowing temporary speed restriction data to be lost during a rollover.

- The required level of safety integrity for validation of temporary speed restriction data uploaded to the RBC following a rollover was not achieved by the design.

- GEST server software was unable to detect and manage the corruption of its database.
- The vulnerability of the system to a single point of failure had neither been detected nor corrected during the design, approval and testing phases of the Cambrian ERTMS project.
