Near miss at Maesyfelin bridge, near Pontyclun, 8 April 2016

2. Summary of the accident

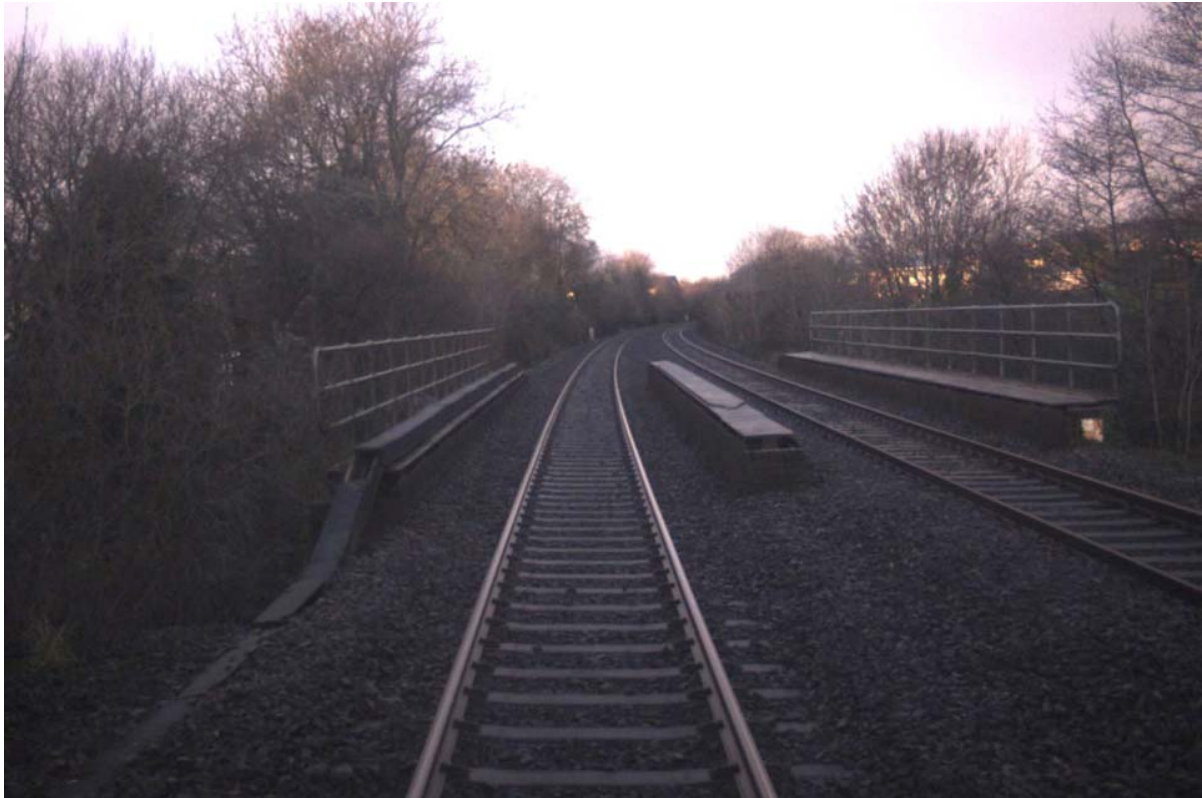
Library image of Maesyfelin bridge (courtesy Network Rail)

Maesyfelin bridge carries the South Wales main line over the River Ely. The bridge is situated around 530 metres south-east of Pontyclun station and on the exit of a curve for trains approaching from Cardiff. The railway consists of the up and down main lines, and the maximum permitted line speed for trains approaching the bridge on either line is 75 mph (120 km/h).

Although both of the proposed SSOW for the inspections had been planned, approved and verified, a preliminary investigation undertaken by the rail industry found that there was inadequate space between the bridge parapet and the nearest running rail for a person to stand in while maintaining the required 1.25 metres clearance needed to implement a red zone with warning given by lookout SSOW. The investigation also concluded that there was not enough space in the cess on the immediate approach to the bridge to implement a separated green zone SSOW.

Although operative A held a probationary competency as a lookout, the arrangements made by the COSS were not authorised by the relevant rules and standards. The rail industry investigation found that the COSS adopted this system because he knew from his local knowledge that there was no position of safety on Maesyfelin bridge and that the sighting distance at the bridge would be limited, due to the curvature of the railway.

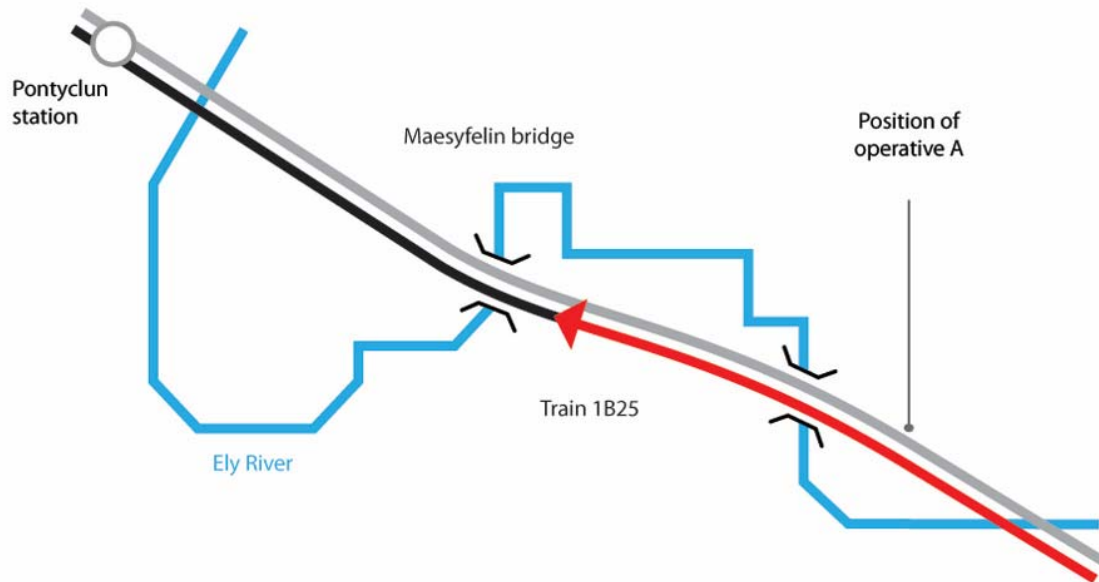
Simplified map showing route of the train and position of operative A (not to scale)

On the morning of 8 April 2016, the work group initially went to sidings where the COSS briefed the workgroup on the SSOW and the group completed a RT9909 'Record of arrangements and briefing' form to confirm that this had been done. The work group then drove to several different locations to undertake inspections before arriving at the Miskin scout hut access point, where they inspected two bridges. After these inspections were completed, the COSS asked one of the probationary lookouts in the group, operative A, to remain at the access point while the COSS and the remainder of the group drove up to the nearby Pontyclun station and walked down from there to Maesyfelin bridge. The COSS briefed operative A on the direction of traffic and line speeds and asked him to provide a warning of any approaching trains using a hand-held back-to-back radio.

The work group reached the bridge where the COSS undertook an inspection on the Pontyclun side. He then decided that he needed to make a further inspection on the Cardiff side of the bridge and used his radio to contact operative A to confirm that the line was clear of approaching trains. Operative A confirmed that no trains were approaching and, after a delay of about 30 seconds, the work group started to walk over the bridge using the down main. However, as they crossed the bridge, the work group felt the track vibrate and the COSS saw a train coming towards them. The COSS shouted a warning to the group and he then ran back off the bridge with another member of the group. The three remaining members of the group had to jump onto the bridge parapet to avoid being struck by the train.
