Learning from Events

The REAL way of life is keeping Everyone safe like family

Power Supply Upgrade 1 (PSU1) delivery includes:

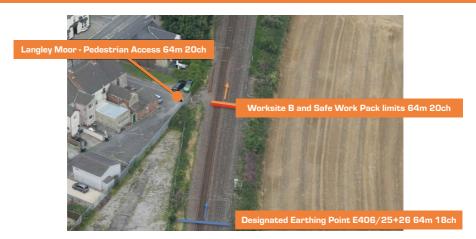
Life-saving rule breach (plans and permits) designated earthing point (DEP) located outside of SWP mileage

- The document used to determine the mileage of the southern isolation limit was incorrect
- The Authorised Person (AP) failed to establish their location in relation to their site of work prior to accessing the infrastructure
- The events from previous weeks were not escalated to the Isolations Manager or reported as a Close Call
- The NP did not recognise that the southern DEP was outside of the planned worksite mileages during the NP walkout

Ineffective planning - The document used to determine the location or the southern isolation limits is uncontrolled and incorrectly listed the location of the DEP. Furthermore, the Nominated Person Walkout did not identify this error.

Illustration of worksite and isolation limits

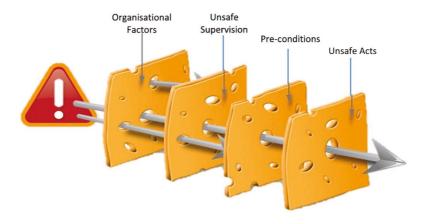
'Reasons' Swiss Cheese Model

- The site visit undertaken by the AP failed to identify the poor underfoot conditions when working in and around the Feeder Stations
- The Long Blue earths are longer than they needed to be and can become a tripping hazard by potentially contacting other risers or feeders
- The Sentinel Training and Assessment package for NP / AP does not cover the specific methodology of Lifting, raising, or swinging the Long Blue Earths in a Feeder Station
- Pre-existing injury (shoulder) meaning the earthing pole was swung from the left side, whereas the right side may have been the safer option. Alternatively, raising the poles straight up is the preferred method

- The provision of specific training on the correct methodology of applying earths within Feeder Stations and keeping a record of who has had the training to support the allocation of NP's to the specific task

- Once the exact measurement for Long Blue earths is determined within Feeder Stations we
 will procure enough earths at that length to allow the teams to work more safely and with
 less risk to come into contact with other risers or feeders or have tripping hazards from our
 own equipment

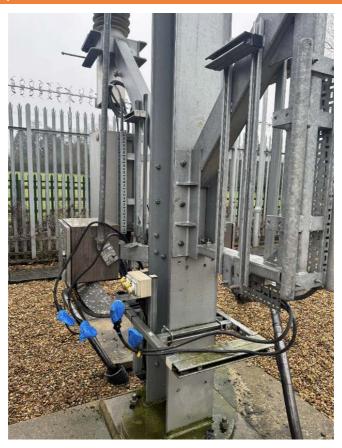
While preparing the testing of Current Transformers (CTs), at 08:00 on 8th February 2025, a circuit breaker mass trip event occurred at Corey's Mill Auto Transformer Feeder Station (ATFS). The mass trip was initiated by a Circuit Breaker (CB) Fail of circuit breaker CSMA/AT2. Immediately following the event all work was stopped on site and the staff stood down. No one was injured during the incident but there was 530 minutes of train delays.

CT secondary wiring removed and bagged/taped

- During the works to disconnect the CT Secondary wiring, rainy weather allowed water to gather in the bag. Staff did not see the weather conditions as a reason to stop the works and reassess how they were being carried out

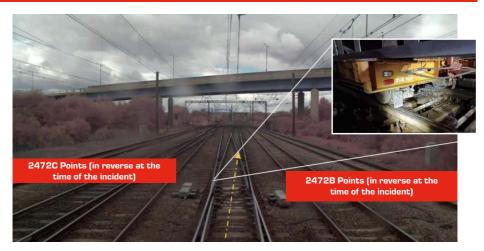
At approximately 03:17, whilst in transit to work location, E/252/01A&B, TRS1027 with propelling trailer TRS1371 made a wrong directional movement over 2472B points at Marshgate Junction.

Illustration of the 'Switch Diamond' at Marshgate Junction

The propelled rail trailer made a wrong directional movement over 2472B points.

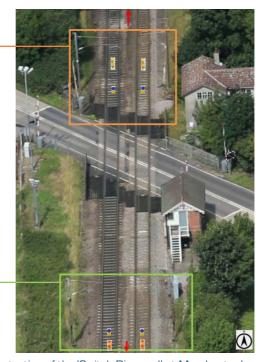
The incorrect positioning of the isolation limits and Worksite Marker Boards. Red arrow indicates the VolkerRail work location North of the Level Crossing.

The correct positioning of the isolation limits. Red arrow indicates the ground inspection work location South of the Level Crossing and the correct position of Worksite Boards (400yds off the bottom of the photo).

Illustration of the 'Switch Diamond' at Marshgate Junction

The AP applied earth straps to an incorrect structure and positioned Worksite Marker Boards at the same location

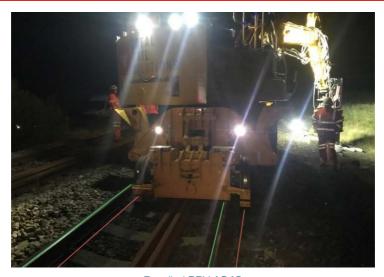
Once at the site of work (Fenham substation) the team began to install the first pile with the use of a MovaxTM RRV attachment (a side grip vibratory-type pile driver). The pile had been vibrated approximately 2 meters into the ground when the RRV became derailed, dropping from the rail head and landing in the 4ft and the CESS.

Derailed RRV 1042

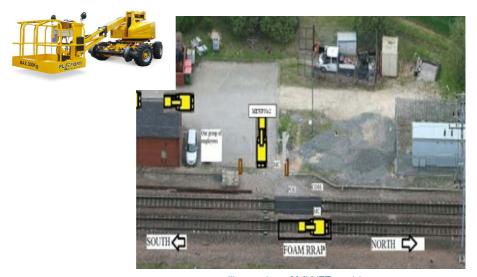
The MEWP was to be on-tracked on the up main and was positioned onto the RRAP under the control of the Machine Controller (MC), the fixed axle end rail wheels were lowered by the Machine Operator (MO). The Machine Controller then walked to the steering axle end and repeated the process. The Machine Operator then commenced the rolling brake test, as the MEWP was driven a short distance forward, there was a loud bang, which was confirmed to be the fixed axle rail wheels being derailed. The steering axle end rail wheels remained in contact with the rail. The Machine Operator then lowered the machines' road wheels and re-railed the machine under the supervision of the POS Rep.

Illustration of MWEP position

Derailment of fixed axle wheels whilst on-tracking.

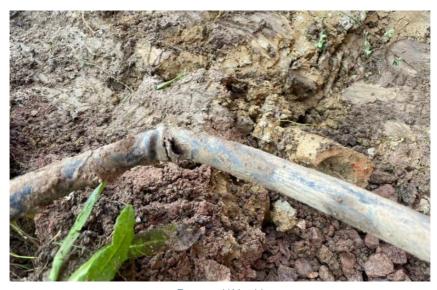
Network Rail Fault Control and the Distribution Network Operator (DNO) were informed and arrangements were made to maintain the low voltage supply to Grantham Feeder via a generator.

Damaged LV cable

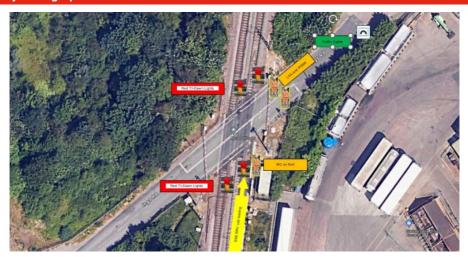
The LXA had not given permission to pass the red Til-Dawn light and the road traffic signals were not set to the road to road traffic. When the LXA and POS Rep noticed the off-tracking had started without permission, a Close Call was raised. There were no injuries or damage as a result of the event.

Overview of the event, showing the position of people and equipment involved

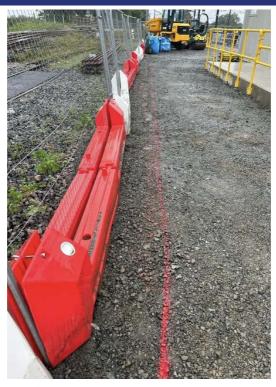
Initial findings established that the segregation had been moved by the site team on 6th September to enable concrete works to be undertaken to the access steps of the adjacent track sectioning cabin. Further review found that no site specific risk assessment had been undertaken in order to establish the site segregation as required under the 'Creating a Site of Work Segregated from the Railway [NR-L2-OHS-00130-02]' standard.

Fixed temporary barrier with demarcation

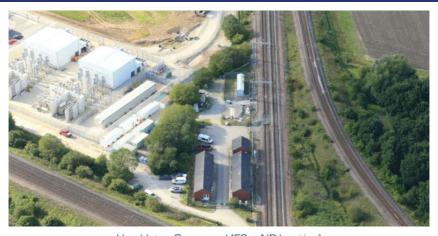
STED Forms detailed that COSS/API was allocated to structures E275/01,02 and E275/09,10. COSS/AP2 was allocated to E274/07,08 and E274/19,20.

Hambleton Compound (ES + NP location)

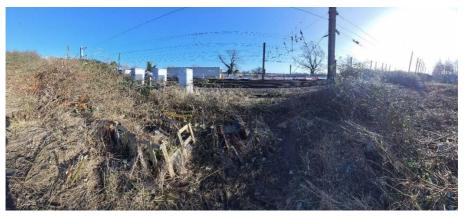
Looking into the rail infrastructure from the landowner's yard, allegedly with a damaged fence

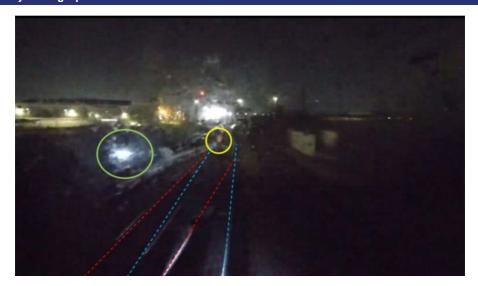
As the train travelled on the Down Thorne / Slow line, it made contact with the board, causing it to detach from the rail head. While the passenger train did not suffer any damage, the board's locking mechanism was damaged when struck by the train. When the incident occurred, the Crane Controller was approximately two meters away from the Down Thorne / Slow line, walking in the cess of the Marshgate Sidings, around four meters away from 2478B points, returning to the Road Rail Access Point where the wider workgroup of the REAL Alliance civil engineering team was convening.

The green circle is the Crane Controller's head torch illuminating their position. The yellow circle is the PLB at 2478B points. The red dotted line is the Marshgate Sidings line, and the blue dotted line is the Thorne Down / Slow line that Train SCO2 was travelling on prior to contacting the PLB

- Lastly, the investigation report will be reviewed with the Rail Safety and Standards Board to
 explore the feasibility of enhancing the rules stated in Handbook 13, 'Duties of the person in
 Charge of the Siding Possession'
