Safety Advice

Stanley TJ10 lifting jack - cracking

Ref: NRA 16/04

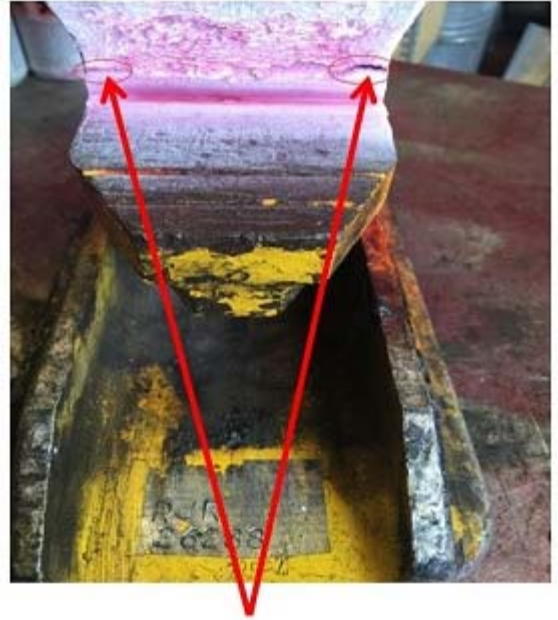
Cracking Points

During an inspection of a Stanley TJ10 lifting jack, cracking was identified approximately 5mm from the elbow at the foot of both sides of the lifting face. [Reference: NIR-Online (8250): NIR 3237 Initial Stanley TJ10 10T Hydraulic Rail Jack Defect]

Subsequent jacks were quarantined by the user with Dye Penetrant Non Destructive Testing (NDT) completed. This testing identified significant numbers of the named equipment as damaged due to cracking.

There is a risk that the damage identified could cause a catastrophic failure when lifting rail, causing severe injury to operators and personnel within the immediate area.

- All users and maintainers of the equipment must quarantine all Stanley TJ10 lifting jacks immediately.
- A competent fitter must complete Dye Penetrant NDT to identify any failure in the indicated area.
- All equipment that has crack indication faults should remain quarantined and be returned to the supplier for repair.
- Upon completion of Dye Penetrant NDT, equipment not identified as unserviceable can be returned to service.
