Safety Advice

Failure of 7 sleeper lifting spacer beam

Ref: NRA 16/08

Location: Newlands

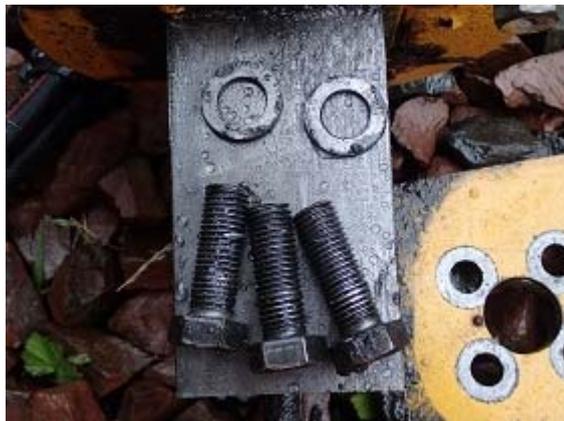
Whilst carrying out track relaying works, sleepers were being lifted on to a rail wagon utilising a 7 sleeper lifting/spacer beam. As the sleepers were being lowered on the wagon, the beam failed, dropping the sleepers onto the wagon. Fortunately, due to the exclusion zone that had been created, nobody was injured.

The beam failed because the retaining plate bolts on the square rotor stem became loose and slackened off, eventually falling out. The bolts have plain washers fitted, not spring washers.

It appears that thread lock may have been used on the beam that failed.

- Prior to any intended use of similar sleeper Lifting/Spacer beams carry out an inspection of the retaining plates and ensure that they are of the correct type and grade, including the washer type and grade as detailed in the operating and maintenance manual.

- Ensure that the bolts are correctly tightened and that wire locking or thread lock is correctly applied.
- All machine operators and crane controllers using similar equipment must be briefed on the need to ensure that the bolts are checked as part of their pre-use checks.
