## Immediate quarantine of Manitou 160 ATJ Plus and 160 ATJ Plus RC based MEWPs

**Ref:** NRA 17/01 Update 1

**Date of issue:** 08/03/2017

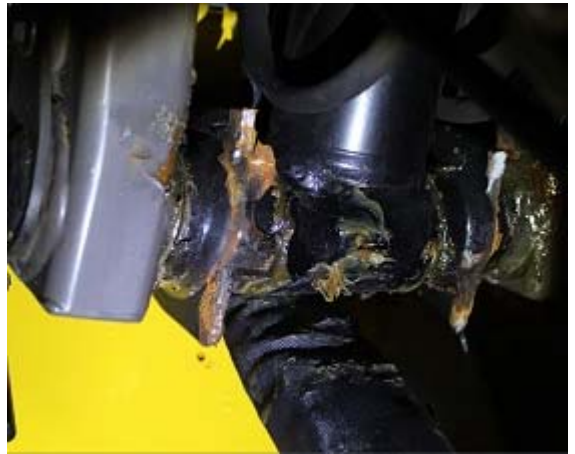
While the machine was in travelling mode the boom rotor assembly holding the basket failed resulting in the basket falling backwards onto the track. The basket was about 1 metre above rail head level at the time with one operator and light tools in the basket. The operator was not injured.

While the exact cause of the failure is not yet known, it is no longer believed to be a manufacturing related defect. Detailed examination once recovered to Cadder depot revealed (un-reported) collision damage at MEWP basket floor level (possibly by a low loader sized lorry whilst the MEWP was parked in the compound) and distortion of the load pin and main boom distortion. The repetitive action of raising and lowering the basket caused flexing of the fabricated assembly where the sleeves were welded through and metal fatigue developed until ultimate failure.

- All MEWPs based on the Manitou models 160 ATJ PLUS and 160 ATJ PLUS RC (both rail mounted and construction variety) are to be quarantined **IMMEDIATELY**.

- All identified MEWPs are to be visually inspected for signs of impact damage, if any are found to have been damaged then a NDT inspection must be conducted.
