Slippage of OLE catenary wire in of Bonomi forked collar

Ref: NRA 17/03 Issue 2

Date of issue: 20/07/2017

Location: Edinburgh Glasgow Improvement Programme (EGIP), Scotland

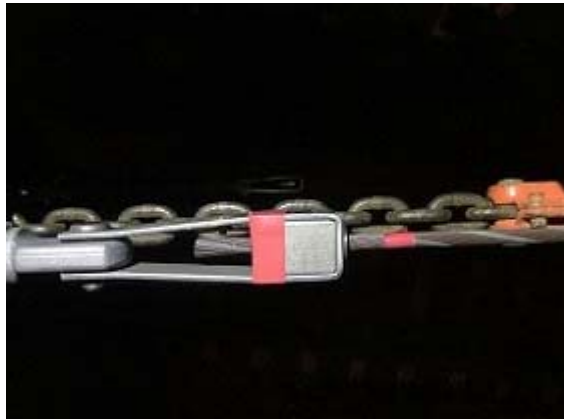
On Friday 5 May 2017 an inspection by the EGIP team discovered that the Overhead Line Equipment (OLE) catenary wire within a Bonomi forked collar socket C21/544/001 had slipped from its original installation position.

Whilst the wire remained anchored there is the potential that further slippage would result in an OLE de-wirement. This was the third reported slippage of the black catenary Bonomi Forked collar on EGIP K01 since April 2017.

- Any Bonomi forked collar sockets that are installed to final system tensions do not require further monitoring after an initial visual inspection.
- If the tension of any catenary wire is modified or disturbed then any Bonomi forked collar socket is to be replaced at the time of those works.
- The previous action requiring periodic inspections has been rescinded.
- Any safety rigs installed can be removed if there is wire protruding past the end of the collar.
- The Network Rail Product Acceptance, PA05/06543, of the Bonomi forked collar sockets, 091/029042, 091/029043 and 091/029044, has been suspended and the product shall not be installed on Network Rail infrastructure.
