### Safe working arrangements for pantograph access

**Ref:** NRA 17/05 Update 1

**Date of issue:** 07/08/2017

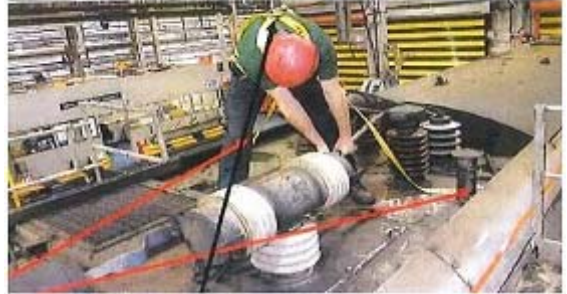
Figure 10 Lanyards correctly attached and connected to the rear of the safety harness allowing work to commence
