Vegetation encroachment on overhead line equipment

Ref: NRA 18/11

Date of issue: 10/07/2018

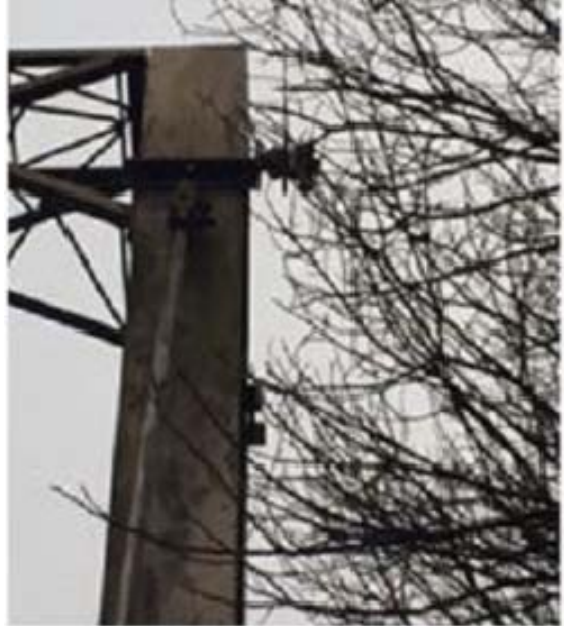
The most recent event was at Dutton Viaduct, on the London North Western Route, where vegetation was in contact with the return conductor.

This resulted in the return conductor parting and a lineside fire causing significant damage to the S&T location cabinets in the area.

- Vegetation within 2.75m of Overhead Line Equipment shall be recorded and managed as a defect in accordance with NR/L2/ELP/21087.
- Vegetation within 1.0m shall be treated as a critical defect.
- Where vegetation defects cannot be managed in accordance with NR/L2/ELP/21087 then a Temporary Variation is required against the standard and safety mitigation measures are to be implemented.
- Vegetation management during nesting period shall follow [Safety Advice NRA 18/08](#).
