## Safety Advice

## Geismar/MAN 18T MEWP Stabiliser Leg Failure

Ref: NRA23-12

Date of issue: 19/09/2023

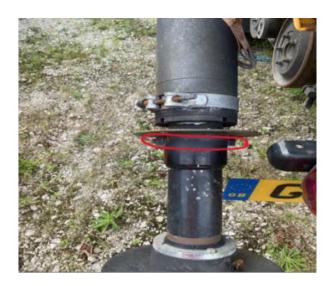
In North West and Central, a Geismar 18T MEWP was found to have a stabiliser foot assembly that had become completely detached from the stabiliser leg. The stabiliser legs are used in conjunction with the crane and can also be used to increase the reach of the basket.

Investigations are ongoing, but initial inspections have indicated that a combination of wear and corrosion have led to the single bolt connecting the foot assembly to the stabiliser leg failing.

- All stabiliser legs and feet assemblies to be thoroughly inspected by a competent person.
- Do not use the stabiliser legs on the Geismar 18T MEWPs until the inspection has been completed and any required remedial work has been carried out.
