# Safety Advice

## Enerpac Stressing Equipment incident

Ref: NRA23-13

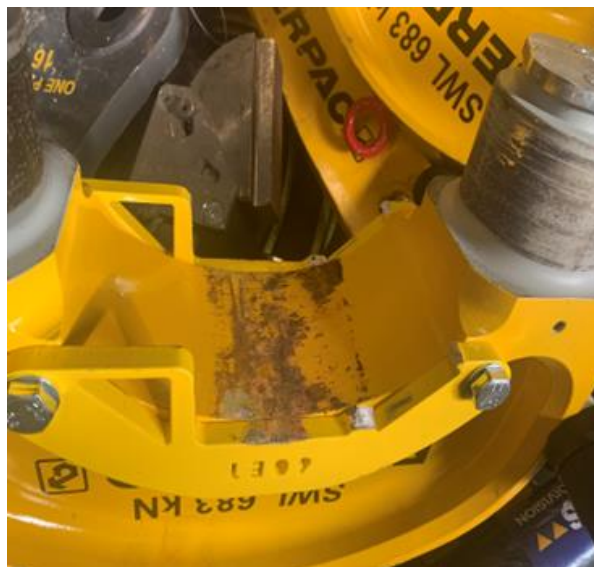
On Saturday 16<sup>th</sup> September 2023, the locating bracket on an Enerpac stressing kit snapped whilst the team were carrying out a stressing job. The stressing kit was correctly installed, but when the team pulled the rail the bracket started to crush and snapped.

The stressing job was around a curve with a radius of 805m and needed to be stressed over 23 chain. The equipment has now been faulted and placed in the quarantine cabin.

- All users of Enerpac stressing equipment should be made aware of this incident.
- Locating brackets on Enerpac stressing equipment should be inspected and reported and quarantined if damaged or deformed.
- Users should be aware of the failure mechanism and cease operation if the locating brackets start to deform during stressing
- Users should ensure that the Enerpac stressing equipment is set up and used in accordance with the manufacturer's operating instructions
