Safety Advice

Temporary road rail access panels left on an open line

Ref: NRA23-14

Location: Stoke Tunnel near Grantham, East Coast Main Line.

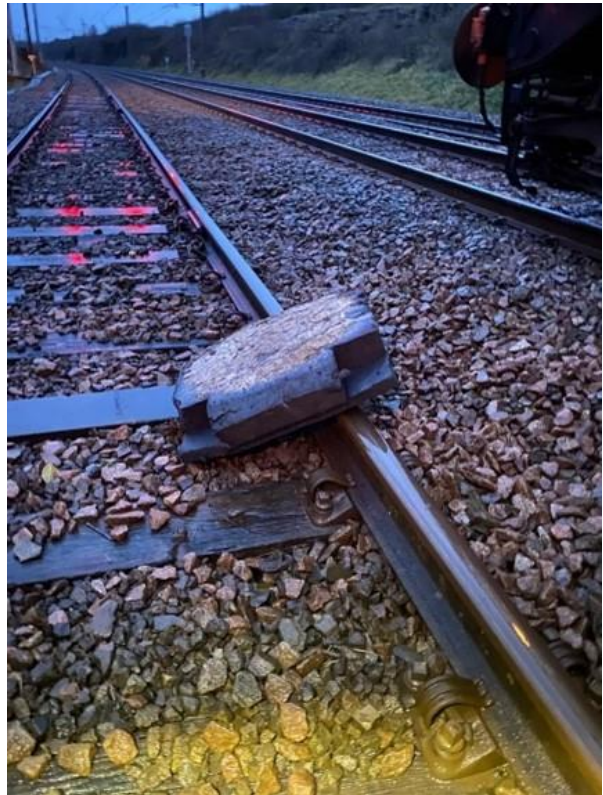
The machine was off tracked at the permanent RRAP on the Up Slow, the temporary RRAP on the Up Fast was inadvertently left in place, the team left site at 04:00.

At 06:00 LNER service 1Y00 travelling from York to London Kings Cross struck the temporary RRAP travelling at line speed. The driver of the train initially reported a train failure to which the assisting locomotive was deployed to recover the failed train. Upon travelling to the stricken train, it discovered two pieces of the temporary RRAP on the Up Fast and Up Slow which was subsequently confirmed to have caused the train damage.

- Any materials being left on site must be removed from the running line(s), secured (where required) in a position of safety to prevent damage to operating services.
- Where practical an electronic means of tracking equipment should be used, such as tagging devices.
- When accessing an RRV you should try and use a permanent or semi-permanent RRAP (see NR/L2/RMVP/0200/P301 section 13)
- When handing back, the COSS is required to confirm the line is safe for the passage of trains.
