## Scaffold equipment failure at Waterloo Station

**Ref:** NRA25-05

**Location:** London Waterloo Station

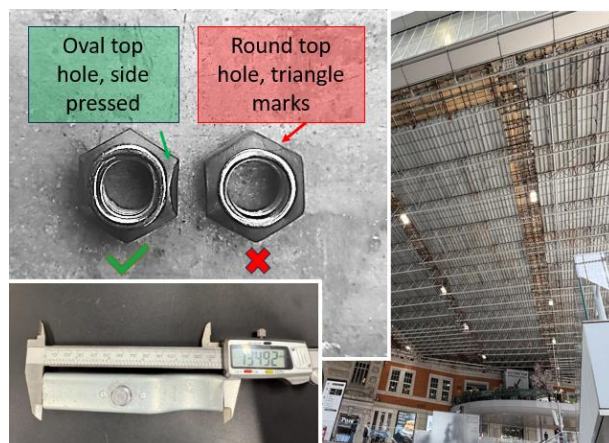
On Monday, 9 June, a passenger reported an object falling onto the concourse floor. The object was confirmed to be a locking clip from an aluminium plank used in the HAKI suspended scaffold system.

**The clip measures approximately 13.5cm and had the potential to cause serious injury or a fatality. Fortunately, no harm occurred in this instance.**

The affected component is assembled by HAKI using a locking nut intended to remain secure under normal conditions. The locking nut, supplied by another manufacturer, should have been crimped or pressed. However, in this instance it hadn't been.

It is believed that vibration and/or thermal expansion and contraction caused the assembly to loosen, resulting in the clip and its connecting bolt falling. The locking nut remained in place on the underside of the deck.

A properly compressed nut should feature an oval-shaped hole. The failed component (pictured) was found to have a round hole. HAKI has raised a non-conformance report regarding this issue.

All work was halted immediately. The scaffolding contractor is now conducting a full inspection of the nut-and-bolt assemblies on every plank before works resume.

- **Precautionary Checks:** HAKI advises that users inspect the tightness of the nut and bolt securing the locking device. This can be done using two wrenches to confirm the locking nut is fully functional. Any decking panel with a loose or damaged locking device must be removed from service, in line with the product manual.
- **Inspection Prior to Installation:** All scaffolding components — **regardless of manufacturer** — must be inspected thoroughly before installation, especially in applications above areas accessible to the public.
- **Temporary works design:** Ensure your temporary works design has been thoroughly assessed for potential hazards and risks.
