Safety Advice

Operational Restrictions on use of FSKII Circuit Breakers

Issued to: **E&P Community, Sentinel Sponsors and registered contractors**
Ref: NRA25-10

Date of issue: 02/09/2025

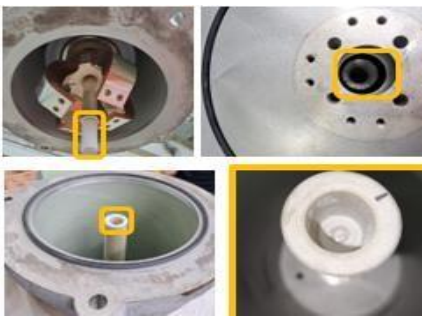
Subsequent investigations have found that a Circuit Breaker, which is an ABB supplied FSKII Circuit Breaker (top photo), had failed in the closed position;

- **Failure Cause:** The operating rod became detached from its base within the high- voltage (HV) pole. This detachment disrupted the mechanical transmission chain between the actuator and the vacuum interrupter, preventing proper operation.
- **Vacuum Interrupter Condition:** The vacuum interrupter was inspected and found to be free of abnormalities. It remains fully functional.
- **Supplier Investigation:** A detailed review of the operating rod’s supplier did not reveal an underlying design flaw.

Where an ABB FSKII Circuit Breaker is being used to effect an Emergency Switch-Off, a second open point shall be created in series with the FSKII breaker before confirming that the ESO has been taken.

Where available, the second open point should be a motorised air-break disconnecter (e.g. Busbar disconnecter), but otherwise may be the TNO/DNO Circuit Breaker, Feeder circuit breaker, bus coupler, set of track feed circuit breakers or overhead line switches and may be another FSKII circuit breaker.

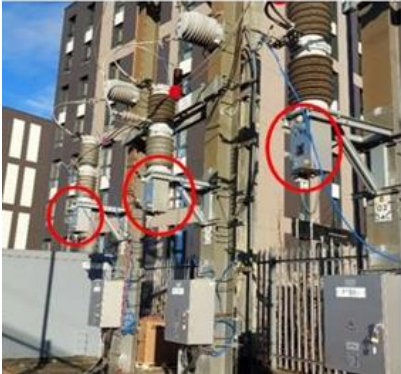
Rating plate in HV Pole, located at the magnetic actuator enclosure.

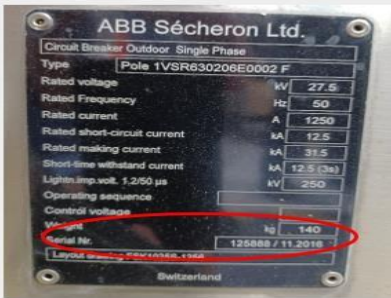
HV Pole Serial Number (125888)/
Manufacturing Date (11.2016)
