# Safety Bulletin

## Molten metal burn to fabricator during bridge refurbishment

**Ref:** NRB 16/17

**Location:** Bridge at Conisbrough, South Yorkshire

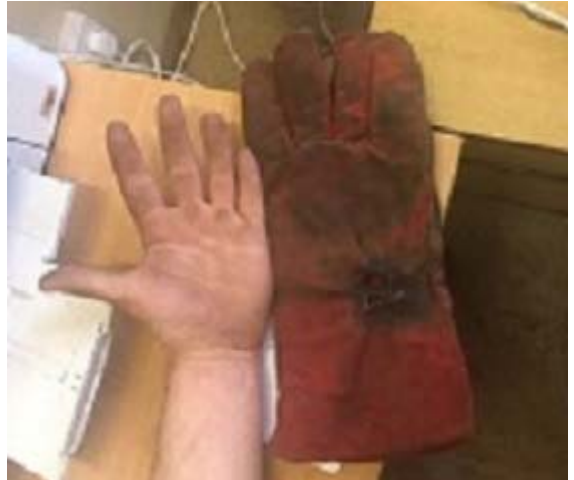
Unknowingly, molten metal had burnt through the palm of their leather gauntlet causing them to suffer minor burns to their forearm and wrist. The leather gauntlet as worn and shown above is the Warrior Red Split Leather Welding Gauntlets (0111WRSC).

Early investigations suggest the gloves may be a inferior import version. The company has since removed and replaced them with the Weldas Comfoflex (10-2087) shown opposite whilst they investigate this issue further.
