Safety Bulletin

Control of railway fog signals (detonators)

Ref: NRB 17/05

Date of issue: 17/03/2017

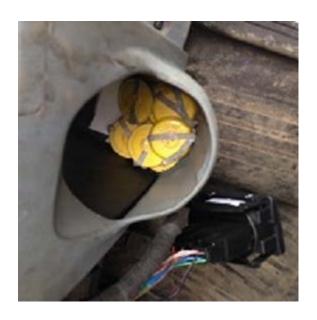
While carrying out fieldwork for a road fleet maintenance audit at Newcastle Delivery Unit's Raven House an auditor noticed fog signals (detonators) present in the vehicle's cup well.

Further checks were made and in another vehicle detonators were again present in the front cup well.

The event was reported to local staff and management who quickly rectified the issue and a close call was raised reflecting the auditor's concern.
