## Advanced lookout struck by a train

**Ref:** NRB 17/18

**Date of issue:** 24/08/2017

**Location:** Raynes Park, Wessex Route

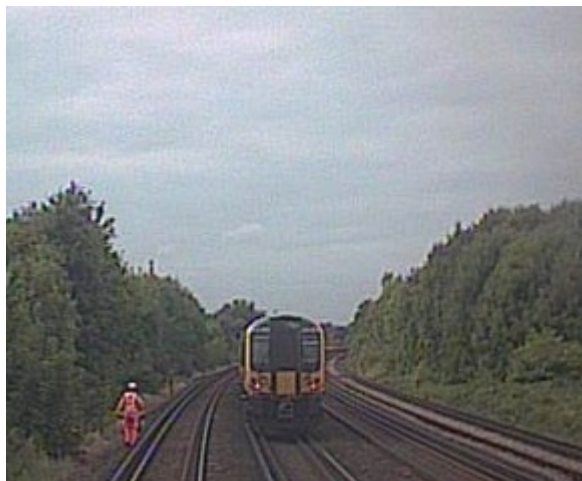
The advanced lookout was ahead of his colleagues, positioned in the down cess on a curve, in order to provide the required warning time to the team. He was standing on the raised ballast shoulder.

One train was passing on the down fast line when a second train approached the advanced lookout on the down slow line at approximately 45mph. That train struck the advanced lookout's right elbow. He was facing the other way as it approached.

When trains passed on either of the down lines, the lookout's view of any trains on the Up lines was compromised.

- How do you maintain awareness of all trains, particularly when focusing on a specific task like looking out in one direction?
- How does the lookout make sure they are in a position of safety while performing their duties?
- How can site conditions such as vegetation impact upon or change the safe system of work in practice?
- How should planners, responsible managers and trackworkers assess whether an area is suitable for working under lookout protection?
