Safety Bulletin

On Track Plant overturned during tandem lift

Ref: NRB 18/15

Location: Market Harborough

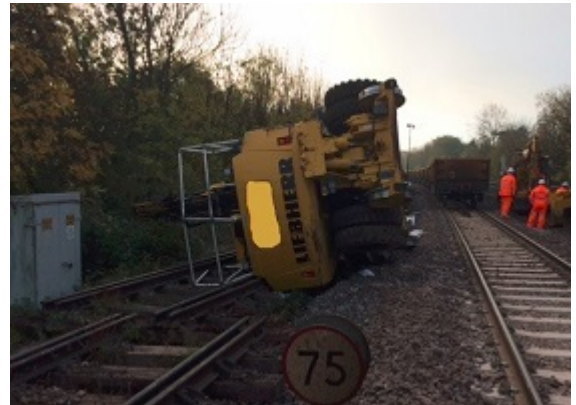
On 22 October 2018 at approximately 03:00 on an Infrastructure Projects site near Market Harborough, a Road Rail Vehicle Excavator Crane overturned whilst tandem lifting concrete sleeper track panels.

- How do we confirm that Lift Planners have planned lifting activities using the correct Duty Charts or planning tools for the specific On Track Plant (OTP) being used?
- How are Lift Planners provided with and able to confirm the dimensions of the load that is to be lifted?
- Practically, how do Machine Controllers confirm that OTP is operating in the correct configuration as detailed in the Lift Plans?
- How do Machine Controllers confirm that OTP is operating in the correct mode when tandem lifting and that Rated Capacity Indicator (RCI) is switched on and functioning correctly?
- How do the Machine Controller and Plant Operations Scheme (POS) Rep confirm the OTP is the equipment identified on the Lift Plans?
