# Safety Bulletin

## Colmar T10000 RRV derailment and overturn

**Ref:** NRB 16/04

**Location:** Riding Mill, Northumberland

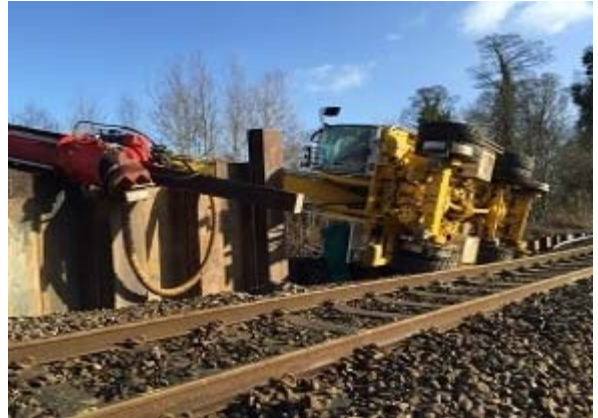
During the early hours of 2 February 2016, a team of piling contractors were carrying out emergency bank slip works on the NEC2 line. During the works a RRV Colmar T10000 derailed and fell over onto its side landing in the up cess.

The machine with piling rig attachment fitted was slowly moving forward when the wheel flange appears to have ridden up the cess rail leading to the machine itself derailing.

- Prior to planned works with RRVs, how do we consider the track geometry, in particular in relation to twist and cant levels?
- How are checks made to confirm that the track geometry is compatible and within the machine's working limits as set out in its Engineering Acceptance Certificate?
- When RRVs involved in piling works are required to transit with the rig attached, how is everyone's understanding of the correct measures to maximise stability assured?
- In particular:
  - Aligning the rig so it is parallel with the track and centred in the four foot;
  - Fully lowering the piling rig and hammer for a lower centre of gravity?
