Trench collapse

Ref: NRB22-07

Location: Eastbourne, Sussex route, Southern region

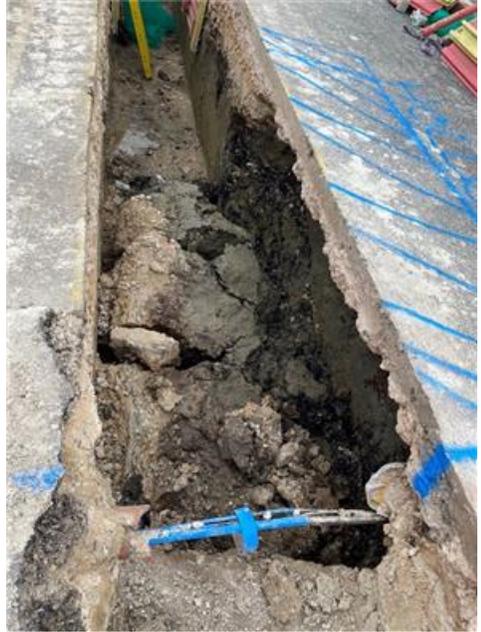
Rather than come out of the trench to install the next set of temporary trench shoring, one person walked along the unsupported trench to the required location to install the trench support in an unplanned manner from within the trench. Clay from the side of the trench came loose and struck the operative on the right hip causing bruising.
