Safety Bulletin

Multiple trains in a signal section

Ref: NRB22-12

Location: Wingfield, Alfreton, Derbyshire

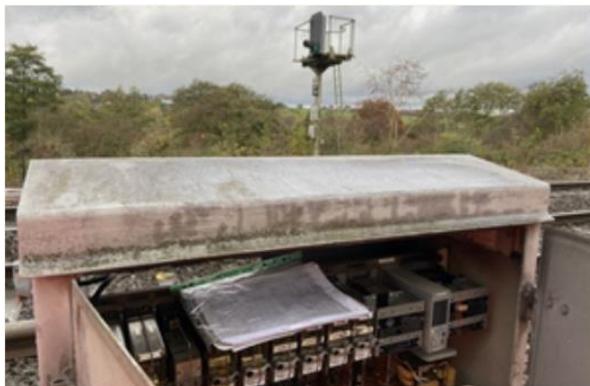
Ballast cleaning works undertaken in the area required disconnection at DY586 signal and associated equipment. When the signalling system was reinstated following completion of the track works, the yellow and red aspects on DY586 signal were transposed.

The incorrect aspect sequence resulted in the first train passing the signal at red when it should have been yellow, and a yellow aspect shown to the following train when there was a train in the forward section.

Testing to reinstate the signal after the works, was not carried out in accordance with the Signal Maintenance Testing Handbook (SMTH). Testing steps in the SMTH would have identified the transposition of the aspects had they been followed. The error was not self-revealing.

- Are SMTH testers aware of the importance of the words “check with the maintenance test plan for all items of equipment fed by the affected piece of equipment being changed and carry out the steps marked with an asterisk” in SMTH?
- Where any steps in a test plan have not been completed, are SMTH testers aware that the Line Manager must be informed and the equipment must not be signed back for operational use, until the testing can be completed?
- When conducting a wire count, are SMTH testers aware of the requirements to check cable core numbers against the wiring diagram?
- This irregularity is similar to the Clapham Rail Disaster, which killed 35 people and injured 484 resulting in the introduction of SMTH. More recently, the derailment at Dalwhinnie was a result of a failure to apply SMTH correctly. How can we prevent this happening again?
