HW Machine Incident

Ref: NRB23-05

Date of issue: 24/05/2023

Location: Ridham, Kent

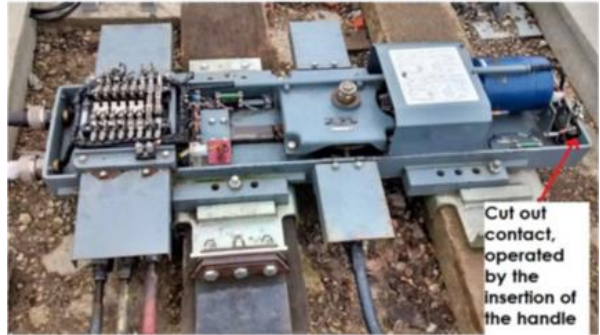
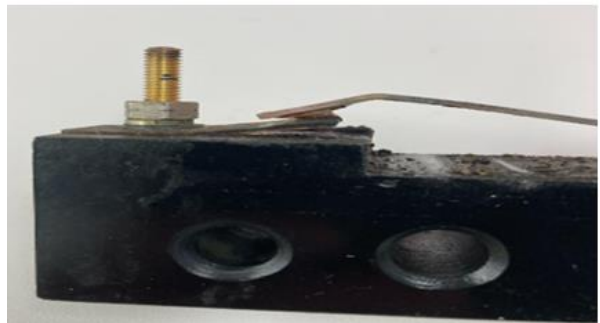
An S&T team were undertaking a full annual service to 2501B HW points at Ridham. The point winding handle was installed for manual operation and the technician began winding the points.

Once detection was lost the point machine motor then tried to drive back to normal. This spun the handle around at high speed with the technician's hand holding the handle.

The technician had managed to let go, however, felt a small amount of pain, but not enough to report it at the time.

Later that evening the IP felt some pain when they got home and went to hospital where they had an X-ray, which confirmed a small strain/hairline fracture to their metacarpal.

- S&T Discipline - Are you and your team clear on:
 - SMS/PartC/PC05 3.1 Examine the crank handle cut out contact. Check that when the crank handle is inserted the contact breaks
 - SMS/PartC/PC05 6.1 Isolate the machine by inserting the crank handle and confirming the crank handle contact breaks

Until further notice it is recommended that once a point machine is believed to be isolated (crank handle inserted), stand well clear and request the signaller to swing the points. The points should not move. If they do, or any doubt please contact your local S&T section for advice.
