Safety Bulletin

Fishplates found missing following track inspection

Ref: NRB25-03

Location: Park South, Cumbrian Coast line

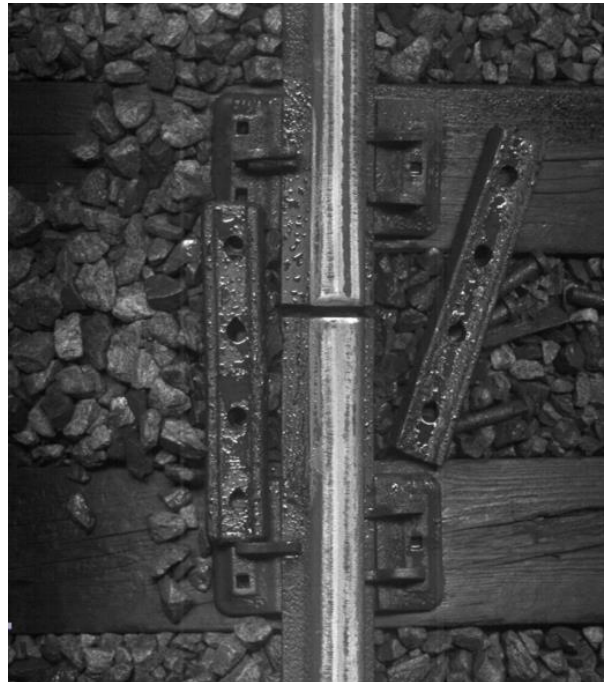
On Thursday 4 September a review of data gathered from an Ultrasonic Test Unit train identified a track joint with all bolts and fishplates detached from the rail at Park South on the Cumbrian Coast line.

A Basic Visual Inspection (BVI) of the track was completed at this location on 20th August in a routine midweek night line blockage. The BVI identified a cracked fishplate at a joint adjacent to this one.

Due to difficulties in installing the replacement fishplates, the fishplates on the adjacent joint were removed to allow some movement of the rail. For reasons not yet understood, these fishplates were not reinstalled before the line blockage was handed back.

Actions were taken immediately to protect the line until repairs were carried out.

Track standards require that a cracked fishplate is replaced within 24 hours of discovery. The team had sufficient access to replace the fishplate in the access they had so made arrangements to do so.
