Shap Cutting Derailment

Ref: NRB25-06

Date of issue: 30/12/2025

Location: CGJ7 Shap Cutting Upside, 0280yds to 37m 0287yds Shap, North West Route

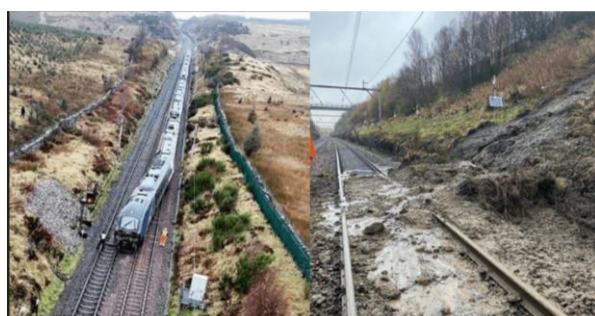
At 06:10 on 3 November 2025, Avanti West Coast service 1R22 struck a landslip on the up main at Shap in Cumbria and derailed. The train was travelling at approximately 80mph. All 86 passengers were safely evacuated with four passengers being treated for minor injuries.

Shap cutting is a 13m high soil cutting formed in the Marsett Sandstone Formation (bedrock geology) overlain by Glacial Till (superficial geology).

Ground conditions at the time of the landslip were wet and approaching saturation with 27 mm of rainfall falling in 6 hours. Levels of saturation and rainfall, although high, were not exceptional.

A drainage condition inspection of the mid-slope drain on the earthwork was completed on 24 September 2025 and sections of it were scored with a service condition 4: performance severely reduced.

It is believed that during the rainfall event that this blockage caused water to discharge locally on to the slope

Our understanding of the root cause of the derailment will be informed by the investigations being undertaken. Our current understanding is that the cause of the derailment was a landslide caused by a drainage blockage that led to localised saturation of the slope.

Additionally, the EFDS signal was unable to pass through the layer of material which covered it following the rapid landslip. See RAIB Urgent Safety Advice [here](#).

- **In consultation with all Regions, Technical Authority have issued lists of sites with similar earthworks and drainage asset characteristics:** Route and Regional teams will be working to update evaluations to determine where accelerated works are required to manage risk.

- **Are you considering drainage condition and its potential impact to earthworks during EWAT's?** Defects in drainage may lead to significant safety risks at rainfall lower than extreme levels.

- **Do you know what EFDS systems you have deployed and understand its constraints to issue alerts?** Technical Authority are working with the principal suppliers of the EFDS to assess the feasibility of reducing the time period for sensors to report potential movement.

- **Do you have the alarms from Earthwork Failure Detection monitoring systems going into control centres?** This enables rapid response to be actioned in accordance with monitoring plans.
