Overspeed incidents, Somerset, 19 July 2016

2. Summary of the incidents

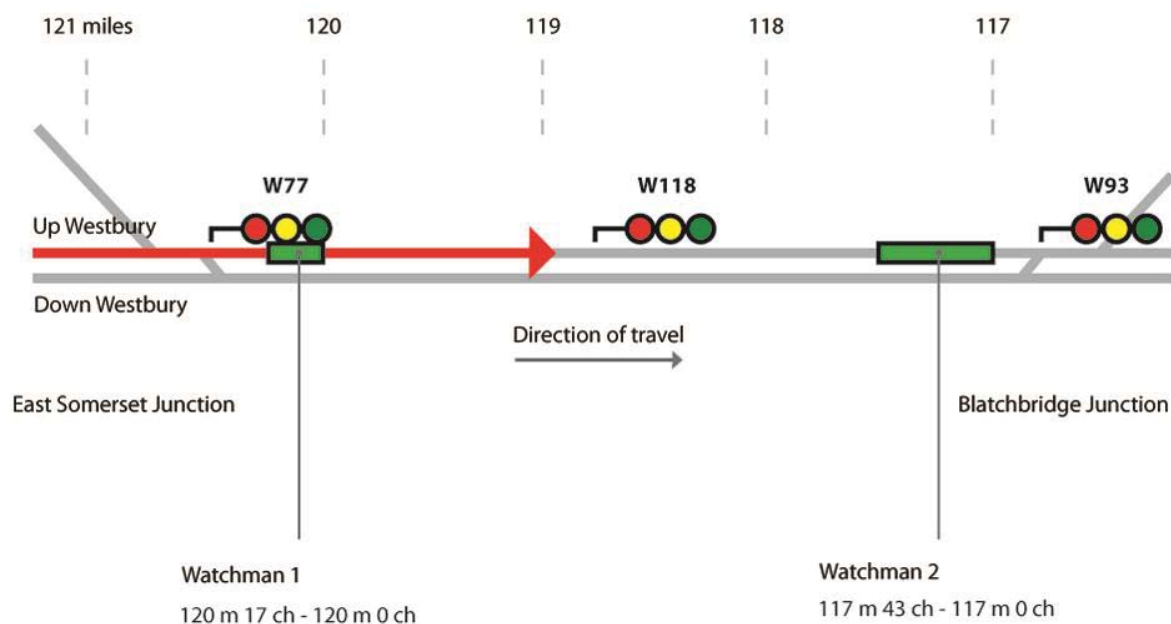
Simplified diagram showing relative positions of the speed restrictions (not to scale)
