Level crossing collision, near Dymchurch, 10 September 2016

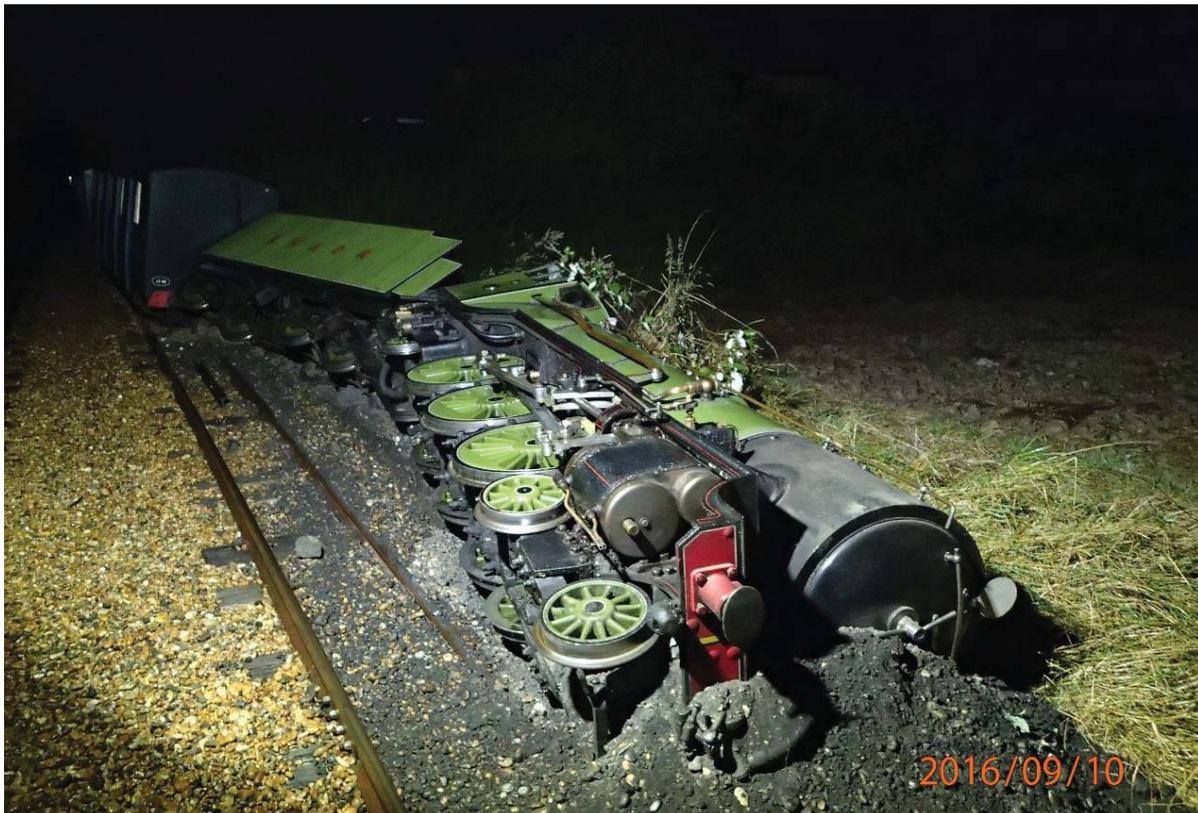
Romney Hythe and Dymchurch locomotive Number 1 'Green Goddess' lying on its side after the accident

The impact caused the steam engine and its tender to derail and tip onto their left-hand sides, coming to rest approximately 23 metres beyond the crossing. The first coach of the train was also derailed but remained upright. The front of the tractor was pushed sideways into the crossing gate and post.

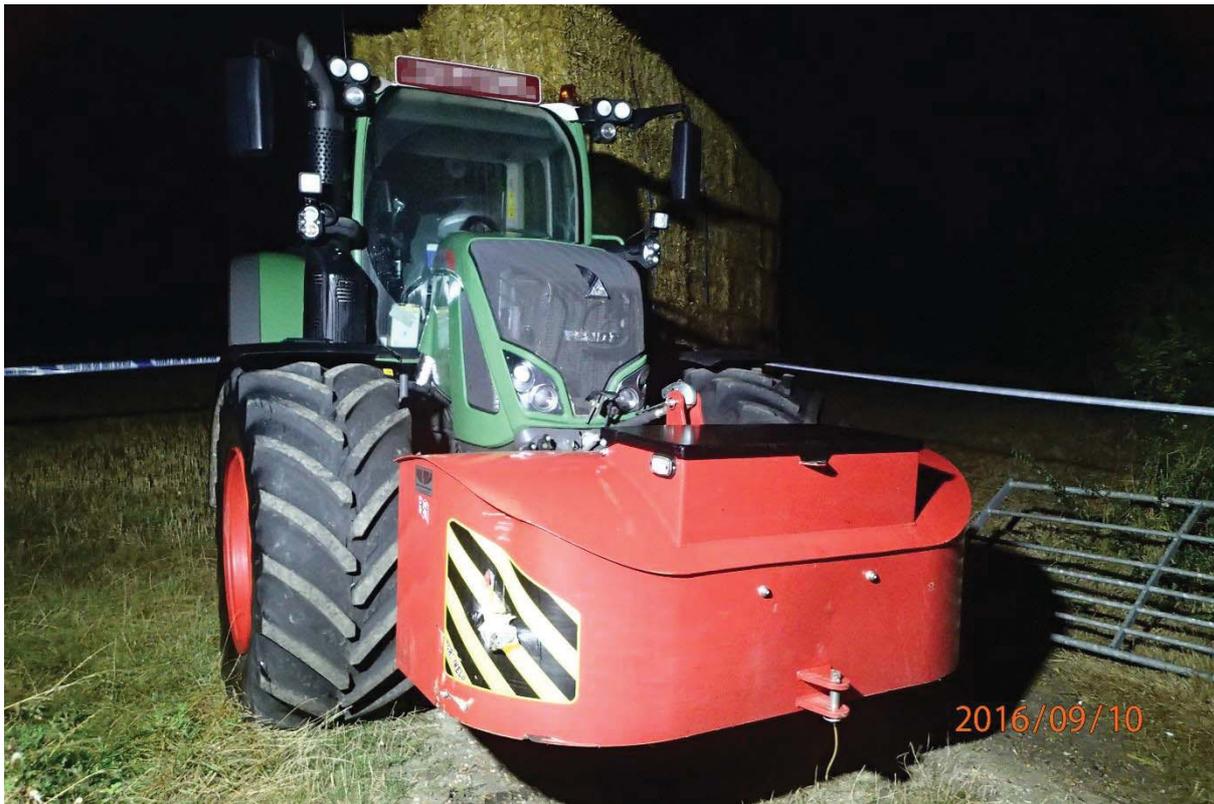
The tractor involved in the accident. The train hit the red counter-weight attached to the front

Having entered the crossing through the open gate and seen the train, the tractor driver incorrectly judged his stopping position, such that the tractor was partly blocking the line. He was not able to move his tractor away from the line quickly enough to avoid a collision once he realised his mistake.

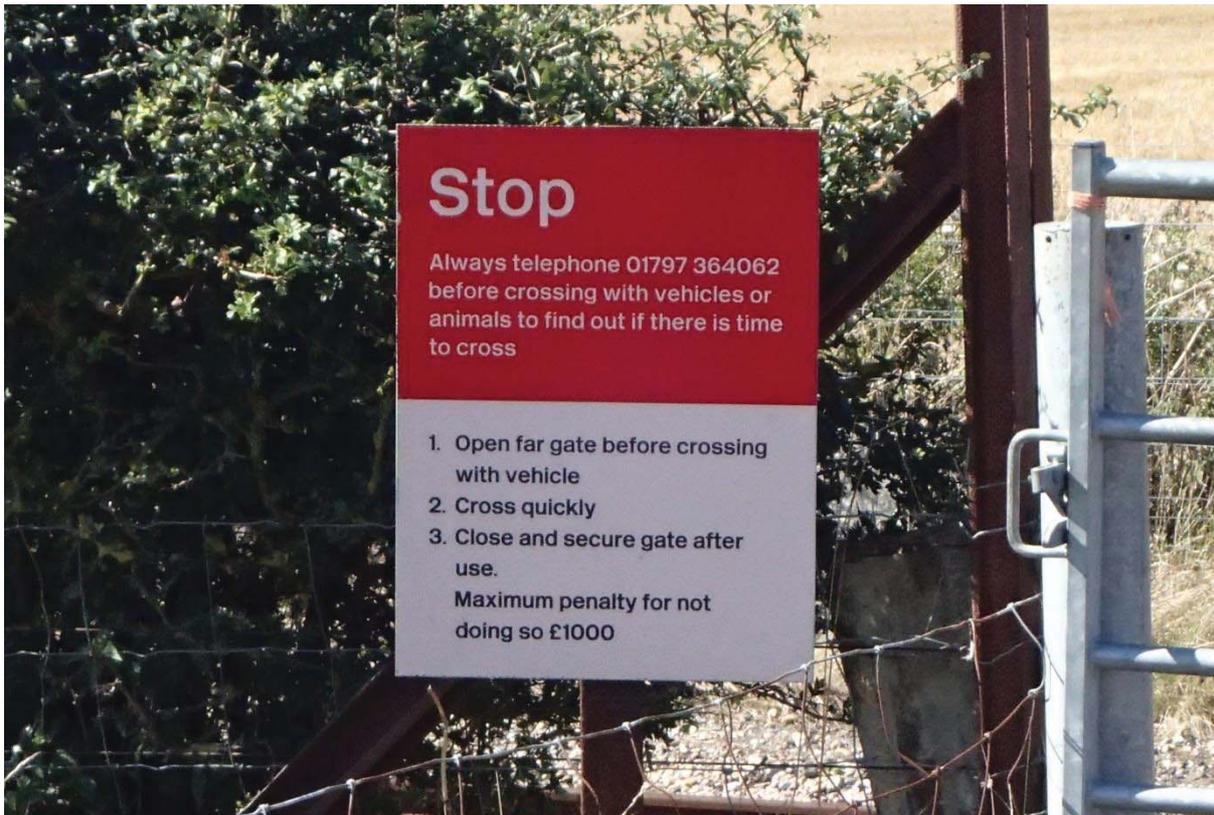
The tractor driver did not use the crossing in accordance with the instructions on the sign. He was not very familiar with this level crossing, having only used it for one day prior to the day of the accident. The tractor driver neither opened and closed the gates each time he crossed, nor telephoned the railway before using the crossing. Neither this driver nor any other farm worker had contacted the railway for permission to cross while harvesting was in progress during the week leading up to the accident.

One of the signs displayed on either side of the crossing, which give users instructions on how to cross

The RH&DR had not briefed the authorised user of this UWC in recent years and had no record of doing so earlier. The method described on the sign had not been briefed to the tractor driver by either his employer (a contractor working for the farm occupier), or by the farm occupier.
