Fire on heritage tram at Gynn Square, Blackpool, 24 September 2016

2. Summary of the incident

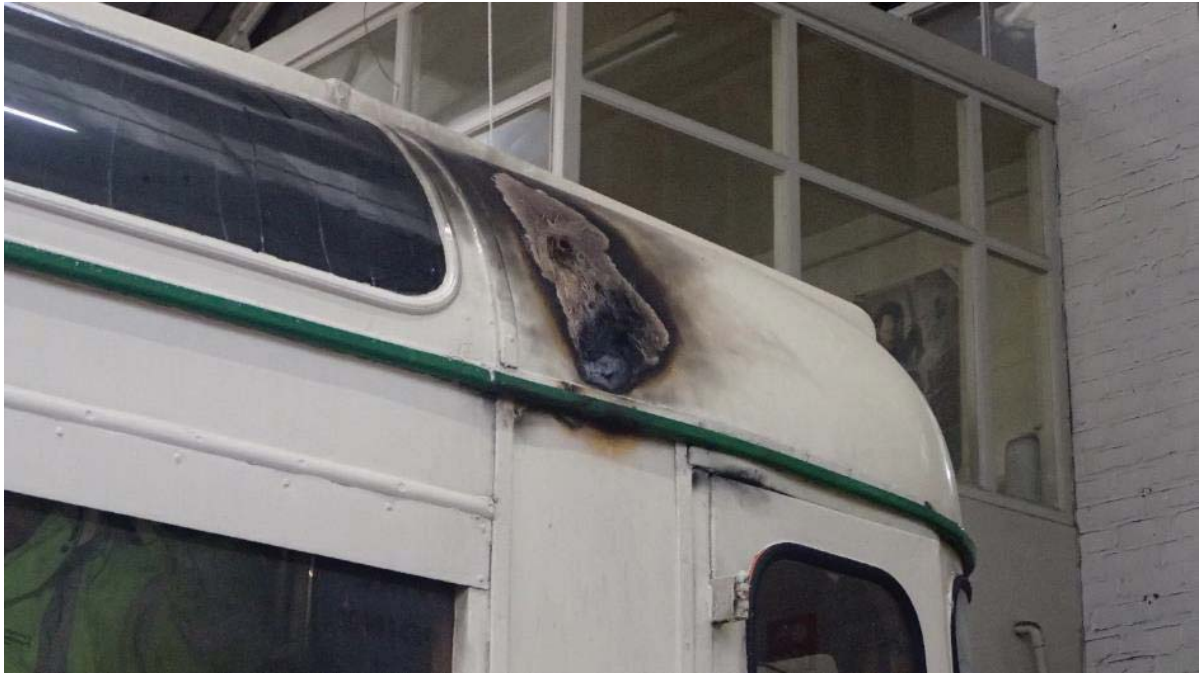
External damage to 272

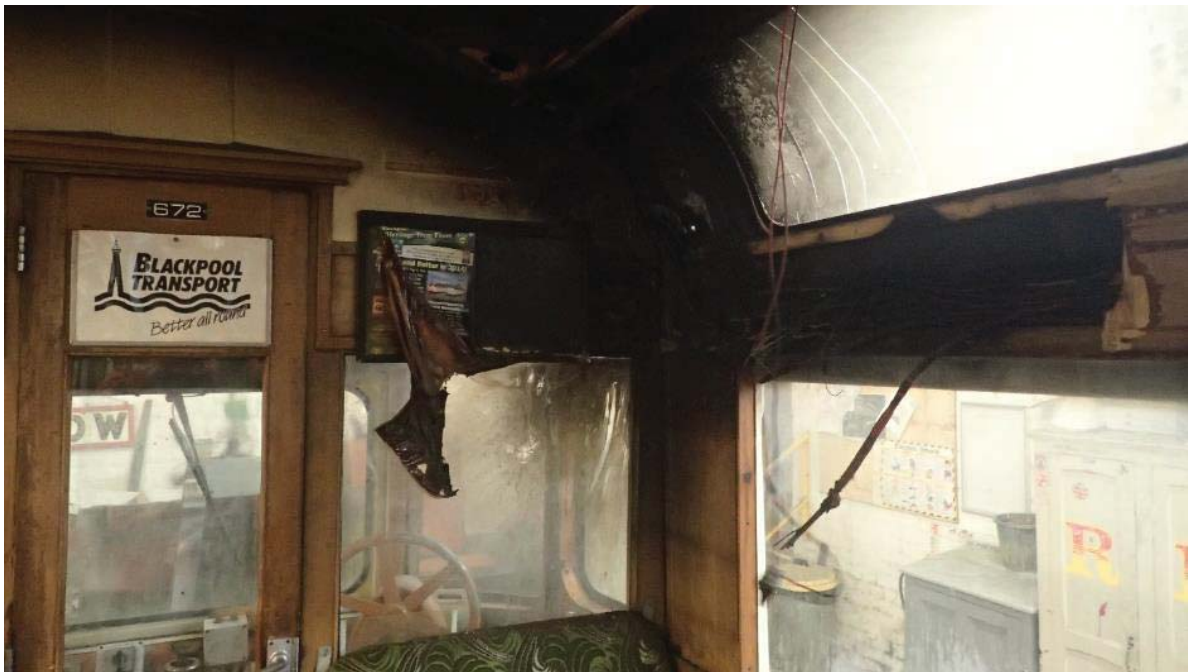
Internal damage to 272

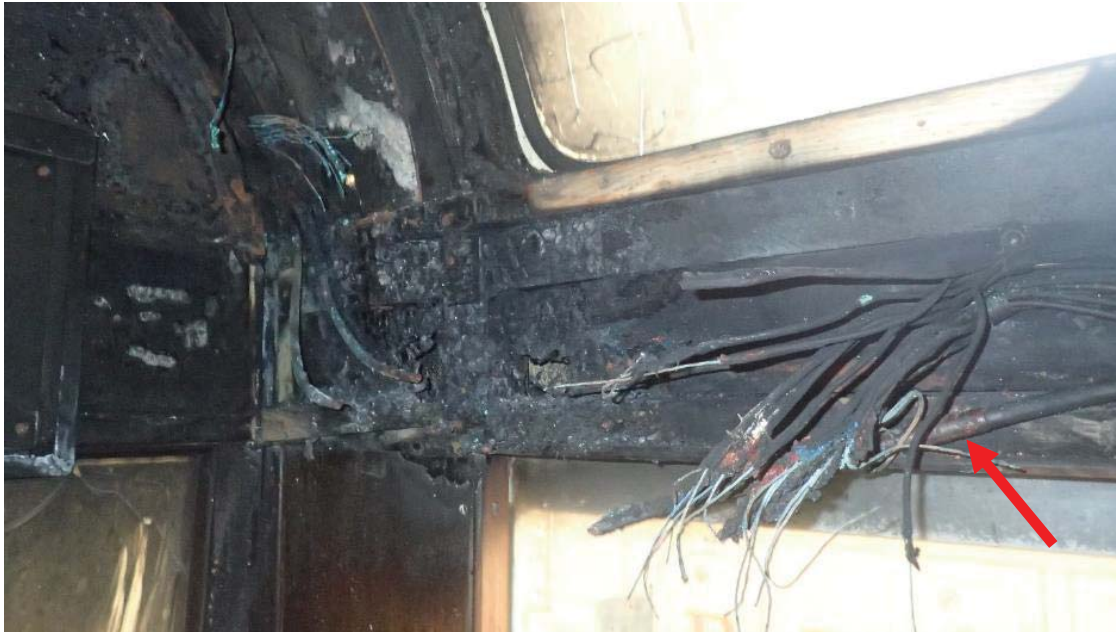
The fire was caused by the failure of the insulation on a cable which ran from the pantograph, via a roof fuse, to the main circuit breaker on the vehicle. This cable was constructed using Vulcanised India Rubber (VIR) insulation. The cable installed on car 272 comprised multiple copper cores surrounded by VIR, and a woven cotton outer layer.

Car 272 was built in 1935 as a single-vehicle tram known as an 'English Electric Railcoach'. In 1960, it was converted to its current configuration as the motor car of a twin-car unit. BTS believe that the VIR cable was installed during this conversion. VIR cable insulation degrades over time (for example, see [here](#)) and the degradation makes the cable insulation more susceptible to mechanical damage. During May 2015, cable repairs were carried out very close to the cable which subsequently failed. This repair work could have caused damage to adjacent cables. It is possible that the insulation failure and fire were caused by such damage, combined with water ingress into the vehicle (see later).

Fire damaged cabling within 272; the previous cable repair is indicated by the arrow

As is common with older tramcars, car 272 was built of non-conductive materials comprising wooden and fibreglass panels on a teak frame. In the absence of extraneous conducting materials, such as water, significant current will not flow to earth even from a cable with degraded insulation. The cables on 272 were subject to a satisfactory insulation test in February 2016 when BTS believed that the vehicle was dry. Due to the severe localised fire damage it is impossible to be certain about the exact development of the fire. It is likely that, subsequent water ingress from the weather and/or routine washing of the vehicle created an unintended path for current to flow. This current flow caused the cable to heat to a point where it caught fire. It is unclear if the initial ignition occurred in the woven cotton surrounding the cable or in the timber structure in close proximity to the cable.
