Collision between two freight trains in a work site near Ivybridge, Devon, 27 February 2016

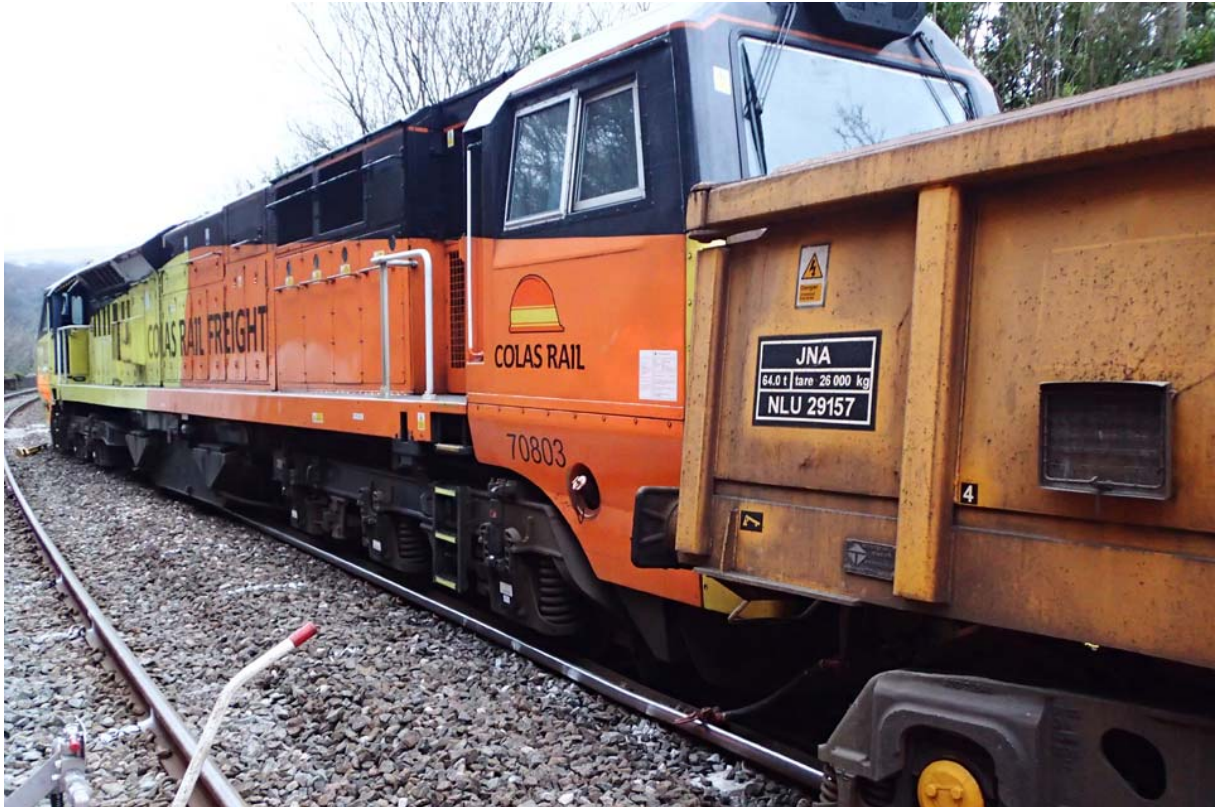
The derailed locomotive and the rear wagon

A freight train operated by Colas Rail collided with the rear of a stationary freight train while travelling at a speed of about 10 mph (16 km/h) within a work site on the Down Main line close to the old Ivybridge station, between Totnes and Plymouth. No one was injured although the freight train driver was badly shaken. The locomotive and the wagon immediately behind it derailed along with the rear wagon of the stationary train. These vehicles and the track beneath them were damaged.
