Near miss at Kyle Beck near Tollerton, North Yorkshire, 3 August 2016

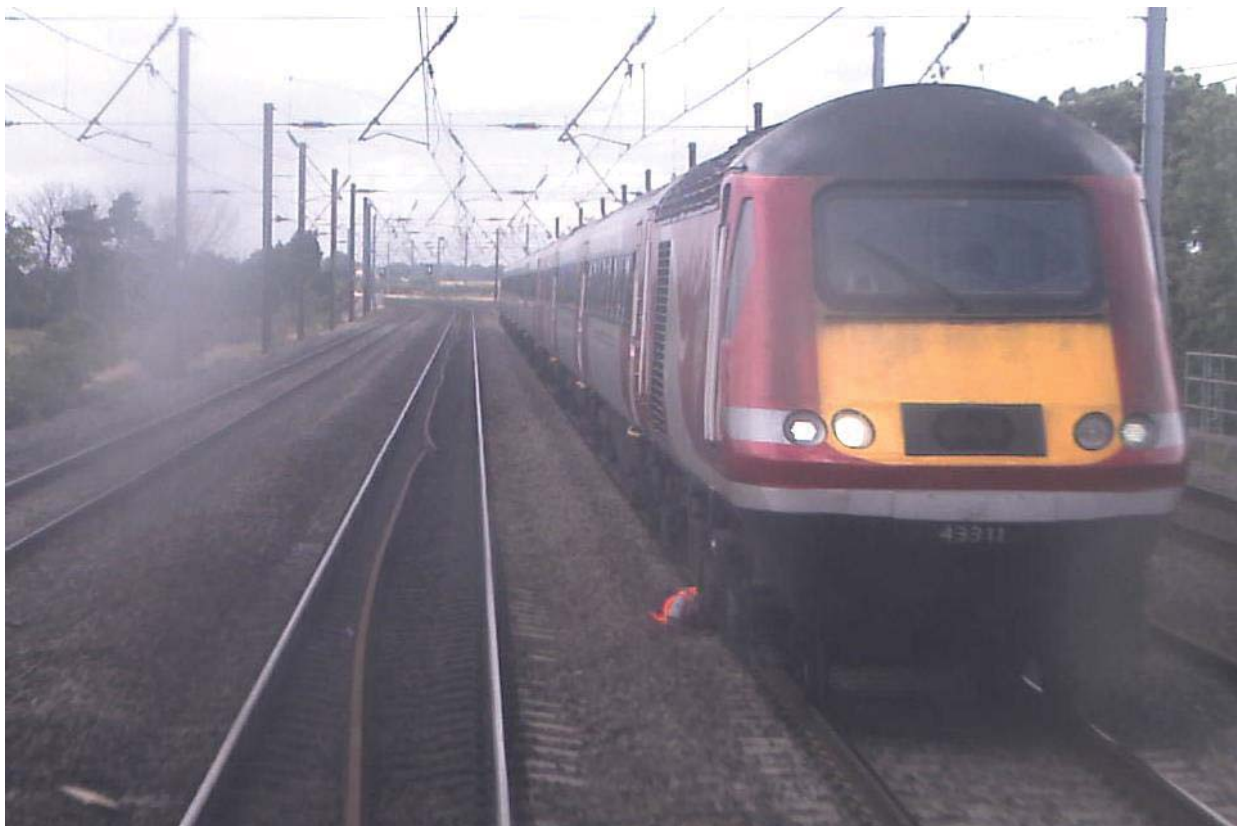
Still image from forward facing CCTV of train 1S16 showing the driver of 1E13 lying in the space between the up and down fast lines (image courtesy of Virgin Trains East Coast)

The permissible speed on the fast lines in the vicinity of Kyle Beck is 125 mph (201 km/h). Train 1S16 was still accelerating after passing through a 90 mph (145 km/h) temporary speed restriction around three miles earlier; as a result it was travelling at around 105 mph (169 km/h). The forward facing CCTV on train 1S16 shows that the driver of train 1E13 became aware of its approach approximately six seconds before it reached him. He then lay down close to his train in the space between the down fast and up fast lines; he was lying on the ground with three seconds to spare.
