Derailment at Paddington, 16 June 2016

2. Summary of the accident

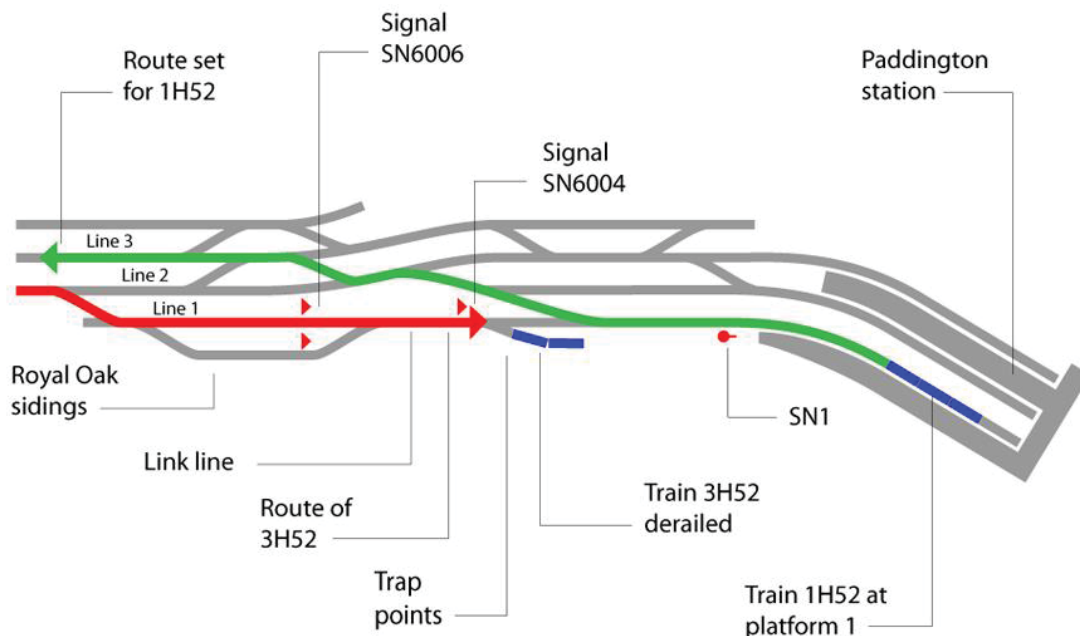
The approaches to Paddington platform 1 showing the routes set and the position of the trains after the accident (not to scale)

At 18:11 hrs the signaller set the route for 1H52 to depart from platform 1. One minute later he cleared ground position-light signal SN6006 for 3H52 to leave the siding. The signal displayed two white lights to the driver, which authorised the train to run along the link line as far as the line was clear, up to a similar position-light signal, SN6004. Train 3H52 would then be ready to run into platform 1 as soon as 1H52 had departed.

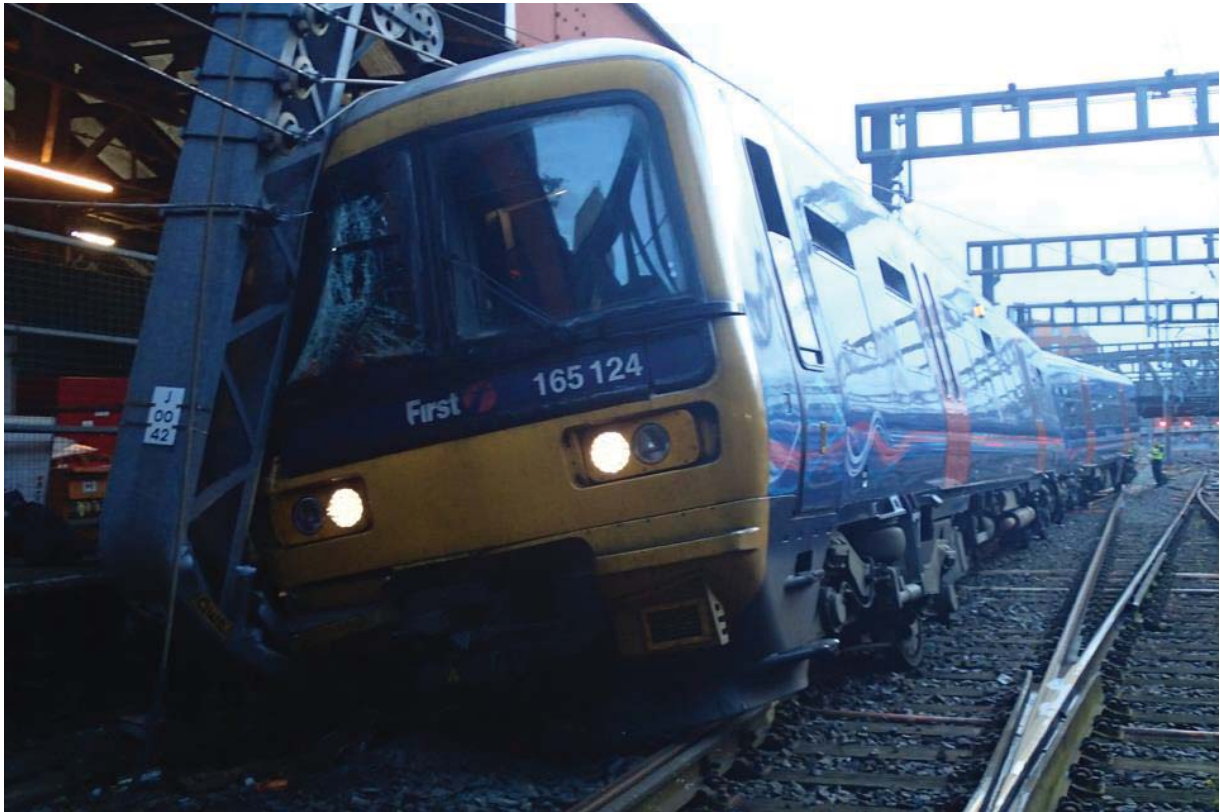
Immediately after he passed the signal the driver realised that his train was being diverted to the right, off the track, and so he made an emergency brake application. However, it was too late to prevent the derailment, and the first three bogies of the train ran off the end of the rails. The right-hand front corner of the train struck the mast of a cantilever structure (J 00 42) which supports OLE on line 1. The impact distorted the mast, and the cantilever dropped far enough to become a hazard for trains travelling on lines 1 and 2. The train was still moving at about 8 mph (13 km/h) when it struck the mast. The trap points diverted the train itself clear of the other running lines, and the derailed vehicles did not obstruct any other routes, so there was no risk of collision with another train.

The front of the derailed train and the OLE mast, after the accident

The OLE mast that was struck by the train is positioned 46 metres, the length of a two-car train, beyond the toe of the trap points. Network Rail's standard for the provision of trap points (former Railway Group Standard GK/RT0064) requires trap points to be located so as to guide derailed vehicles away from other lines, structures, and any other hazards. In the congested area close to Paddington station, there is little scope for varying the relative positions of trap points and OLE structures, and the distance available beyond these trap points would normally have been regarded as sufficient for a train that derailed on them to be stopped. In this case, because the train was travelling at the maximum permitted speed, and its brakes were not applied until after it had derailed, the space was not sufficient and the structure was damaged.

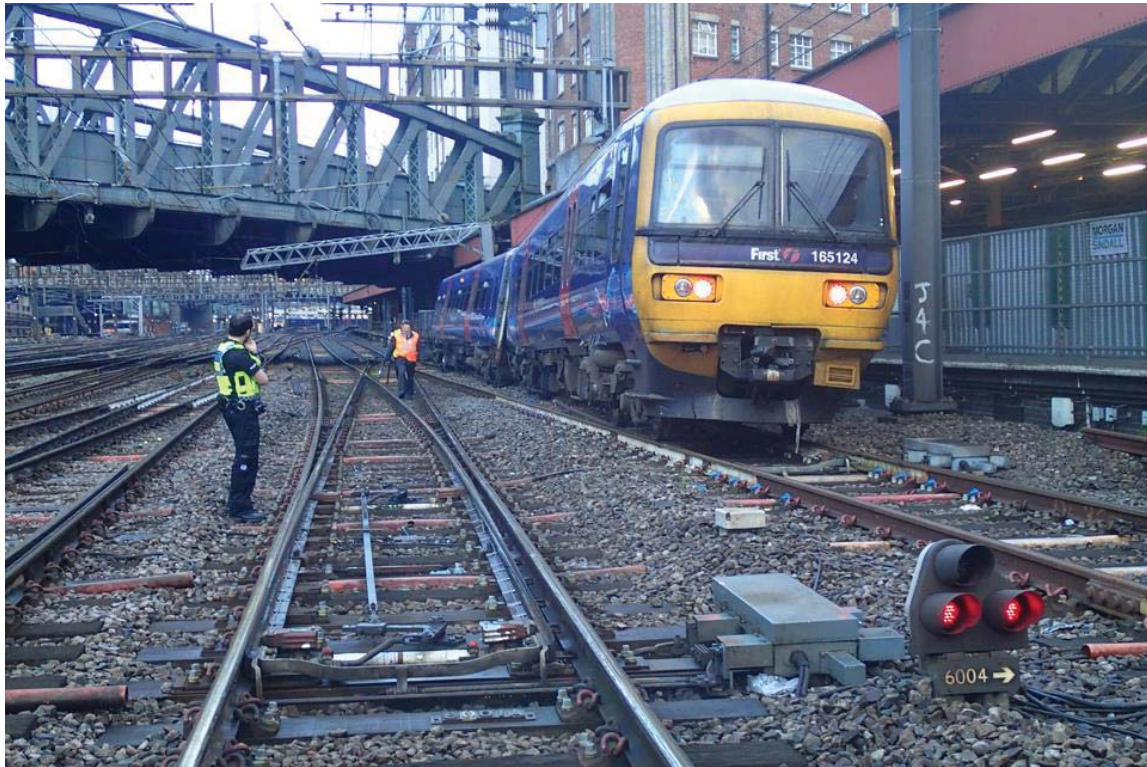
The driver of 3H52 started his train a few seconds after signal SN6006 cleared. He drove along the link line towards the station, reaching 25 mph (40 km/h), which is the maximum permitted speed on that line. Although he had not seen a train leave platform 1 since his conversation with the signaller, the driver had formed the impression in his mind that the clearance of signal SN6006 meant that the route was set all the way into platform 1. Signal SN6004 was clearly visible, but the driver did not realise that it applied to his train, so he drove past it although it was showing two red lights, meaning 'Stop'.

The train from the rear after the derailment. Signal SN6004 is at the bottom right
