# Collision between a train and an engineering trolley, Stowe Hill Tunnel, 7 December 2016

## 2. Summary of the accident

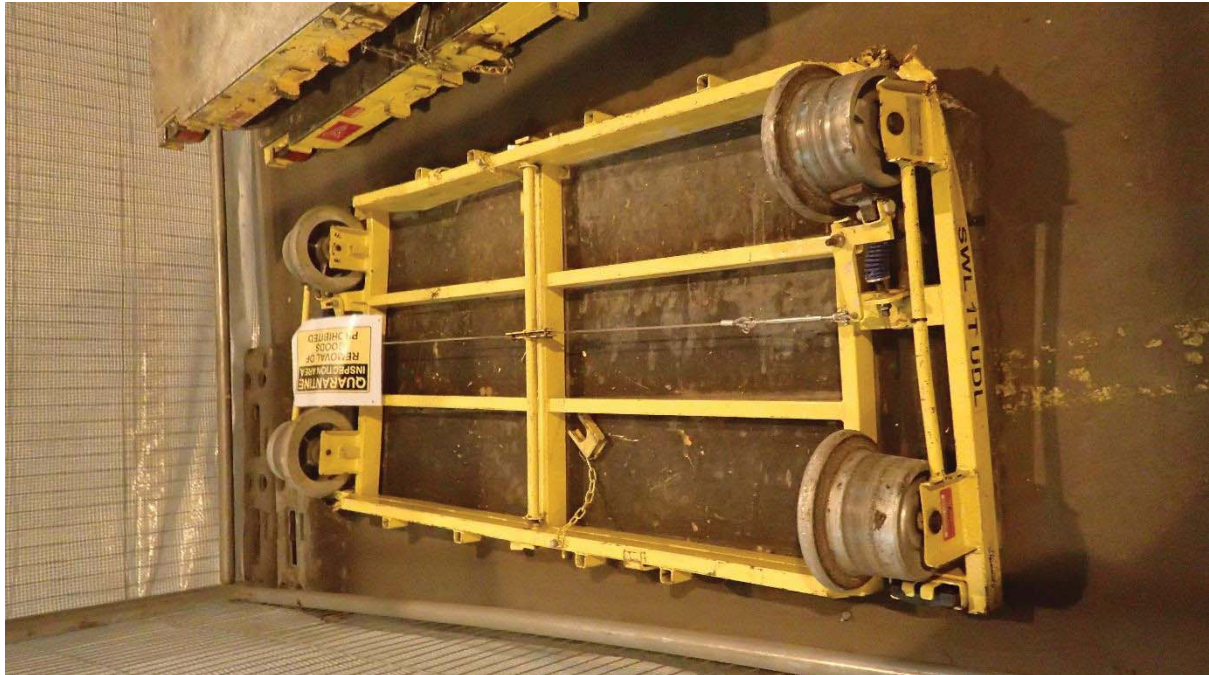
**The engineering trolley found between the Up Main line and the Down Main line**

- one trolley was between the tunnel wall and the Up Main line and had been completely destroyed;
- a second trolley was located between the Up Main and Down Main lines and had damage consistent with having been struck by passing trains;
- a third trolley was in the recess of pressure relief shaft No.1 and was undamaged; and
- a fourth trolley in the recess at pressure relief shaft No.2, also undamaged.

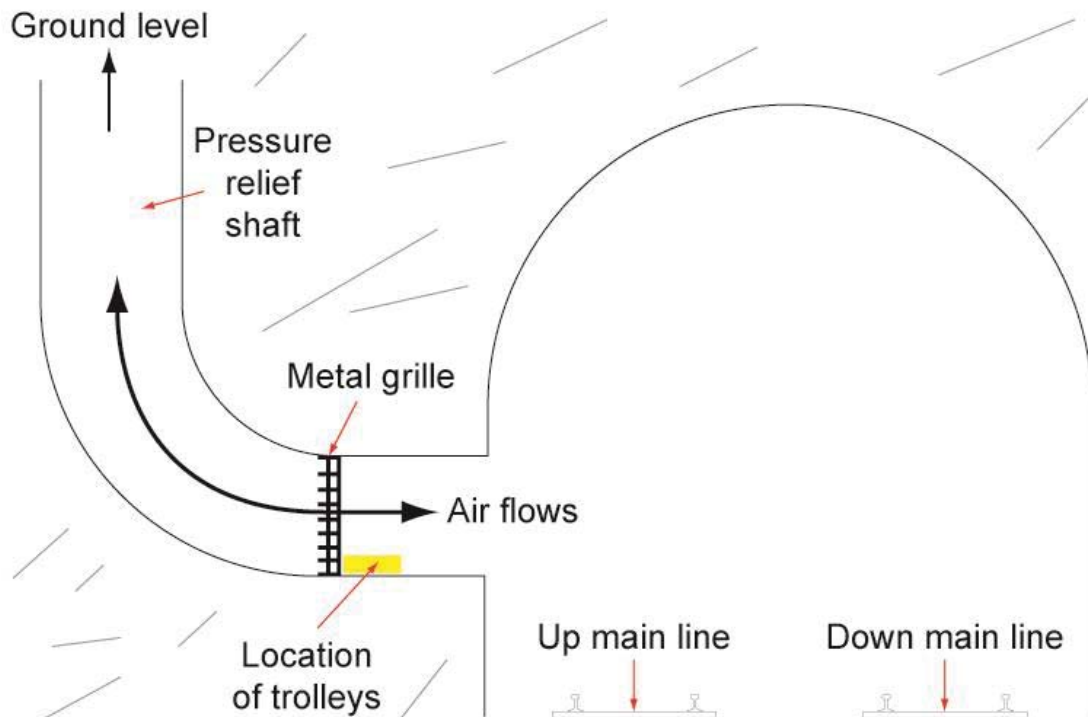
**Cross section through the tunnel showing pressure relief shaft and location of trolley stowage (schematic). The edge of the trolley is 1.77 metres from the Up Main line.**

The railway rulebook (GE/RT8000), Handbook 1, Section 7.1 states that 'Tools & equipment must not be placed any closer than 2 metres from a line on which a train could pass, unless you are absolutely sure that they will not be hit by a passing train or be moved by the slipstream of passing trains'. In this case the trolleys were less than two metres from the Up Main line, and had not been adequately secured.

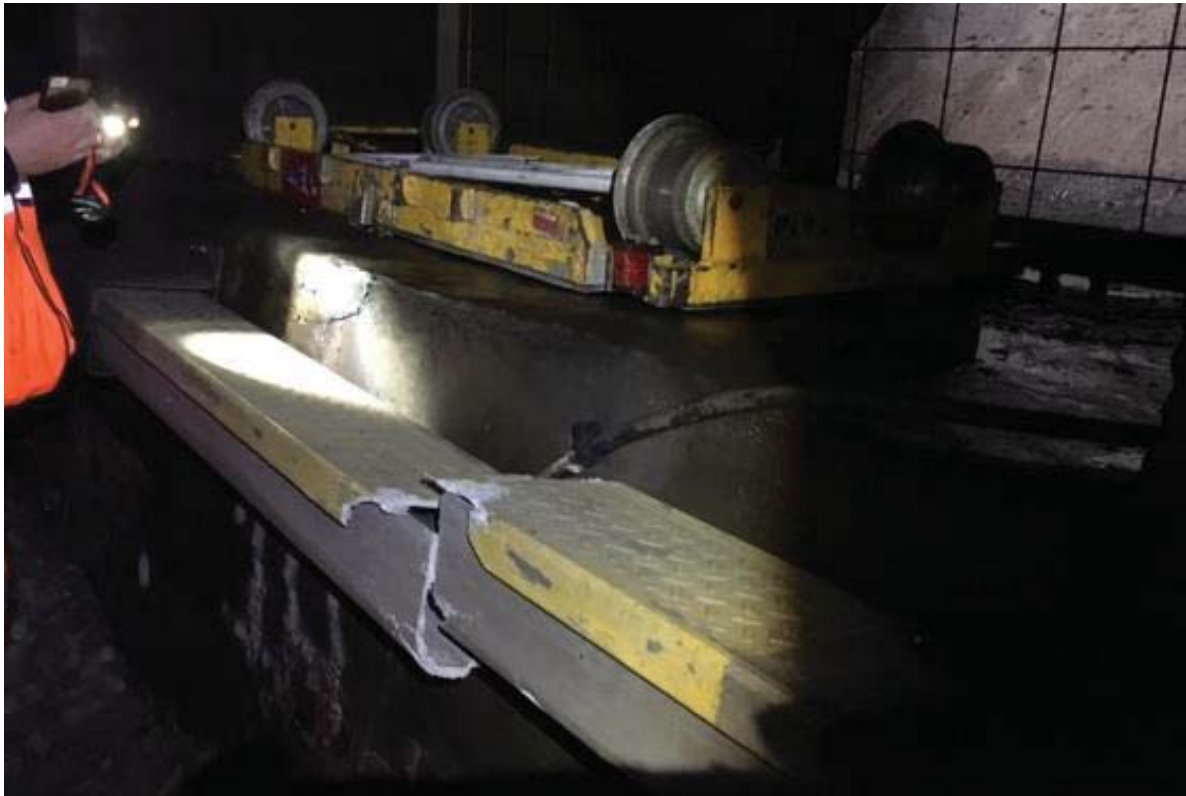
The two trolleys which had remained in the recesses were reported to be unsecured. However, broken cable ties were subsequently found in the vicinity of the trolleys.

Undamaged trolley as found within the pressure relief shaft No. 1 recess in Stowe Hill Tunnel. The metal grille at the bottom of the shaft can be seen in the background (photo courtesy Network Rail)

However, at the end of the planned work, and after the Network Rail staff had left site, the AMCO staff realised that they did not have any chains or padlocks available. They reported that the four trolleys were placed and secured in the recesses at No.1 and No.2 shafts, two per recess. In each recess, one trolley was placed on top of the second, and they were secured to the grille using cable ties.
