Collision at Yafforth level crossing, 3 August 2016

2. Summary of the accident

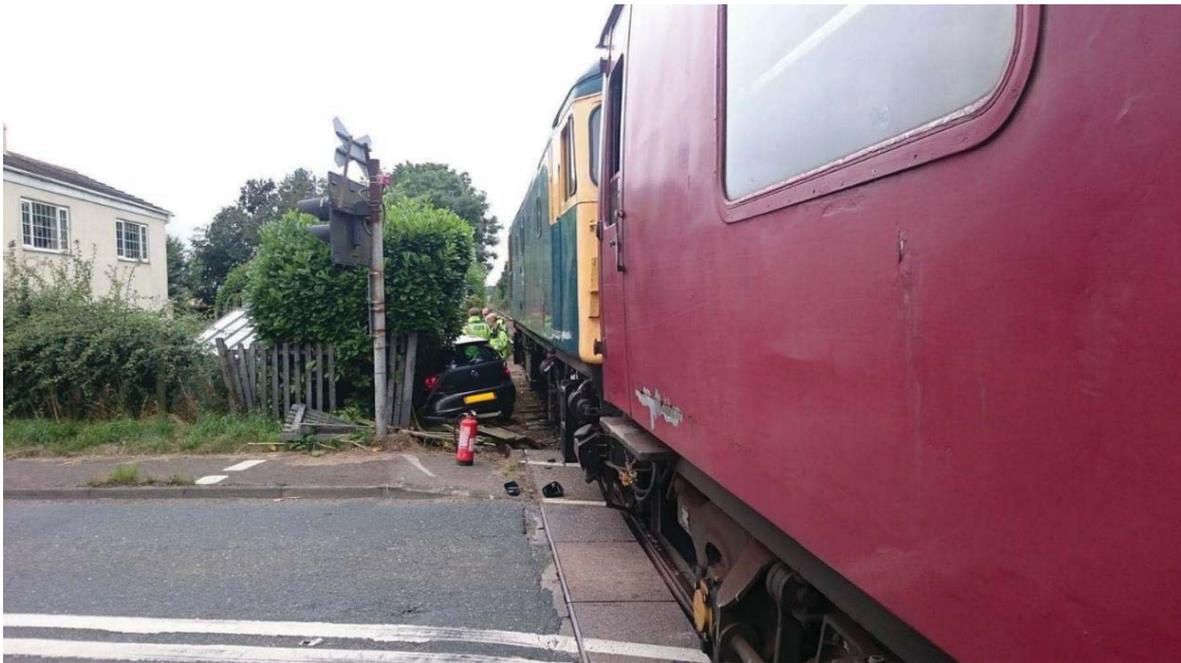
On 3 August 2016, at around 13:55 hrs, a passenger train struck a car on Yafforth level crossing, near to Northallerton, North Yorkshire. As a result of the accident, the driver of the car was trapped in their vehicle and received injuries which required hospital treatment. The car was later reported as having been damaged beyond economic repair. Two passengers on the train also received minor injuries. Fencing at the crossing was destroyed and the train involved was slightly damaged.

A photograph of Yafforth level crossing taken immediately following the accident (image courtesy of the Wensleydale Railway)

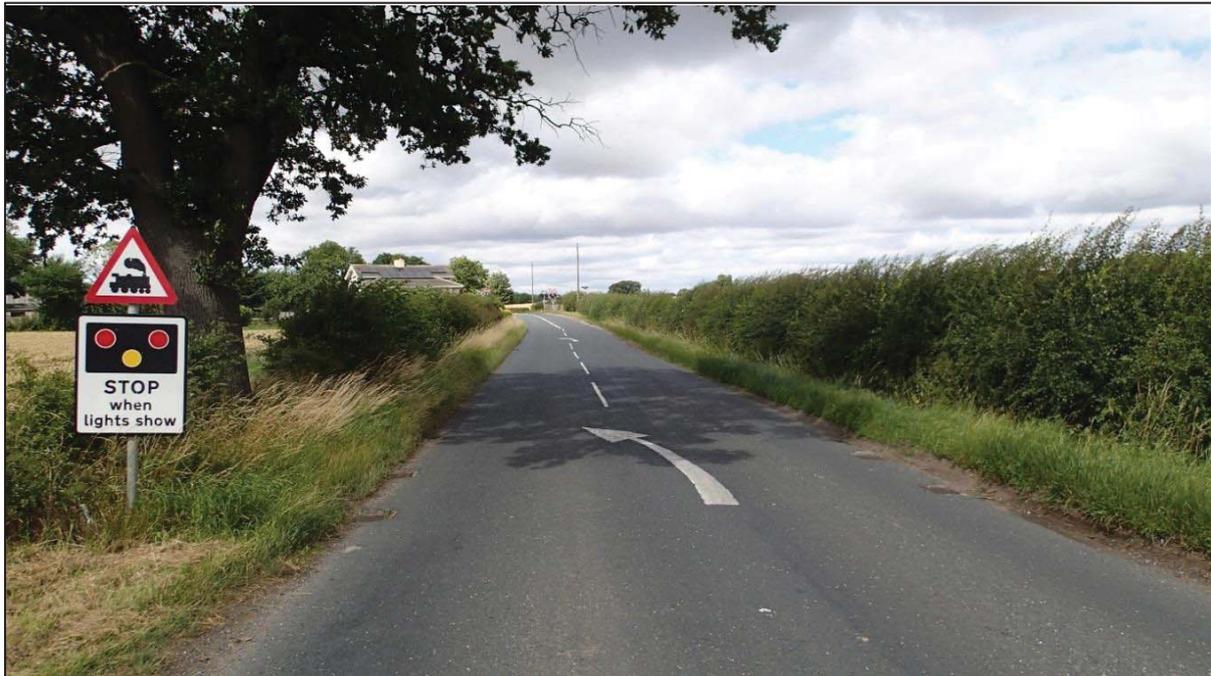
The approach to Yafforth level crossing from the south, showing the road layout around 120 metres from the crossing

Dolly Lane is a single-carriageway road, subject to the national speed limit. This is 60 mph (96 km/h) for cars. The road runs approximately north to south, with the railway crossing it at a skew. The road approach to the crossing from the south has a number of changes in direction and vertical profile. This includes a left-hand bend which starts around 50 metres from the crossing.

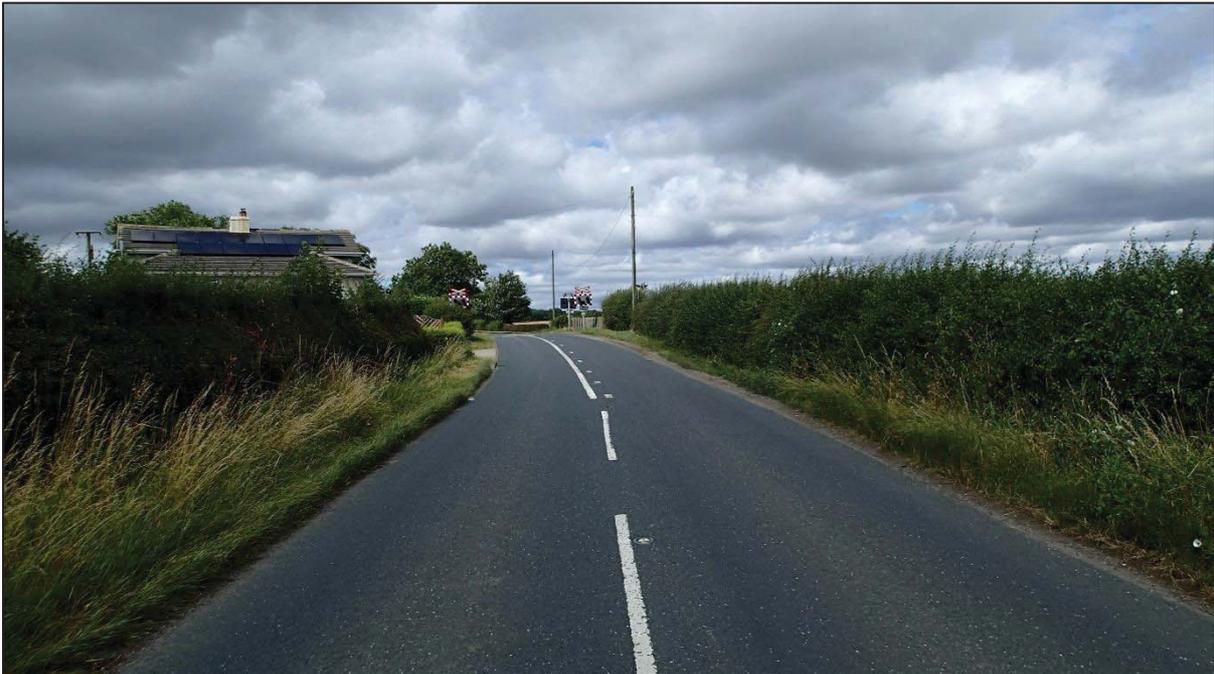
The approach to Yafforth level crossing from the south, showing the road layout around 65 metres from the crossing

The examination also found that the road traffic signals were visible for over 220 metres when approaching on the road from the south. The nearside signal was, however, obscured for significant parts of the approach due to road layout and roadside vegetation until around 90 metres from the crossing. Inspection records for the crossing provided by the Wensleydale Railway stated that the road traffic signals had been correctly aligned when they were last checked in June 2016. The required alignment of these road traffic signals was not clear from the documents provided by the Wensleydale Railway. However, a crossing of the same type on Network Rail managed infrastructure and which had a comparable road approach would be required to have its road traffic signals aligned to the point where a road vehicle driver could first see them. The RAIB's examination confirmed that road traffic signals at Yafforth level crossing broadly met this requirement.

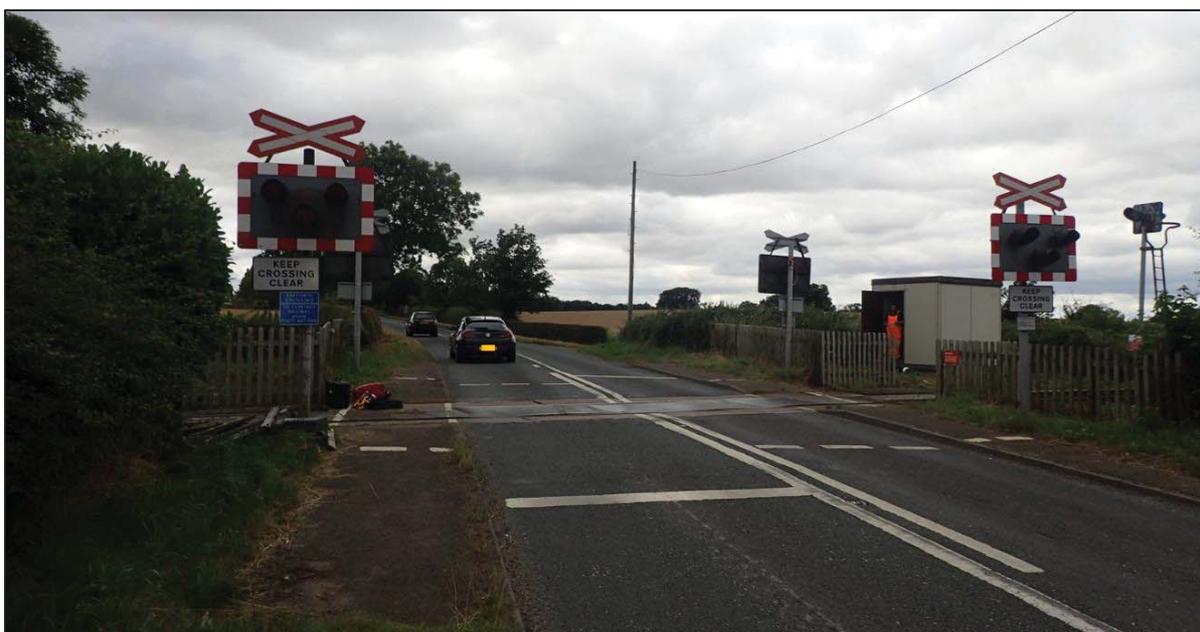
The RAIB's examination also found that the road traffic signals at Yafforth level crossing were fitted with 36 W incandescent lamps. These lamps were designed to cast a narrow, intense beam of light. This light reduces in intensity and becomes difficult to discern as the angle between the beam and the road user increases. There are other long-standing issues which may affect how a road vehicle driver reacts to signals fitted with these lamps. The 1987 [Stott Report](#), for example, concluded that their light output was only half that of the conventional road traffic signals in use at that time. This relatively low level of brightness means that they are less likely to be noticed by approaching road vehicle drivers compared to signals using brighter types of lamp, such as modern LEDs.

Although the sun was probably not a factor in this accident, 36 W incandescent lamps are also known to be susceptible to sun-related effects that can impair a road users' ability to see that a signal is illuminated or flashing.

The road traffic signals at Yafforth level crossing for the road approach from the south

- road traffic signals at level crossings being visible and sufficiently conspicuous to draw the attention of approaching road users
- replacing 36 Watt incandescent lamps in level crossing road traffic signals with lamps that have a higher level of brightness, such as modern LEDs
- infrastructure managers giving careful consideration to the factors which influence user behaviour at level crossings without barriers and the potential value of installing barriers at higher risk locations
- appropriate competency management arrangements for staff maintaining safety critical equipment.
