Rail Accident Investigation Branch

Rail Accident Report

Collision at London Waterloo 15 August 2017

Report 19/2018
November 2018

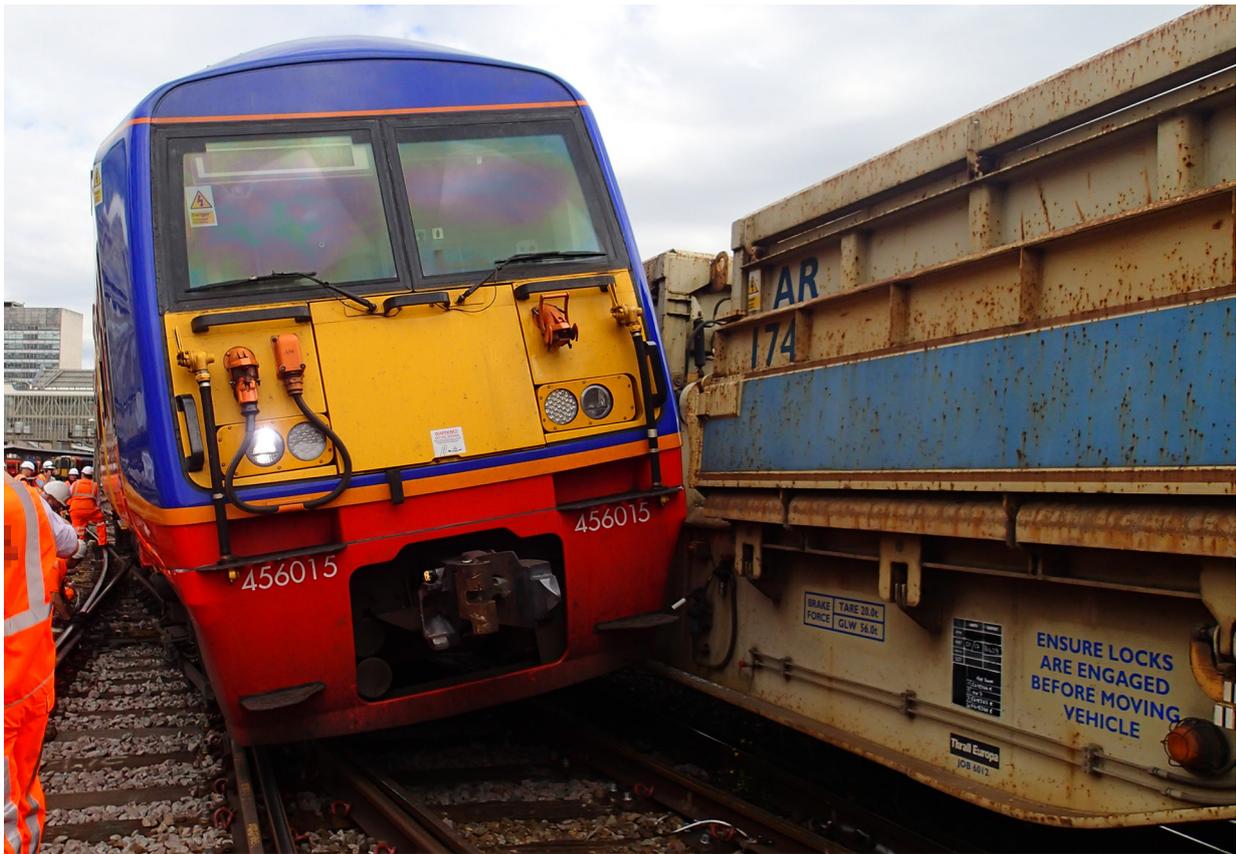
At around 05:42 hrs on Tuesday 15 August 2017, a passenger train was leaving London Waterloo station when it collided with a stationary engineering train at a speed of 13 mph (21 km/h). No injuries were reported but both trains were damaged and there was serious disruption to train services until the middle of the following day.

Figure 2: Passenger and engineering train after the collision

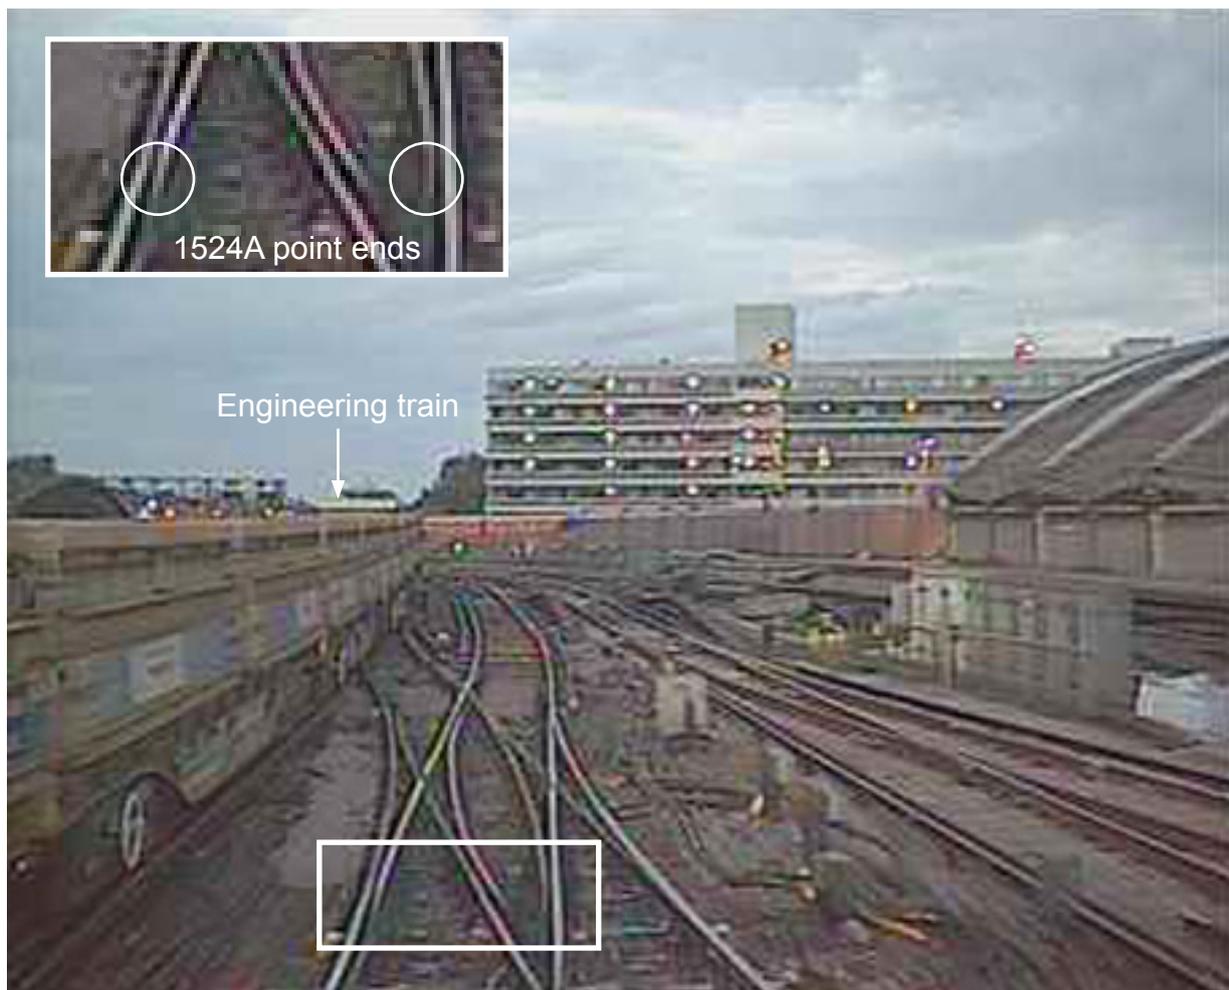
- 30 Soon after moving away from the platform, the train was travelling at about 15 mph (24 km/h) when the driver noticed that 1524 points were not correctly set and applied the train's brakes (figure 8). The points should have been set to direct the train straight on, but were incorrectly lying in an intermediate state and directed the train to the left and into the side of the engineering train. The collision occurred about three seconds after the brake application which had reduced the train's speed to 13 mph (21 km/h). Drivers are not required, and not expected, to check point positions in these circumstances. The driver of train 2D03 is to be commended for noticing that they were lying incorrectly and for his prompt brake application.

Figure 8: View from the train's forward facing CCTV showing 1524A points lying approximately midway between normal (wide gap at right-hand point end, no gap at left-hand point end) and reverse (gap only at left-hand point end)

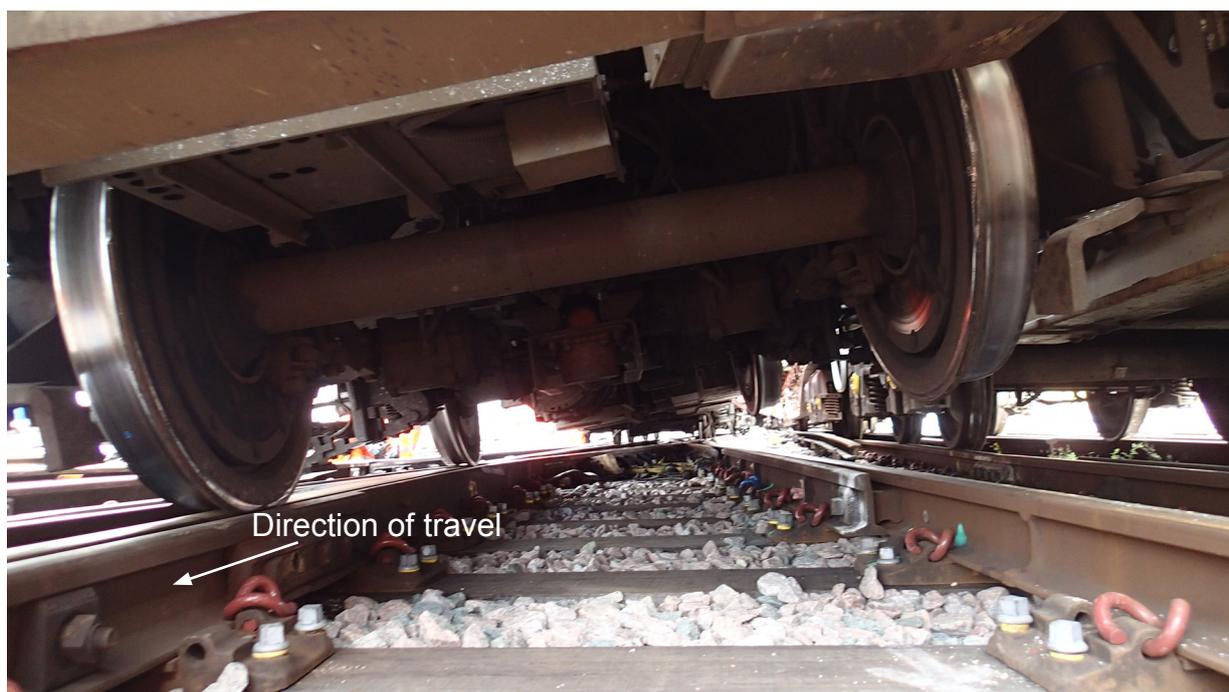
- 31 After the collision, the passenger train slid along the side of the engineering train for around four seconds before coming to a stop with the left-hand wheels of the leading coach above the rail and the right-hand side wheels remaining on the rail (figure 9).

Figure 9: Train 2D03 with left (in direction of travel) wheels of the leading bogie above the rail

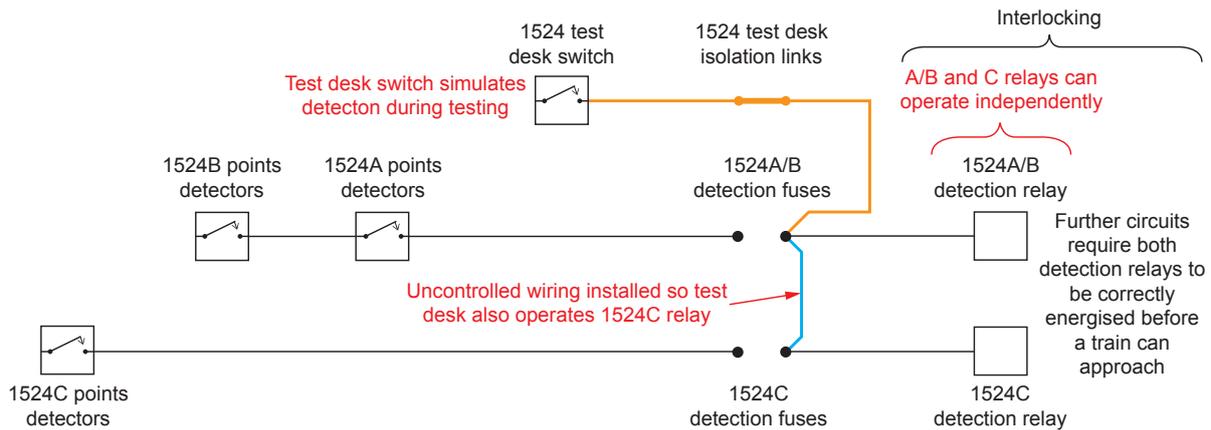
Figure 17: 1524 points in test mode after replacement of location case W14 and addition of uncontrolled wiring

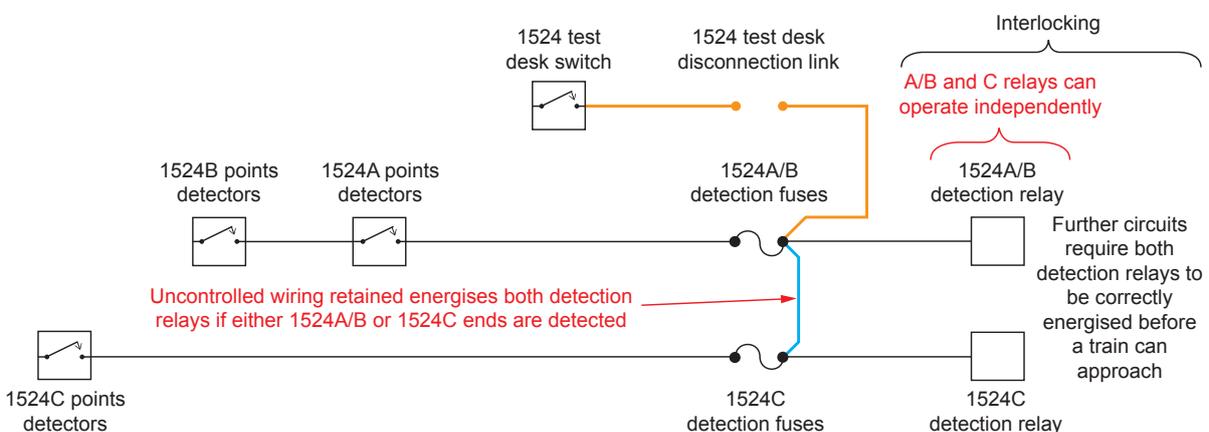
Figure 18: 1524 points detection at time of derailment
