Learning from history:

Lessons from past accidents 1981-2017

Produced by RAIL magazine

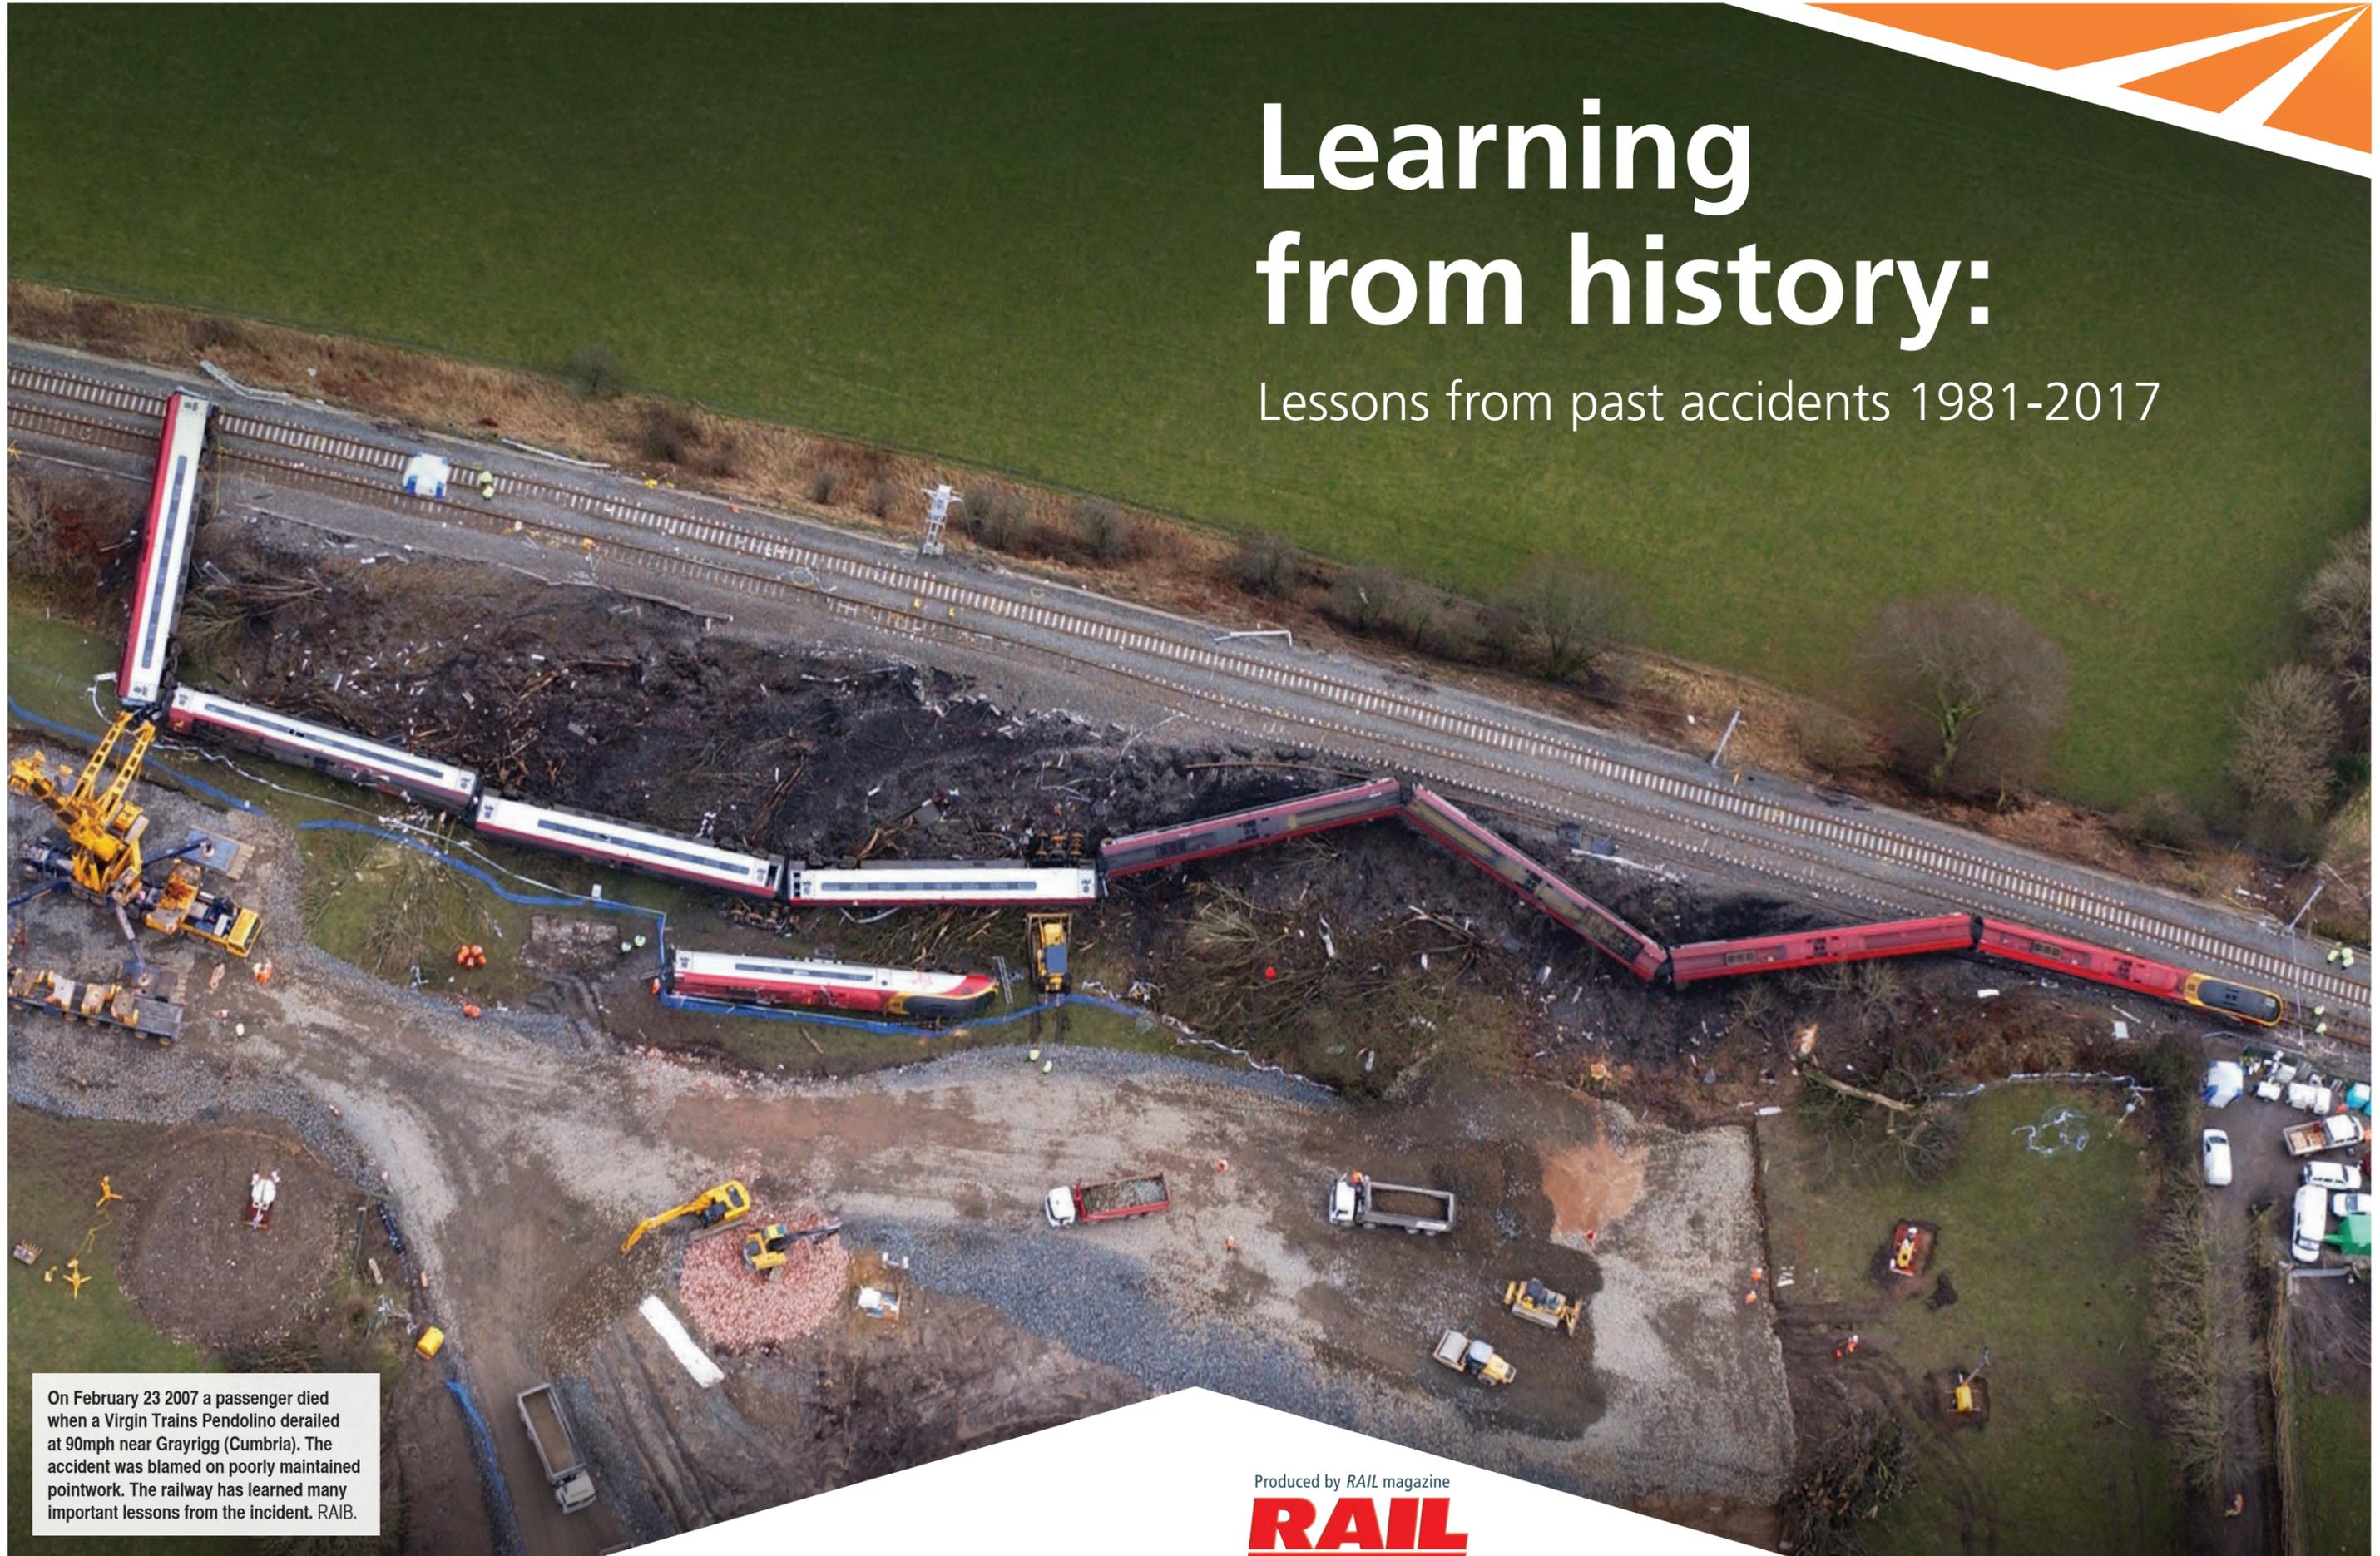
On February 23 2007 a passenger died when a Virgin Trains Pendolino derailed at 90mph near Grayrigg (Cumbria). The accident was blamed on poorly maintained pointwork. The railway has learned many important lessons from the incident. RAIB.

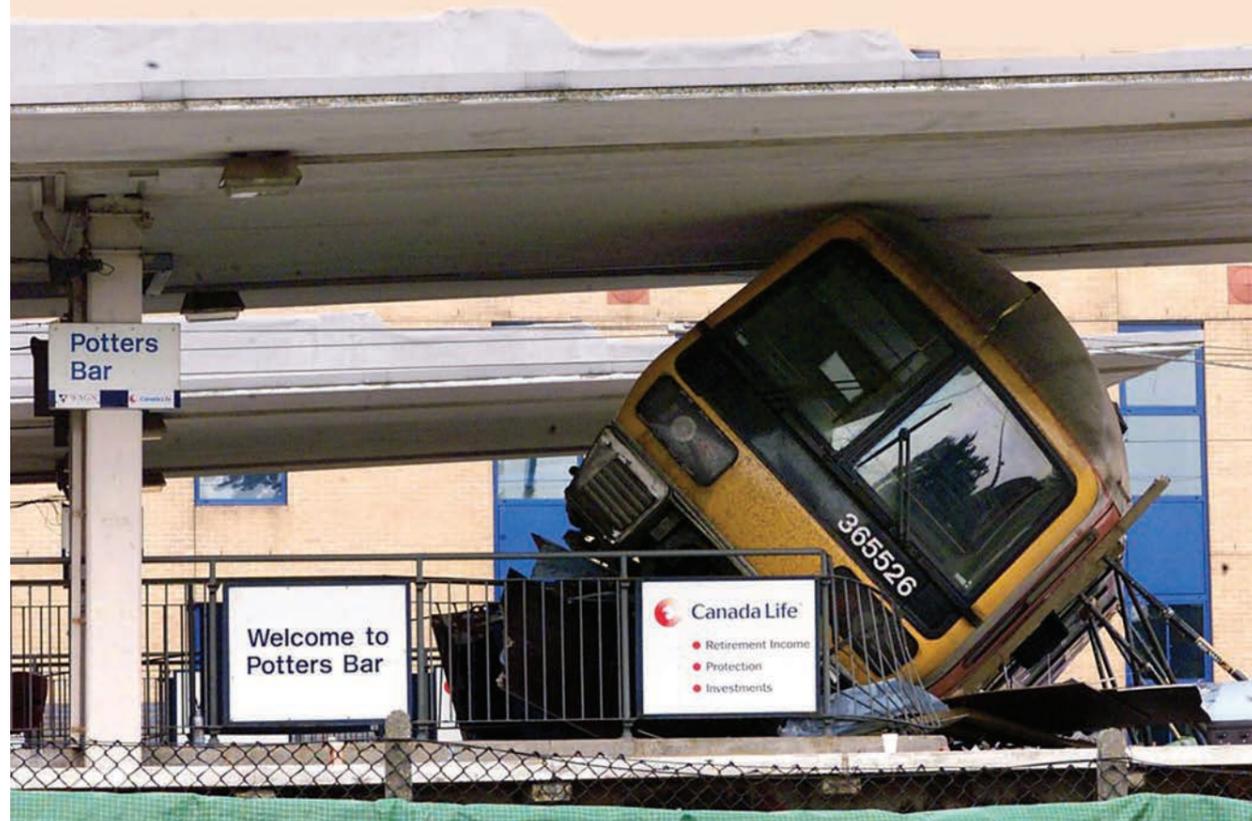
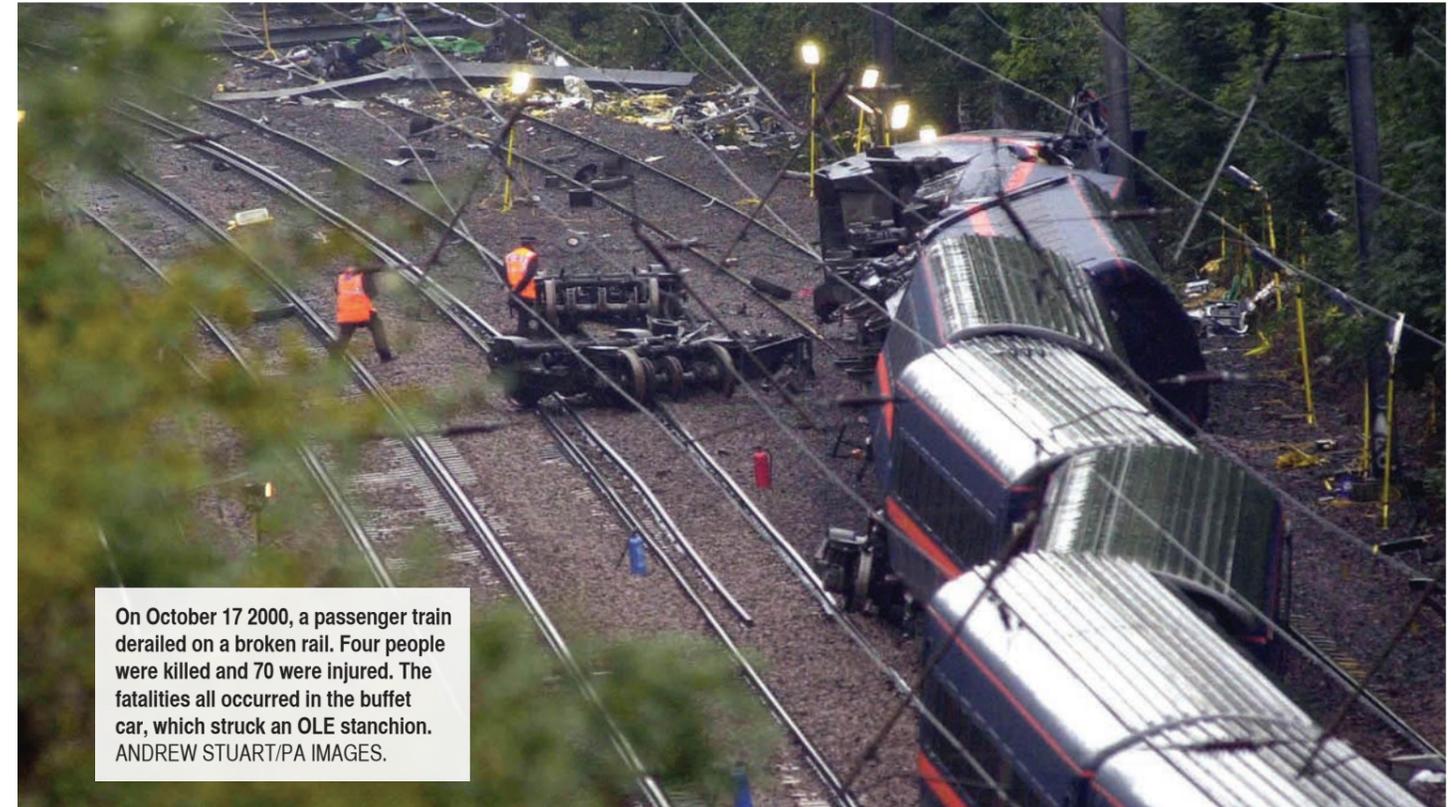
Below: During the accident at Potters Bar, the fourth carriage became detached, crossed onto the adjacent line, flipped into the air and landed in the station under the platform canopy. SEAN DEMPSEY/PA IMAGES.

On October 17 2000, a passenger train derailed on a broken rail. Four people were killed and 70 were injured. The fatalities all occurred in the buffet car, which struck an OLE stanchion. ANDREW STUART/PA IMAGES.

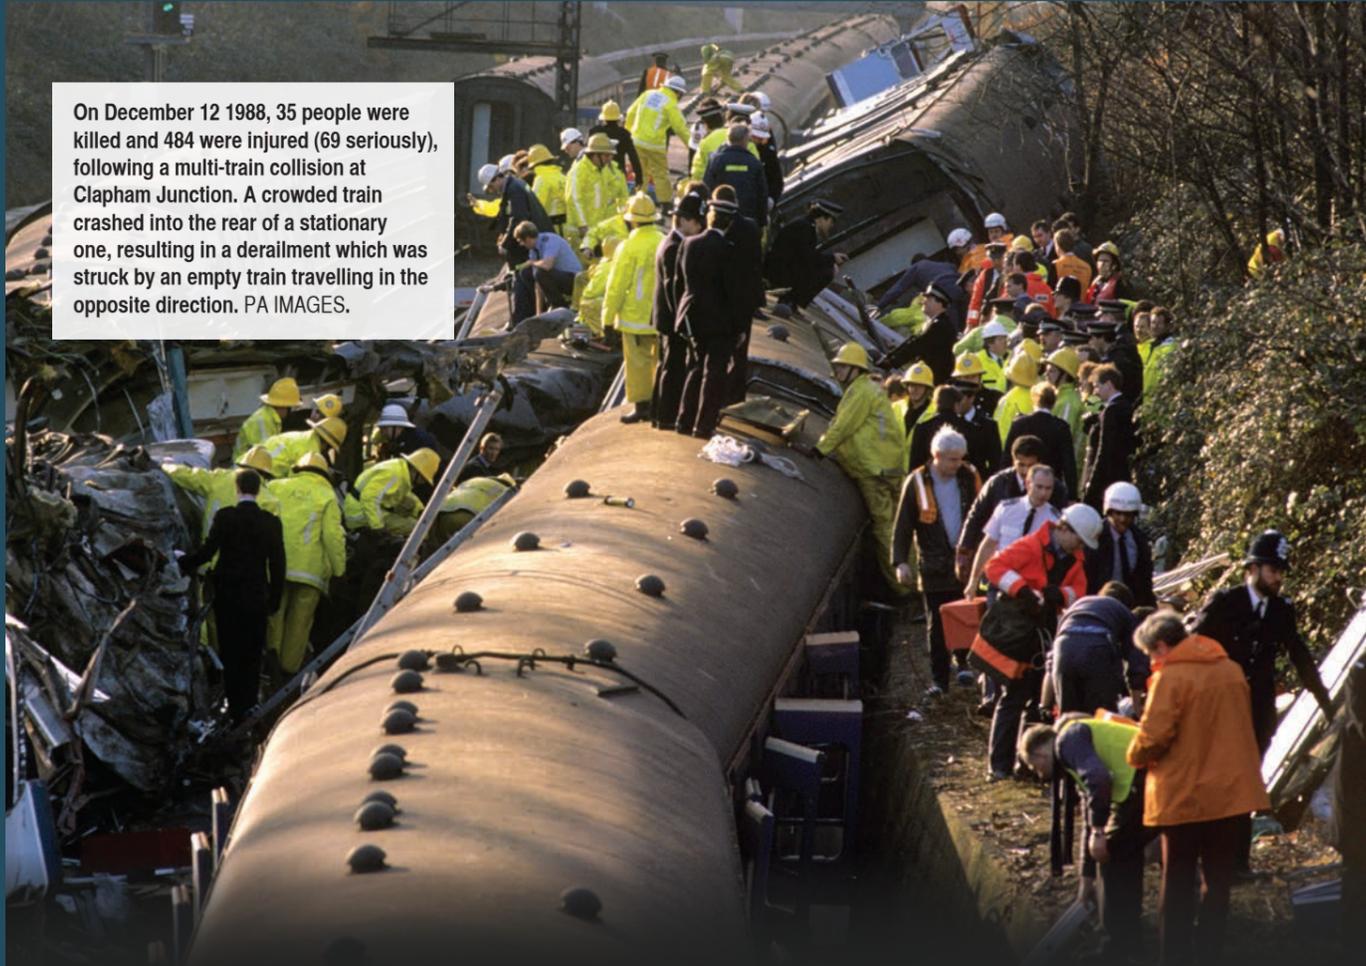
On December 12 1988, 35 people were killed and 484 were injured (69 seriously), following a multi-train collision at Clapham Junction. A crowded train crashed into the rear of a stationary one, resulting in a derailment which was struck by an empty train travelling in the opposite direction. PA IMAGES.

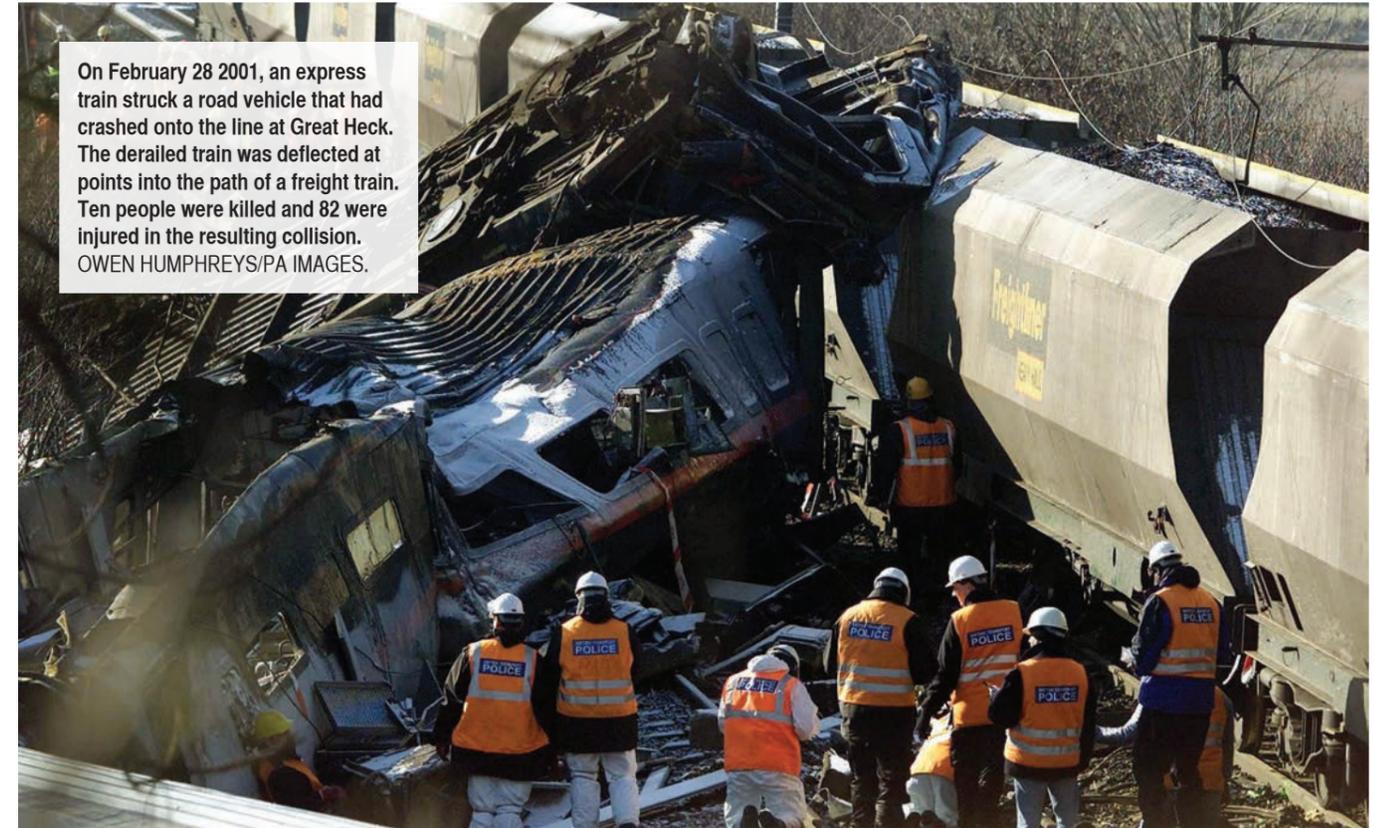
On February 28 2001, an express train struck a road vehicle that had crashed onto the line at Great Heck. The derailed train was deflected at points into the path of a freight train. Ten people were killed and 82 were injured in the resulting collision. OWEN HUMPHREYS/PA IMAGES.

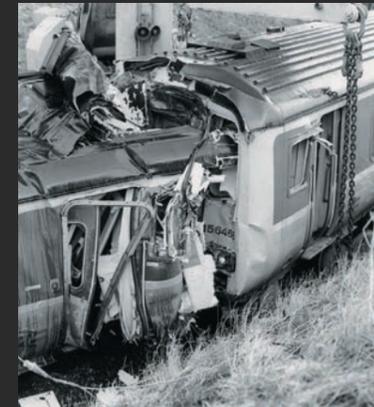
The devastation near Ais Gill following the collision between two Class 156 units on the Settle and Carlisle Line. MALCOLM STEAD.

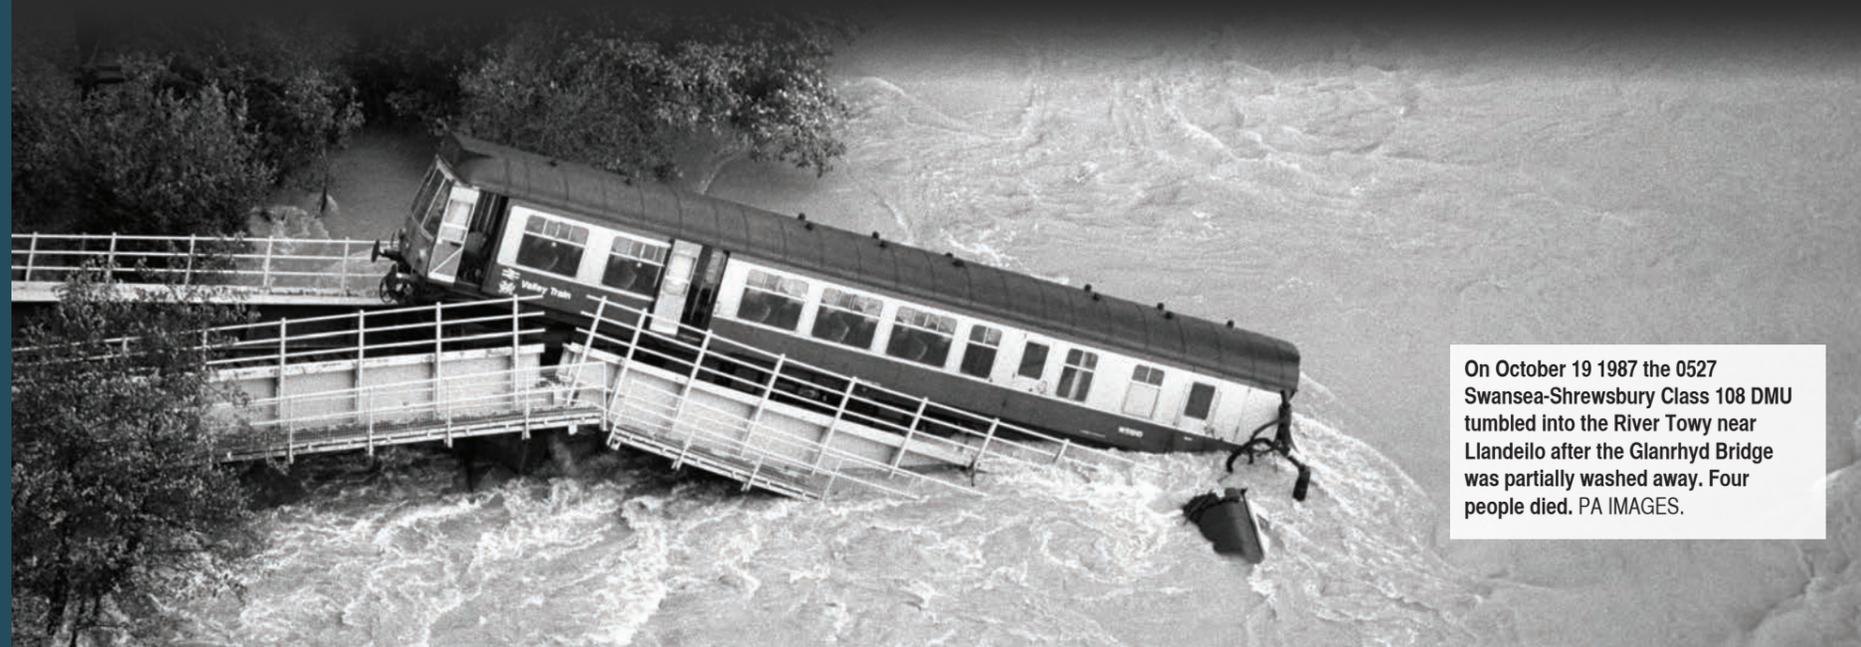
In 1987, Glanrhyd Bridge partially collapsed as a result of the River Towy swelling after many hours of heavy rainfall. The previous evening, adverse weather conditions had led to a number of reports of flooding and potential ballast wash-out on the Central Wales Line, but attempts to inspect the track visually were thwarted by local roads being blocked by those same floods. It was duly agreed that the first train in the morning would be used to examine the line.

On October 19 1987 the 0527 Swansea-Shrewsbury Class 108 DMU tumbled into the River Towy near Llandeilo after the Glanrhyd Bridge was partially washed away. Four people died. PA IMAGES.

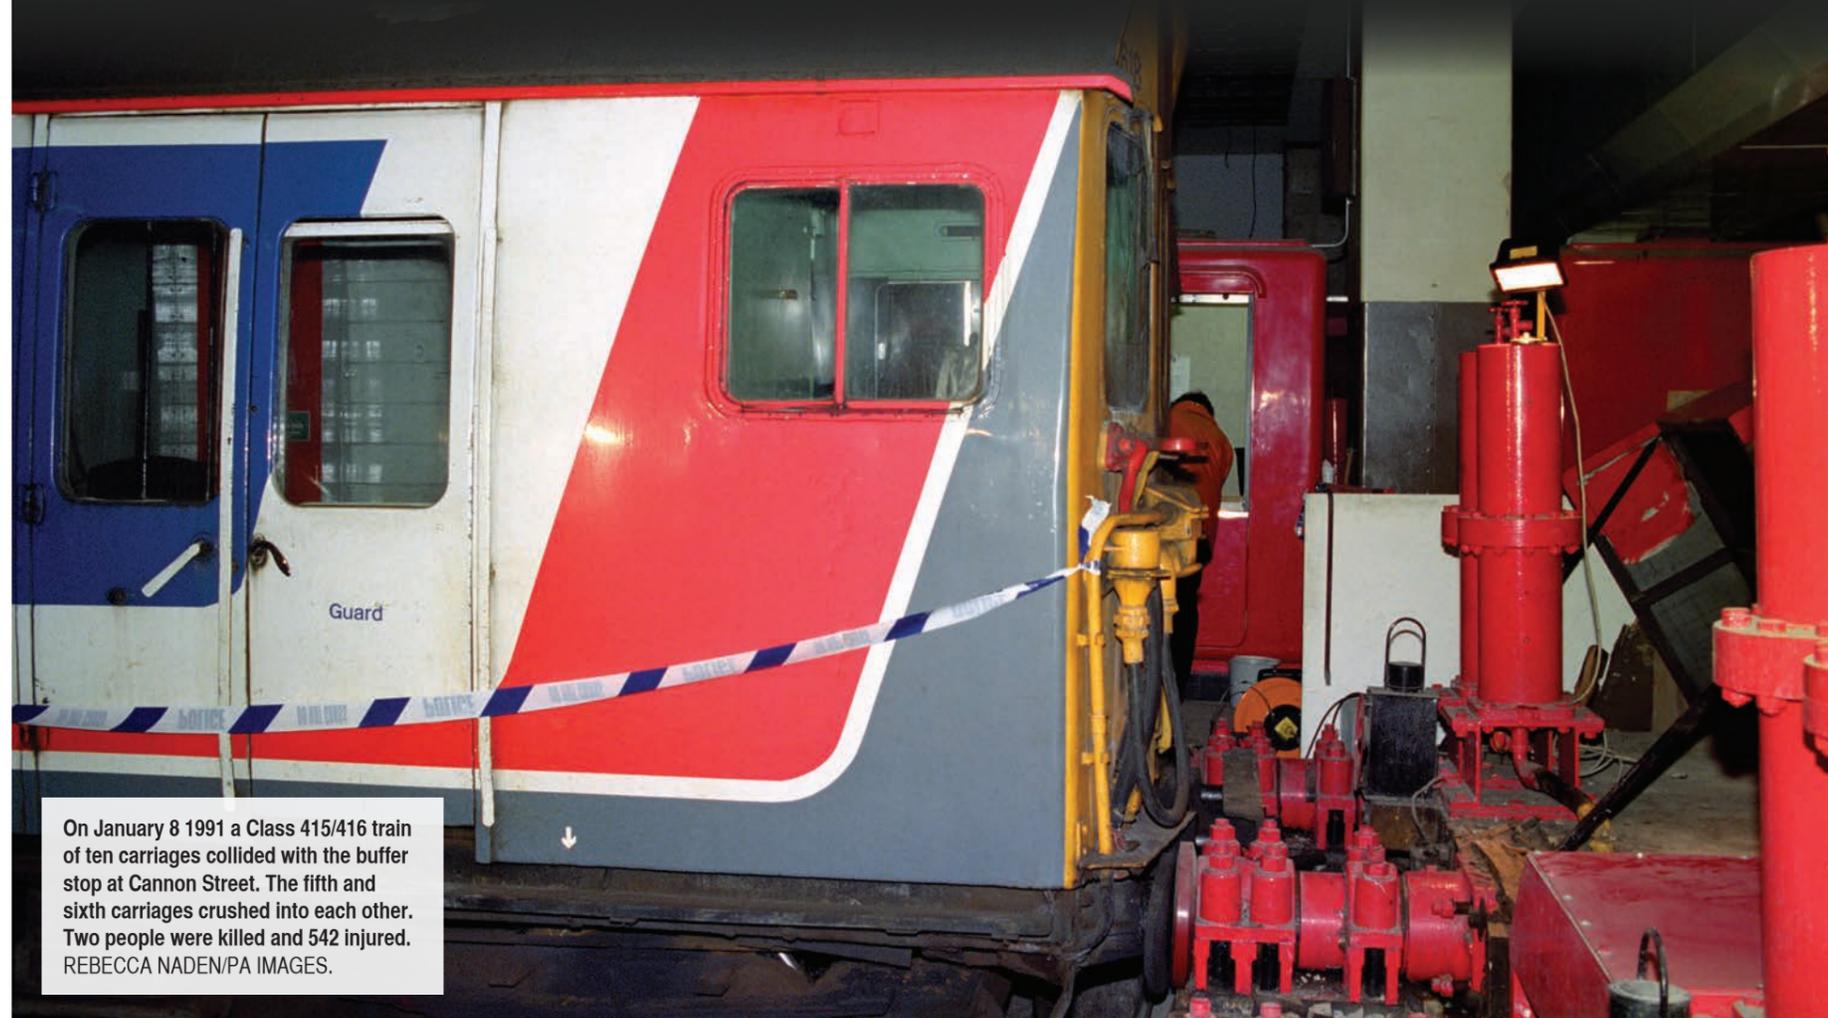
The accident at Cannon Street station occurred because the driver of an incoming train failed to control its speed sufficiently to bring it to a stand short of the buffer stops. The high number of injuries that resulted was compounded by an overcrowded train and the relative lack of crashworthiness of the ageing rolling stock.

On January 8 1991 a Class 415/416 train of ten carriages collided with the buffer stop at Cannon Street. The fifth and sixth carriages crushed into each other. Two people were killed and 542 injured. REBECCA NADEN/PA IMAGES.

New buffer stops are required to be of an energy-absorbing design and assessed for the risk arising from a train colliding with them.
