IP Signalling

Issue Number: IPSIG-SL008

Title: Euston Enabling Works Irregular Signal Sequence

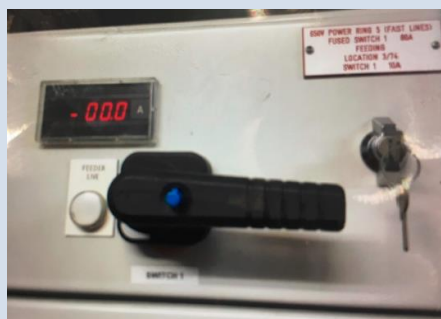
Photo of Switch :

This Fused Switch had been isolated during what was meant to be a non-intrusive survey of location case 3/74A and Kilburn SSP by the Siemens E&P Construction Manager and the Maintainers E&P Engineer. Historically the switch that was isolated inside the Kilburn SSP had not been in use, but due to a recent non project related cable strike the circuits had to be re-configured resulting in this switch now being utilised.

The Siemens Construction Manager was showing the NR E&P Engineer project work which had taken place within the location, believing he was assisting the Engineer, he isolated the switch to allow them to look inside. This unfortunately isolated an operation signal supply, which resulted in the irregular signal sequence.

Operational equipment must not be switched 'OFF' or 'ON' during operational hours! The only time, operational equipment can be switched 'OFF' or 'ON' is during planned works or during a 'Planned Possession'.

Additional or unplanned works that have not been documented within the task briefing sheet must not take place.
