# ***Infrastructure Projects Signalling Shared Learning***

Issue 18/01: July 2017 – February 2018

This Shared Learning document details key issues and incidents that have occurred on Signalling Projects between July 2017 and February 2018; and provides the key learning points associated with them.

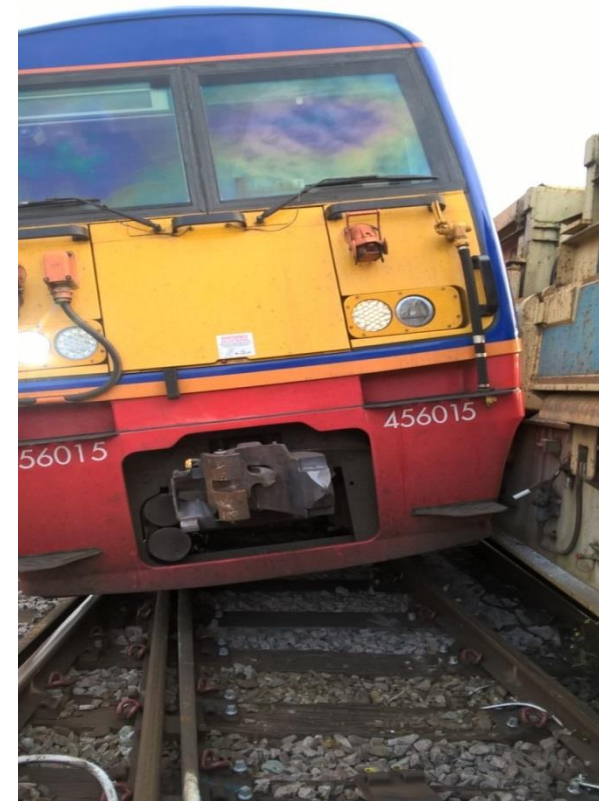
As a signalled train left the Station at low speed, it was directed towards the possession and struck the side of the Adjacent Line Open Protection train, which was positioned as part of the planned protection arrangements. Video evidence from the train shows that neither the left hand point switch, nor the right hand point switch, was fully closed and locked.

The ongoing investigation by RAIB identified that the points were misaligned and had directed the train away from the intended route.

- Ensure all points required to be Clipped & Padlocked (C&P) as detailed in the Test Plan and stage / scheme plan are C&P prior to the commencement of Testing & Commissioning (T&C) works. All operatives shall be demonstrably competent, and be aware of their accountabilities in the point securing process.
- Test desk connection and disconnection process must be followed.
- TICs to ensure that they have robust process to control issue, use and installation/removal of Test Straps.

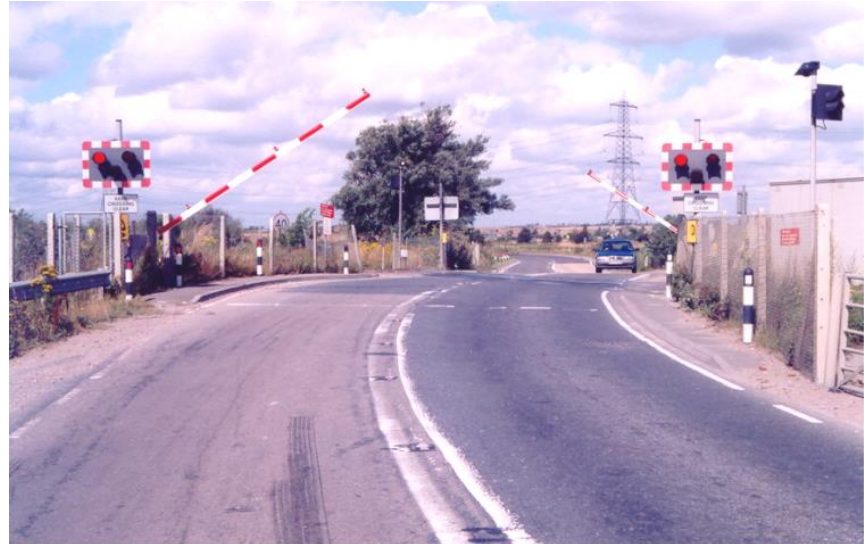
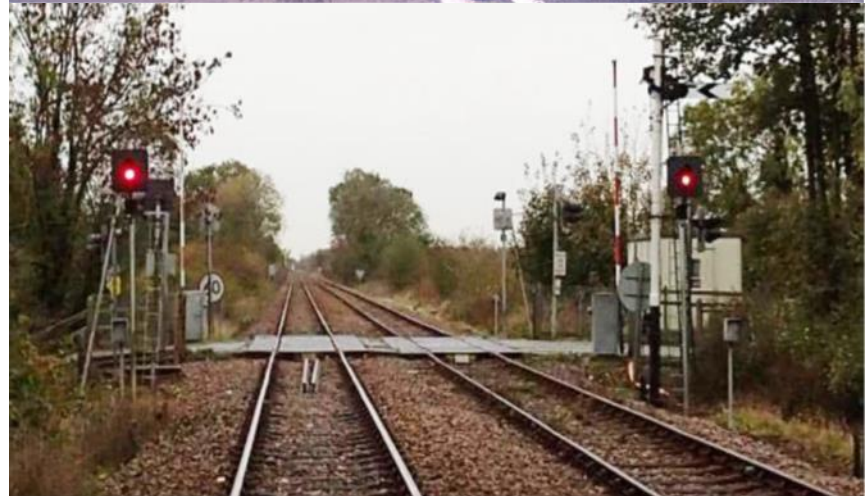
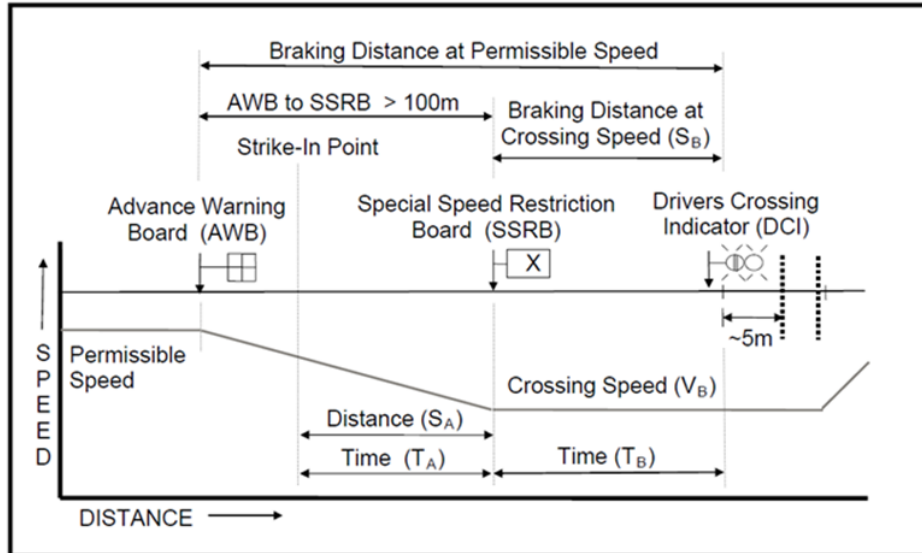
A driver reported a 'late' change of aspect of the Drivers Crossing Indicator (DCI) on all routes, with the signal changing from Drivers Red Light to Drivers White Light when the train was '*closer to the crossing than expected.*'

The Strike-In Points (SIPs) were commissioned into use as designed and calculated. However the SIPs were incorrectly positioned in relation to the Special Speed Restriction Boards (SSRB) for all approaches due to an error in translating the requirements of NR/L2/SIG/11201/ModX11 Section 3.1.13 during the design process.

The same calculations had also been used at another crossing, to be commissioned shortly after the issue was identified. A modification was issued to move the Strike-In's further out to prevent a similar occurrence.

- Within the calculations; the minimum time between the SIP and SSRB of 14 seconds should take into account the requirements of NR/L2/SIG/11201/ModX11 Section 3.1.13 with respect to the 10s Minimum Road Open Time (MROT) required for two or more tracks over crossings. This should be reviewed during the independent check of the Scheme Plan and calculations.

- Key information with respect to time and distance could be detailed on the Scheme Plan; something that *may* have assisted in the error being identified.
- Post commissioning in-service checks, as prescribed by the ABCL Testing Specification, should be completed at the time of the commissioning.
- The competence of designers should be considered with respect to the particular type of crossings involved. Mentorship arrangements should be put in place where staff lack experience.
- Network Rail standards on Locally Monitored Level Crossings are being updated to clarify and resolve potential conflicts.

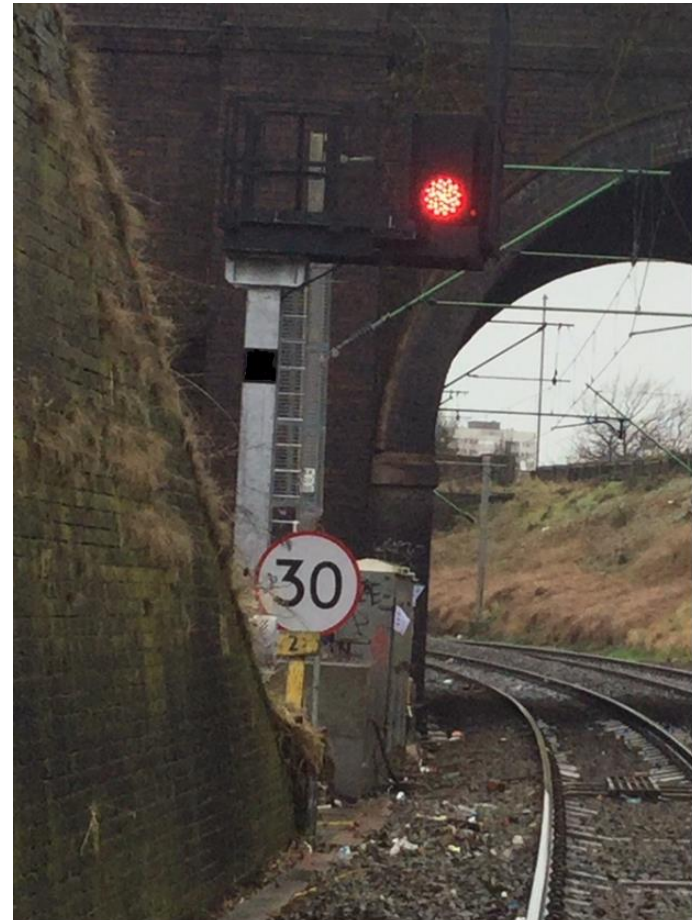
Following a major resignalling there were reports of multiple aspect changes as a result of momentary loss of lamp proving during normal changes of aspect.

The project had commissioned VMS Mk1 110V signals in a voltage proving configuration with a Westlock interlocking.

The above signal head is fully product accepted but there is no in-built delay in the internal lamp proving circuitry in this version of the head.

In order to complete the commissioning a '3 second slug' was written into the interlocking data.

Although a product acceptance certificate confirms that a product **may** be used on the infrastructure it does not necessarily confirm all the applications / restrictions. It is still the designers responsibility, as system integrator, to ensure the design configuration meets the project requirements.

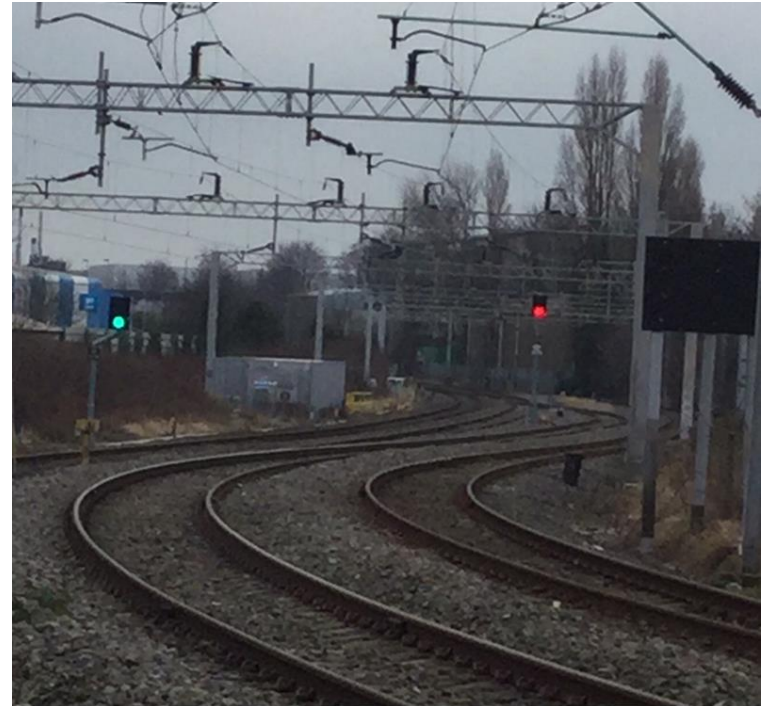
Post commissioning reports of poor signal visibility or dim signals have been received on a number of projects, due to signal aspects not being aligned in accordance with the Signal Sighting Assessment Form (SSAF). The alignment is particularly critical on 3° narrow beam LED signals.

Staff should be able to identify the type of signal head and know how to set up / adjust the alignment, using the correct tools. It is imperative that the correct alignment tool is used for each type of signal head; they are not interchangeable.

It is also considered best practice for the Signal Sighting Chair to complete the final sighting check as part of the commissioning.

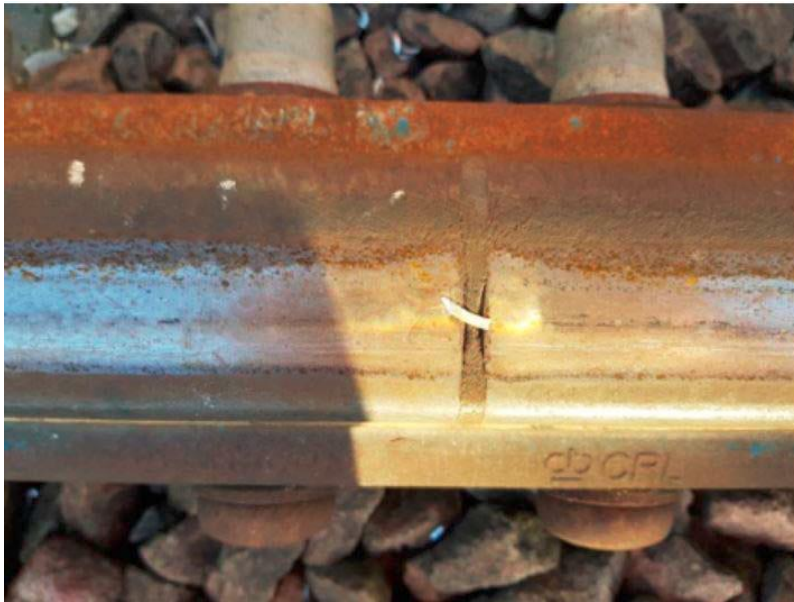
A project had been drilling rail and installing bonds in preparation for resignalling works which would remove a large number of IBJs.

Despite the operatives collecting swarf with magnetic wands a small piece of swarf subsequently bridged the insulation of an IBJ causing the track circuit to fail.

Whilst it was evident that the team involved had collected a large proportion of the swarf, it was noted by the attending fault team that some remained. This was found to have blown from the immediate site of work to the adjacent track bed. Attention to detail and ensuring all swarf is collected whenever drilling works are undertaken is therefore of critical importance when planning and delivering such works.

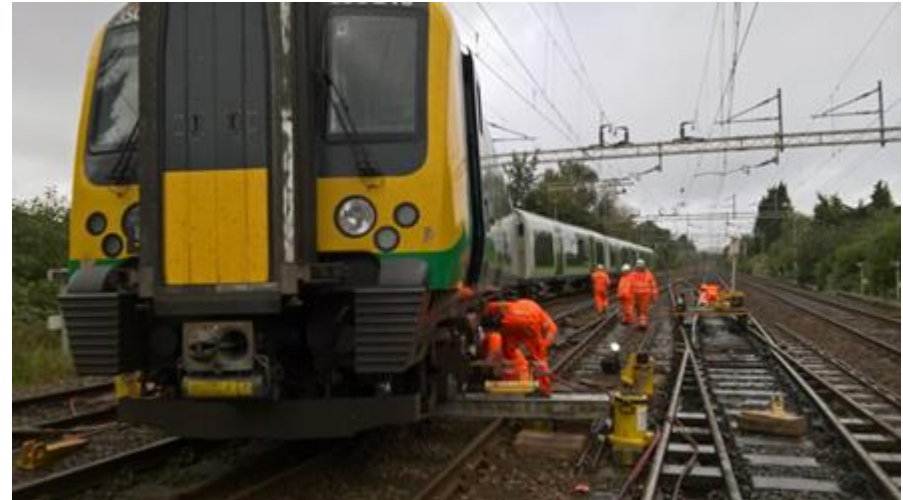
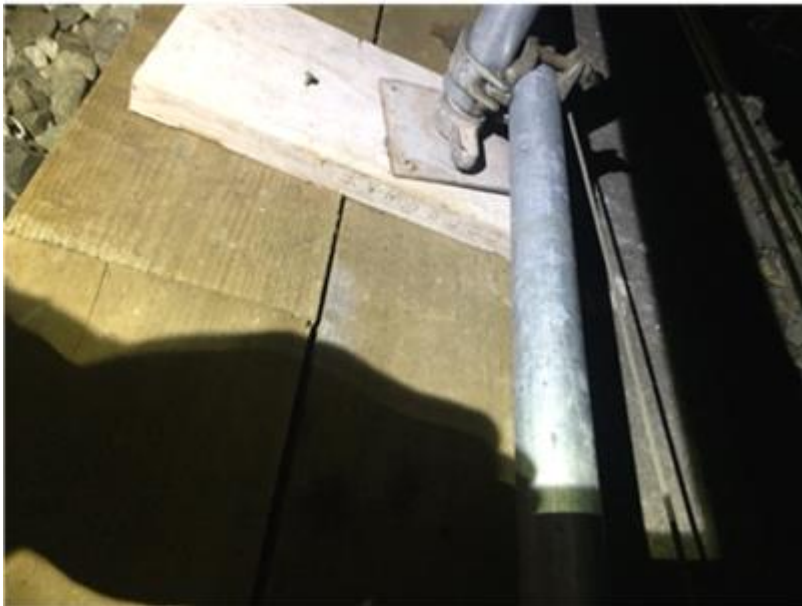
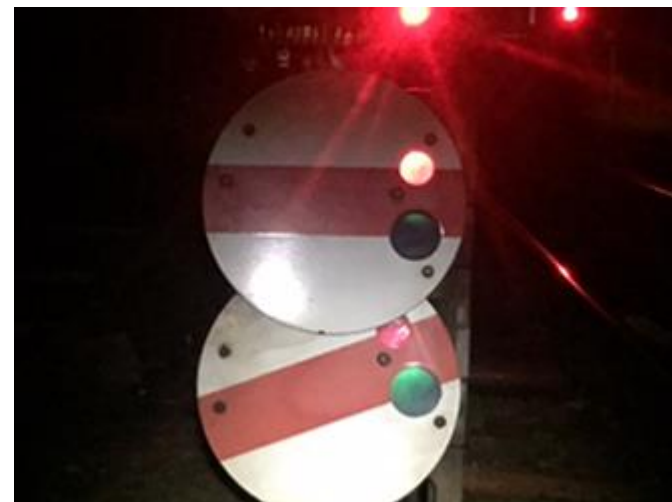
A temporary platform extension, constructed from scaffold tubes and timber decks, to facilitate the turn back of trains during a blockade, caused a mechanical ground signal wire to snag.

A train turning back at the ground signal passed the signal, which appeared to be displaying a green aspect, and derailed on the points.

**Design out the conflict:** Relocation of the signal wire run would have been a better solution, although it would have involved more extensive works.

**Integrated Design:** Location of signal wire run picked up during topographical survey and depicted on Civils General Arrangement (GA), however scaffold design 'referred' to the Civils GA and didn't show wire run. A 3D depiction of the scaffold tubes could have been produced.

A Signalling Project Engineer should be appointed in all cases.

**Post installation inspection:** Inspection of existing interfacing assets to ensure condition hasn't been compromised.

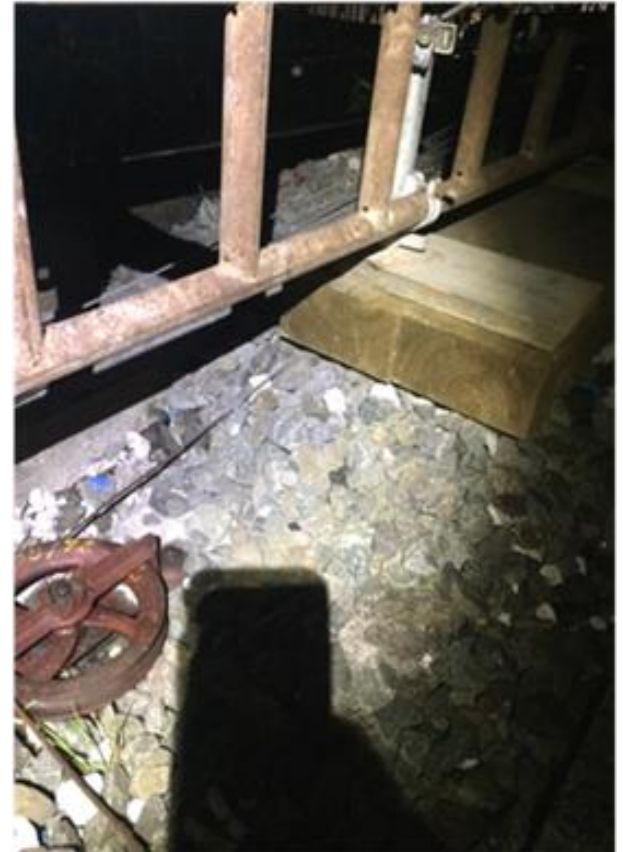
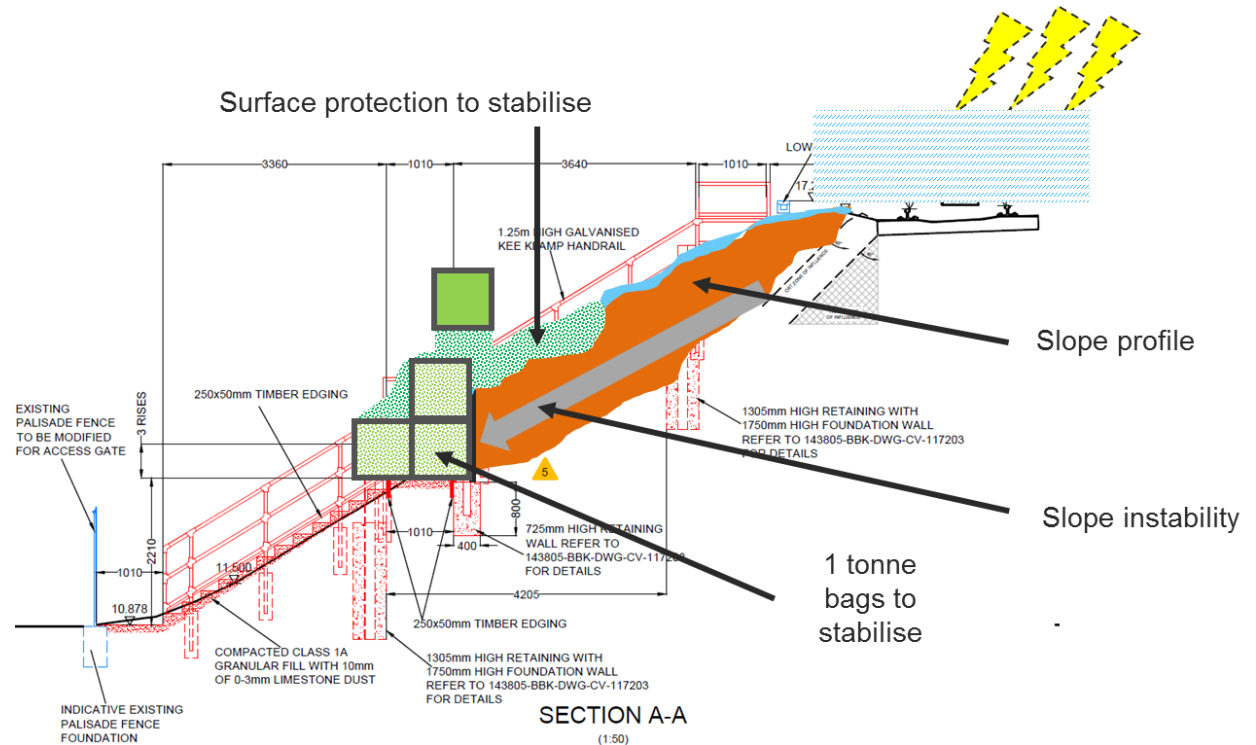
During construction of access steps as part of a project, earth movement was noted on site and both adjacent running lines were blocked for safety reasons. Contributing factors included a period of prolonged heavy rain, on site changes to design and concerns around the verification of the topographical survey.

When Signalling projects involve significant work by other discipline engineers, be aware of these elements and utilise the expertise of our colleagues in other disciplines.
