***Infrastructure
Projects (Signalling)
Shared Learning
19/01***

**January 2019
– June 2019**

This Shared Learning document details key issues and incidents that have occurred on Signalling Projects between January 2019 and June 2019 and provides the key learning points associated with them.

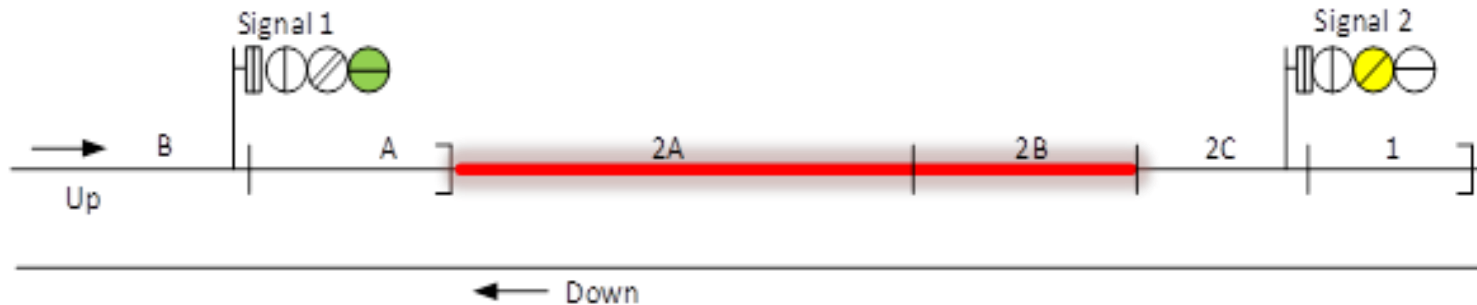
Track Sections not included within Aspect Controls for Signal 1

A level crossing upgrade project required a Solid State Interlocking (SSI) data change, and associated track circuit alterations for accurate strike-ins. The planned work was unable to be completed due to interface issues with the control system and so it was decided to revert to the signalling arrangements prior to the commencement of works.

A number of required procedural steps were omitted whilst conducting the wiring reversion, and signal wiring changes were incorrectly applied during the installation and test activities. Contacts from an individual track circuit repeat relay, instead of a combined track circuit repeat relay, were wired into signal controls. The commissioned works didn't provide adequate controls to prevent a train being signalled onto an occupied line.

When undertaking works, including those to return the signalling system back to its original state, the implications of all changes should be identified, and documented processes are to be applied at all times. Please see Notice Board 174 ([NB174](#)) for further information.

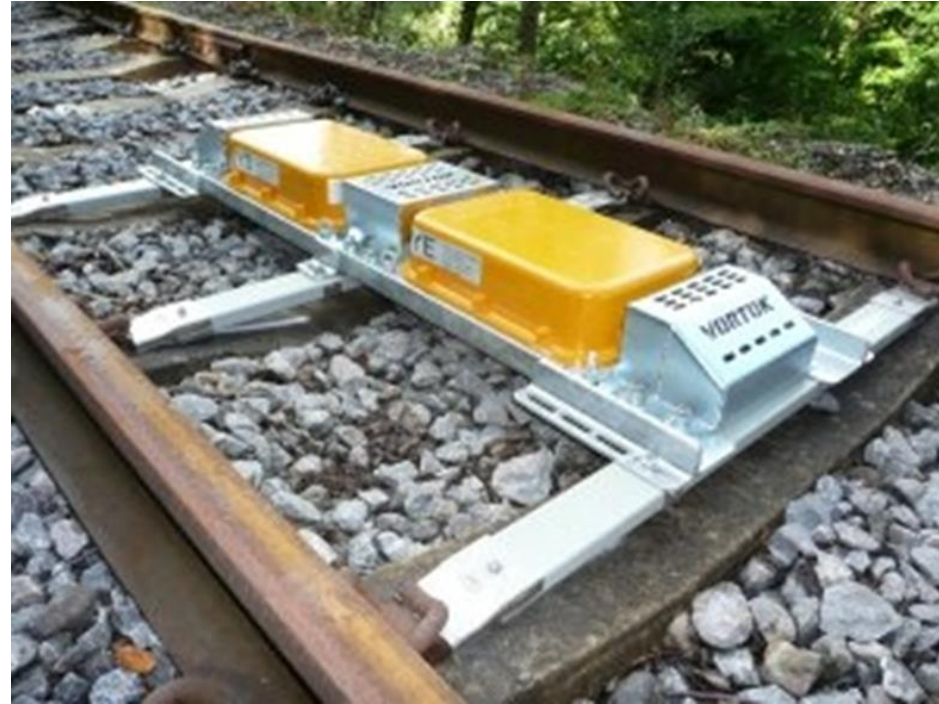
The driver of a tamper unit approaching a red signal received an incorrect AWS audible indication; bell vice horn, due to incorrect energisation of the AWS electro magnet.

The immediate cause was identified as the omission of a contact of the relay controlling the most restrictive aspect, in this case the HR (yellow relay), from the AWS controls, normally being included via the DR (green relay) circuit. The signal had been altered as part of the fringe works for a project, changing from 2 aspect (R/G) to 3 aspect (R/Y/G) in the process. When 2 aspect only a DR was provided and during the upgrade to 3 aspect the required control was omitted from the design.

Various checking and testing processes did not identify the omission of the required contact, additionally principles testing was not undertaken based on a desk top review of the circuitry which showed that the magnet wiring was unchanged conceptually from old to new.

The design, checking and testing process must take due cognisance of all changes undertaken as part of the works.

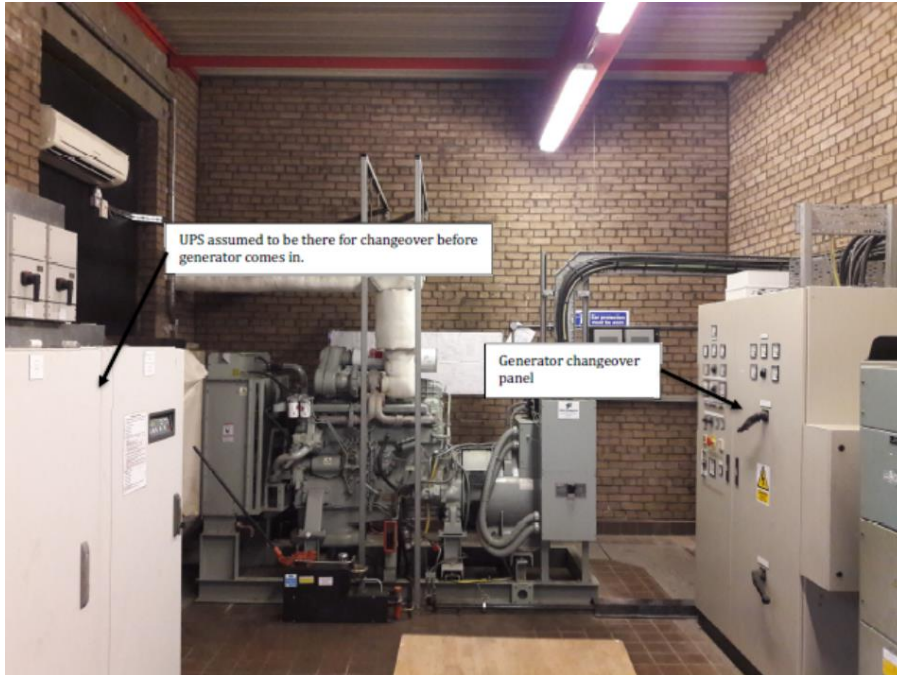
A momentary loss of power due to a Distribution Network Operator (DNO) fault caused a total loss of supply to an SSI interlocking on an Integrated Electronic Control Centre (IECC) Workstation. The loss of power subsequently led to a loss of communications.

It was identified that the Fixed Telecom Network (FTNx) apparatus had failed because it was not fed via an Uninterruptible Power Supply (UPS); the main distribution board was only backed up by a generator.

It had been assumed that as the distribution board was adjacent to a UPS and labelled as an "essential loads panel" it was backed up by the UPS as well as the generator.

Don't assume "Essential" means "Uninterruptible" when working in older Signalling Control Centres. Ensure that equipment provided to ensure resilience is fed from diverse sources as far as practicable.

Full and thorough surveys are essential.

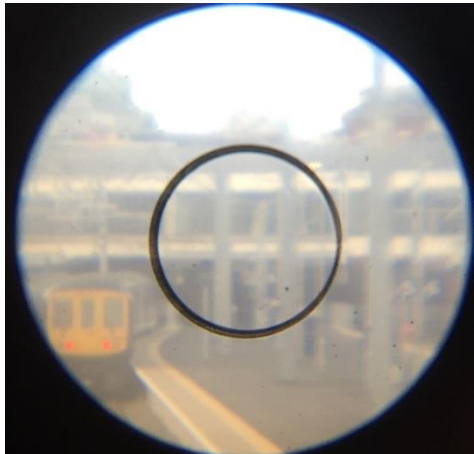
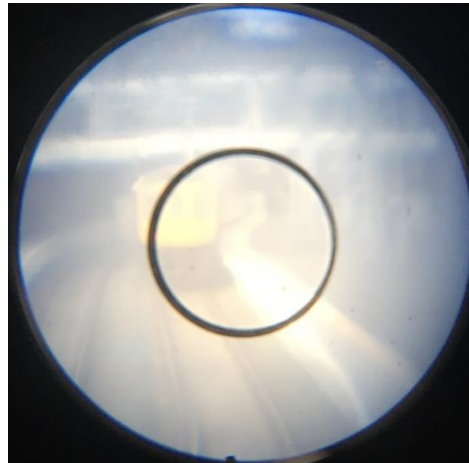
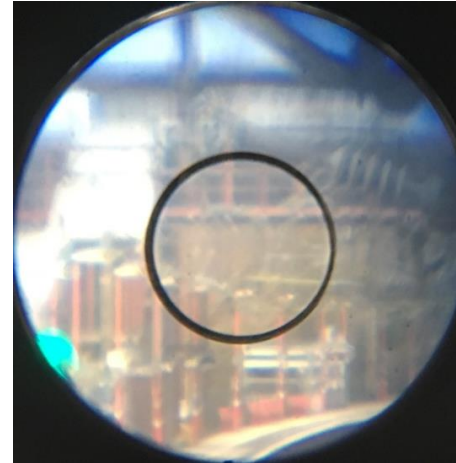
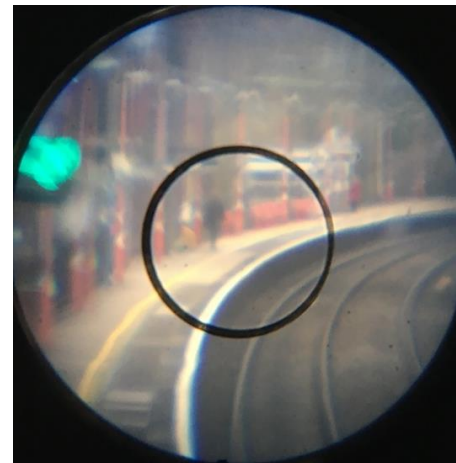
Incorrect signal beam alignment has been identified as a contributory factor in a number of incidents, and recent experience of new signals provided by projects has highlighted a deficiency in providing correct signal beam alignment.

All projects shall follow the guidance detailed in Notice Board 165 ([NB165](#)) which clarifies the responsibilities of those introducing or adjusting signalling equipment.

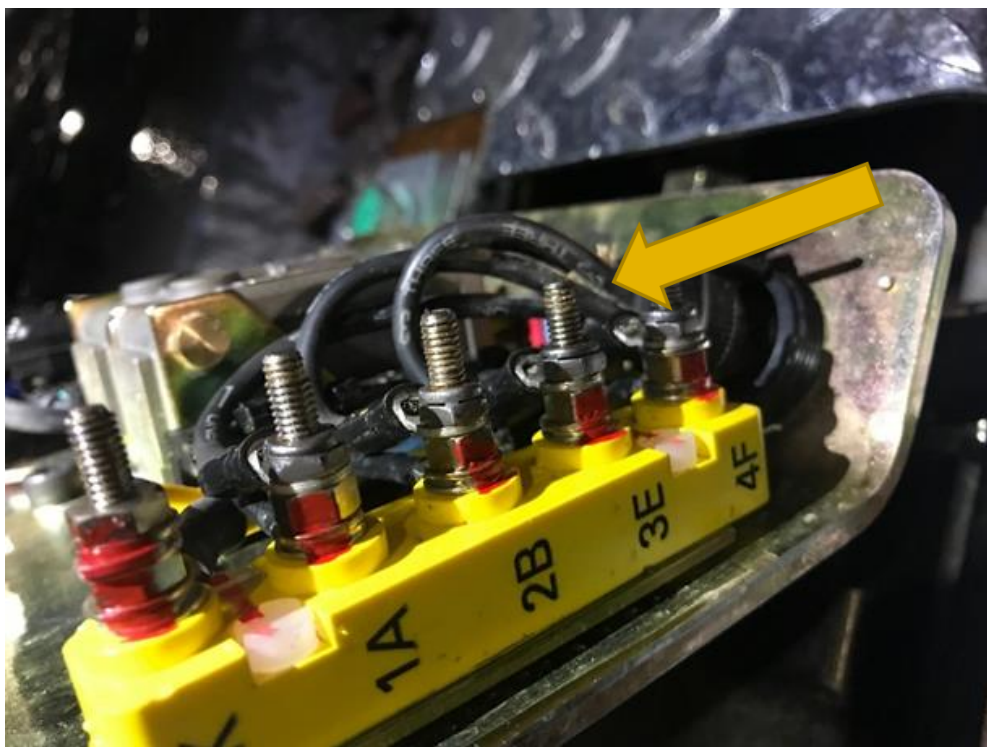
Following a Switch & Crossing (S&C) renewal, a set of points lost detection. A sparking detection cable on the microswitch assembly was found, and the cable was changed.

Further investigation revealed that incorrect lock nuts had been fitted, and cross threaded the cable termination posts. The cable was slightly loose although the lock nuts appeared to be tight.

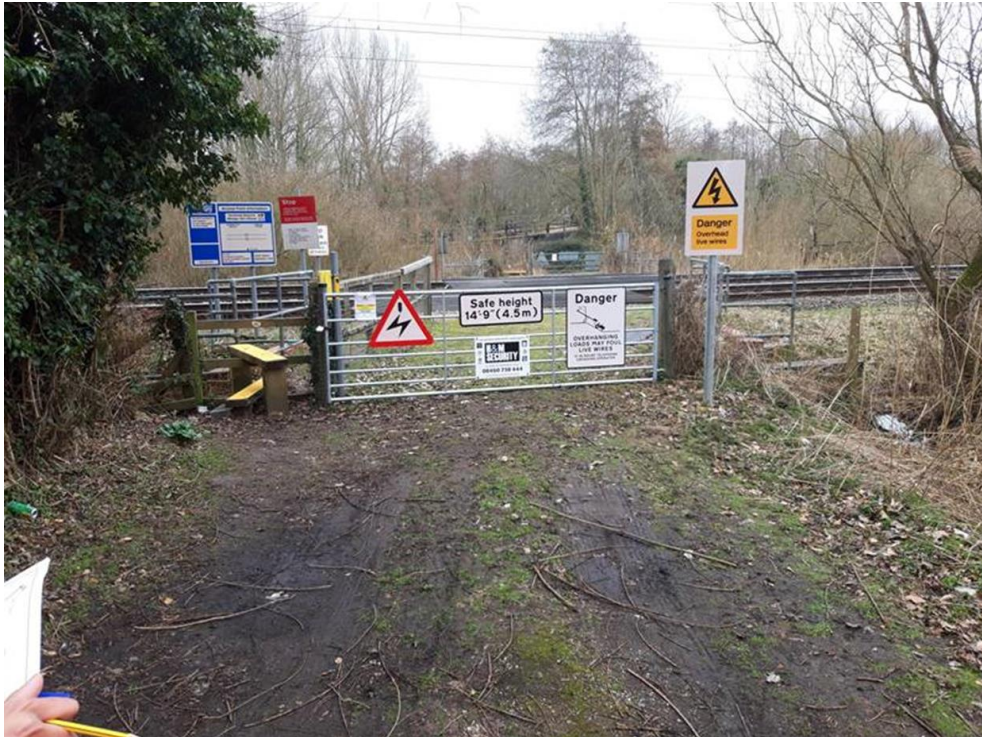
There have been a number of instances where Over Head Line Electrification (OHLE) signage at level crossings on newly electrified lines have been incorrectly or poorly installed, as shown.

Projects should seek advice from the E&P Route Asset Manager (RAM) and Level Crossing Manager before modifying or installing any crossing signage.

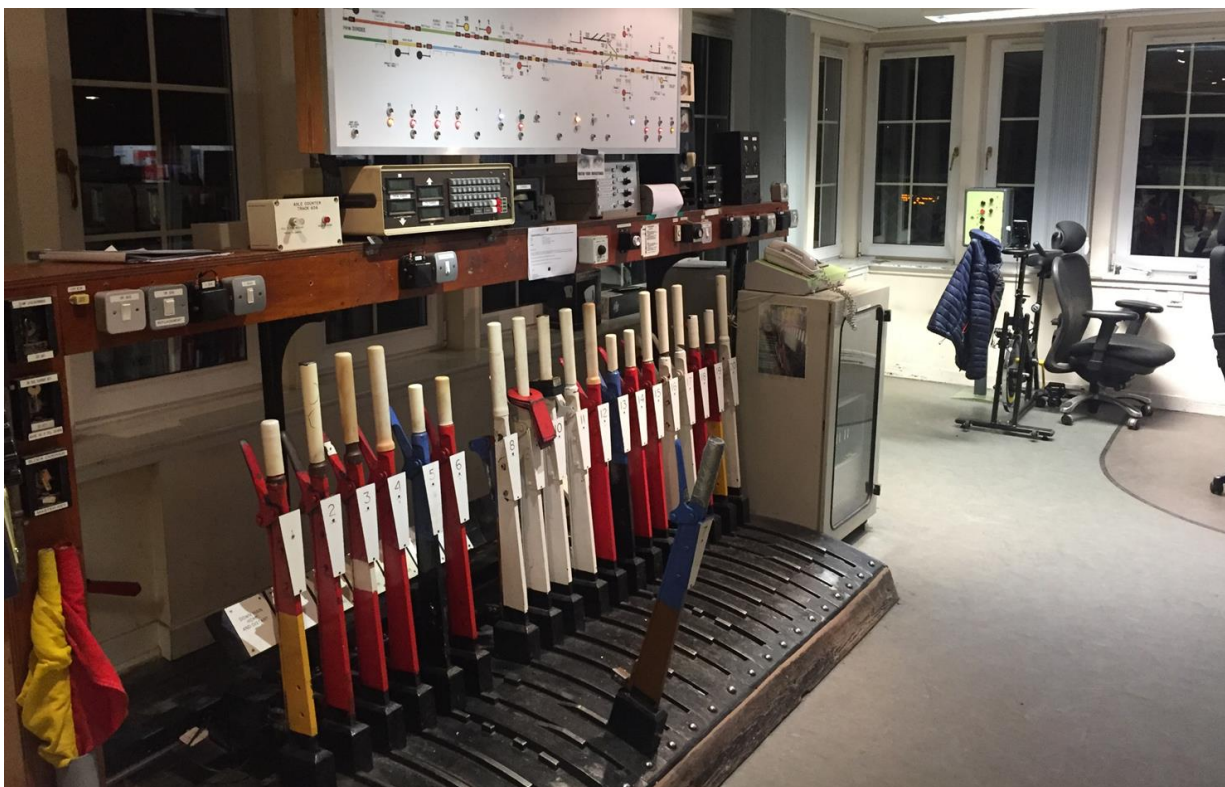
Following the commissioning of a recent Signal Box life extension project a number of design issues were highlighted related to the application of electro-mechanical circuitry, particularly approach locking.

An independent review of the entire design was later carried out, which identified further additional minor errors.

Project staff must have a demonstrable competence for the systems they are altering.

Where design houses, installers, testers and/or project engineers are unfamiliar with equipment; in this case mechanical interlocking design and practices; a suitably competent mentor should be engaged. An independent check of the design by a technical expert should also be considered.

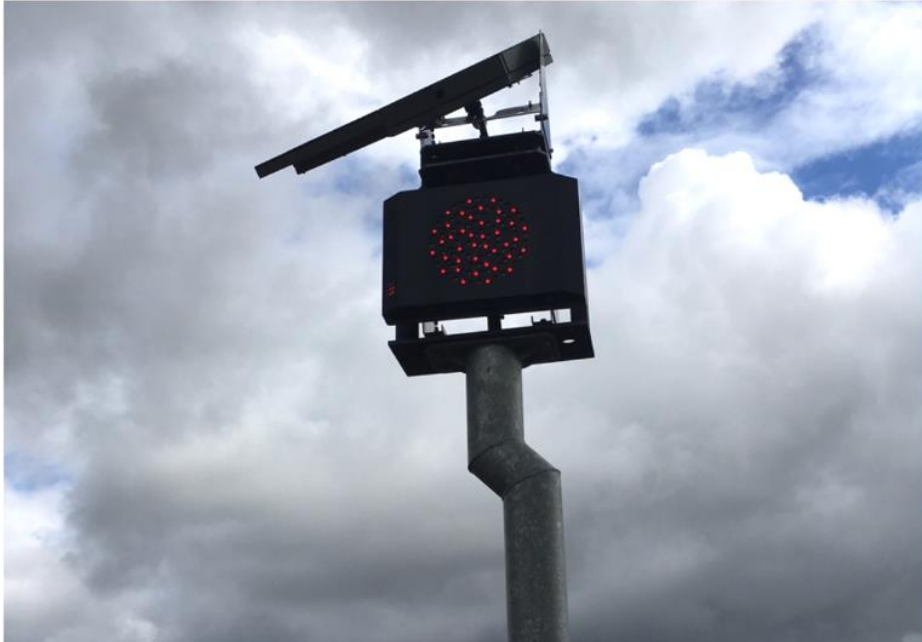
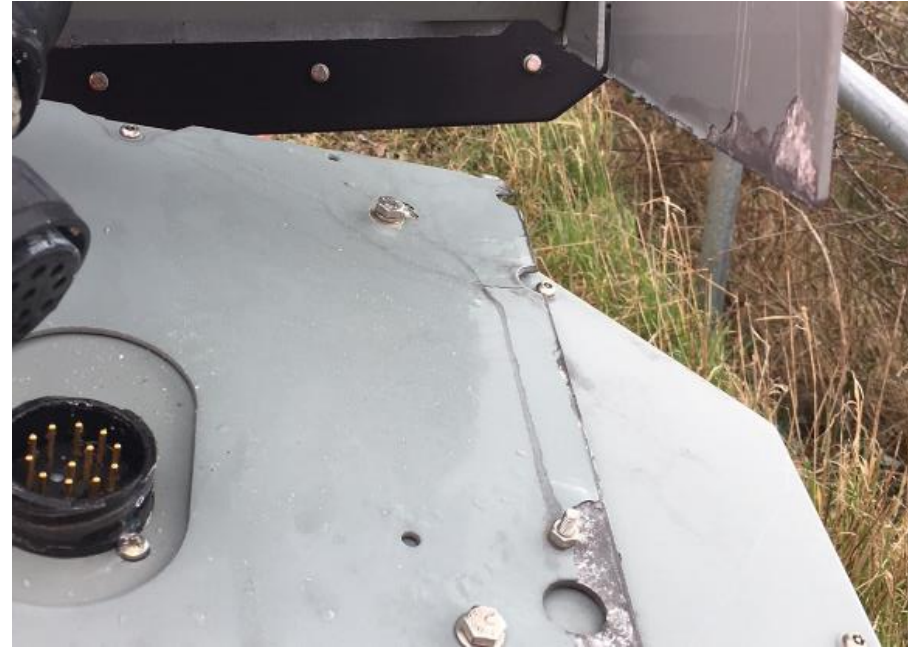
A lightweight junction route indicator signal recently snapped off during a period of high winds, due to lack of mechanical strength.

Ensure mounting plates are fit for purpose and inspected for mechanical integrity after high wind or storm conditions.

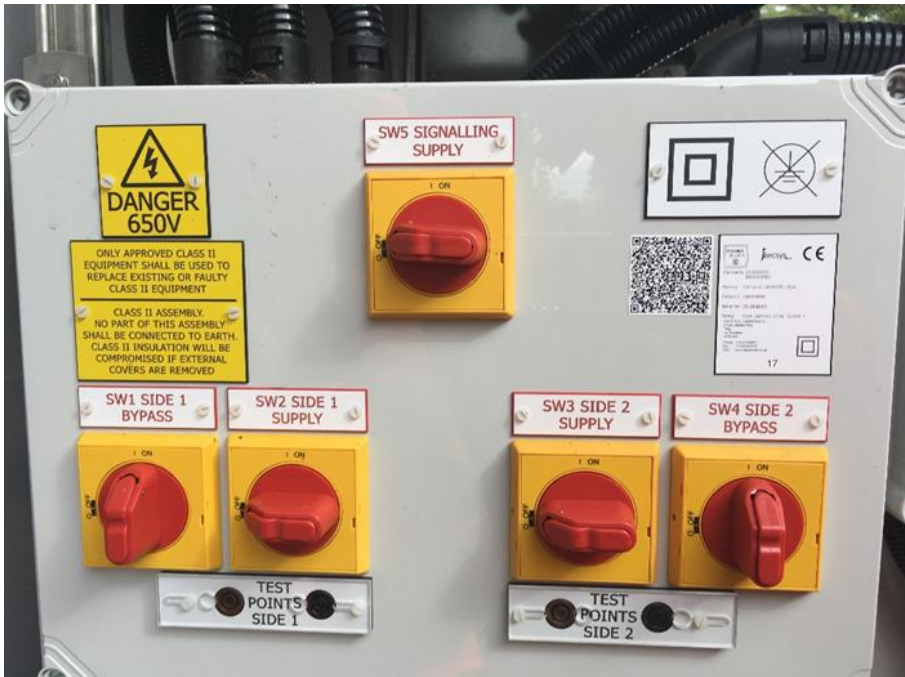
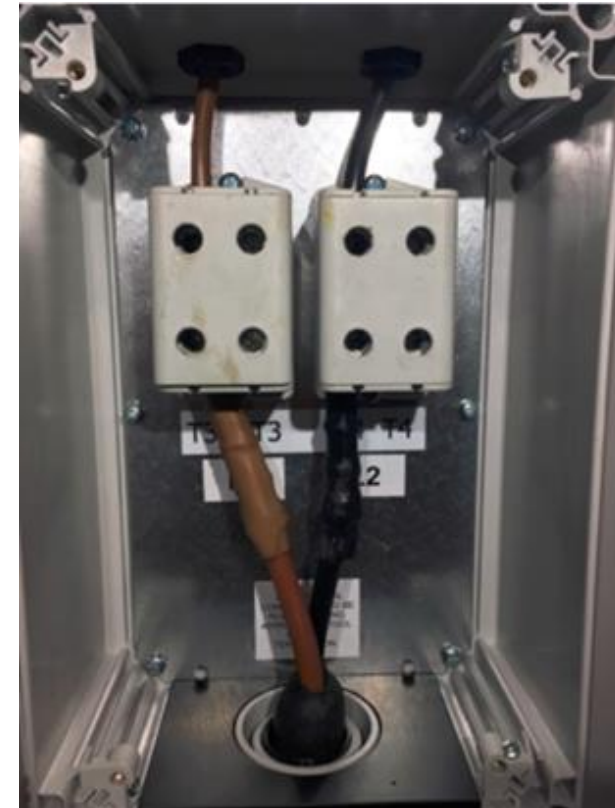
A complete loss of power to a signalling area was investigated, and a loose cable termination repaired to rectify the fault.

During the investigation, it was identified that the electrical installation did not match the design. Further investigation revealed that the original manufactured power enclosure had used a template design for an auto-reconfigurable system, although it was not required at this location. This resulted in a non-functioning switch in the unit. Neither installation nor testing of the subsequent installation identified the error.

Power enclosures should be inspected and design and installations fully tested prior to commissioning.

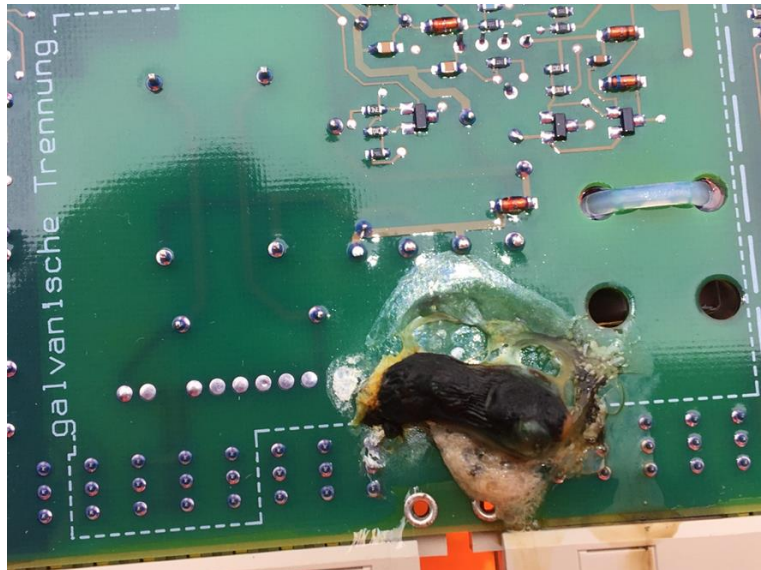
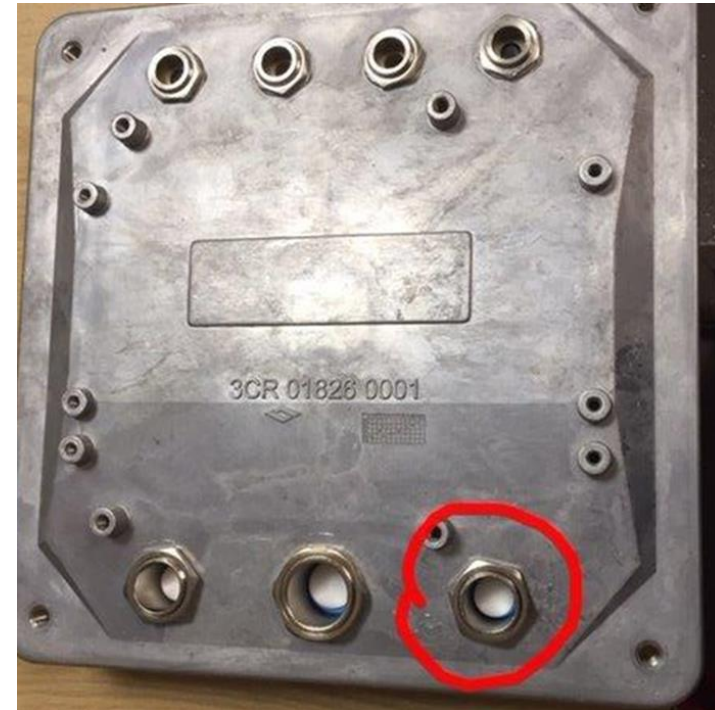
An incident occurred where an axle counter section failed. It was identified that a slug had managed to find its way into the junction box “mushroom” and shorted out the circuit board.

It was noted that blanking plugs were missing from the bottom of the base plate cable entry points.

The failure led to 52 full cancellations, 10 part cancellations and 377 delay minutes.

Installers and Maintainers should ensure that all cable entry points are blanked off to maintain the integrity of the IP (Ingress Protection) rated enclosure.

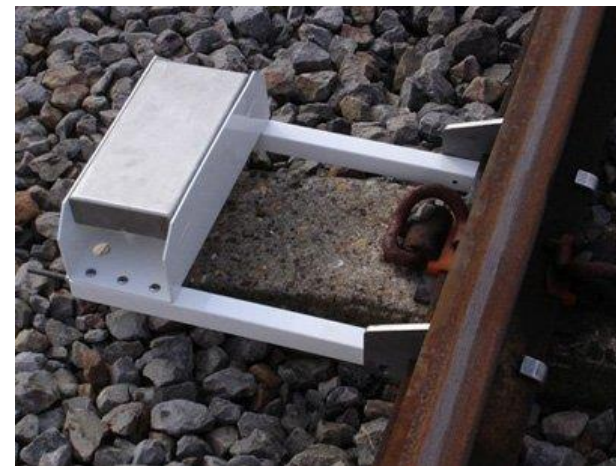
During testing of Intercity Express Trains (IET) trains, unwarranted Vehicle Circuit Breaker (VCB) operations were experienced. These affected trains operating on the rear pantograph and were reported in roughly the same location each time. Investigations identified Automatic Power Control (APC) magnets were incorrectly installed in 3 locations on each line, in the position of Automatic Power Change Over (APCO) balises.

APC Magnet, installed in pairs before and after neutral sections.

Consider the knowledge, competence and experience of staff in deriving information from signalling scheme plans, especially when installing a non-signalling asset that is shown on a signalling plan.

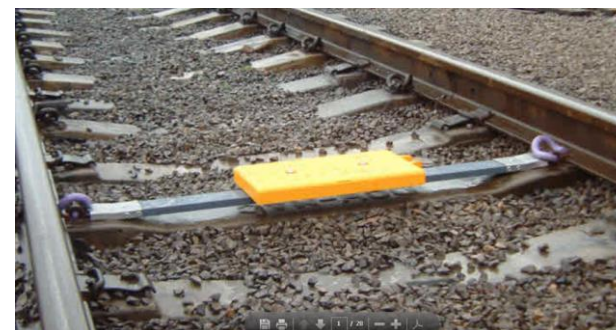
Eurobalise – used for various functions including APCO tilt activation (TASS), ETCS and Selective Door Opening (SDO) etc.
