Shared Learning

Hackney Wick double fatality

Ref: NRL20-01

Location: Hackney Wick, Anglia Route, Eastern

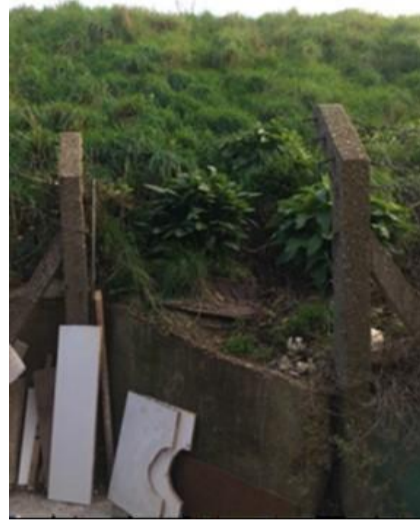
The two men most likely accessed the railway via a hole in the chain link fence that was built on top of a small 900mm wall and embankment. The fence did not prevent access.

The hole in the boundary fence allowed easier breaching of the railway boundary at Hackney Wick and was considered an underlying cause.

The Off Track inspectors who did the inspection recorded they could not undertake a tactile inspection of the fence due to vegetation. No attempt to view it from the public side was made, nor alternative measures used (e.g. de-vegetation).

Where boundary fence inspections cannot include a tactile test, inspectors must use alternative means to view/inspect the fence integrity from wherever possible. This includes accessing from the public/3rd party side, alternative vantage points, by technology (e.g. drones) or removing vegetation to improve visibility (if appropriate).

Managers must ensure Non-Tactile forms are suitably processed and reviewed, especially for repeat locations. A Special Inspection Notice is due to be issued.
