Hook Embankment Failure

Ref: NRL23-08

Location: Hook, Wessex, Southern region

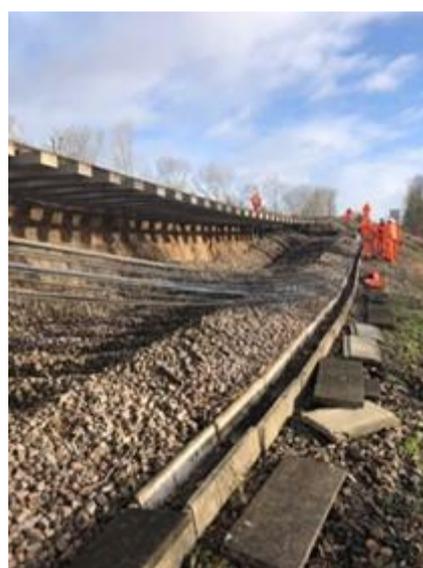
On Saturday 14th January 2023 a landslide occurred which closed the railway between Hook and Winchfield in Wessex Route (part of Southern Region). The landslip occurred during a possession for a track renewal.

Based on the evidence available there was more than average rainfall at the time (5 months of rain fell in the 3 months prior to the landslip). This led to a loss of strength of the clay embankment and the softer alluvium below. The surrounding area at the bottom of the embankment and in surrounding fields was also pooled with water and a local river had overtopped.

The drainage at the bottom of the embankment was ineffective at removing the water and had not been maintained over a period of 10 years. The drainage had not been inspected prior to the failure occurring and this location was not listed as a priority.
