## OLE Head Span Cable Strike

Ref: NRL24-07

Location: Darlington Station, Eastern region

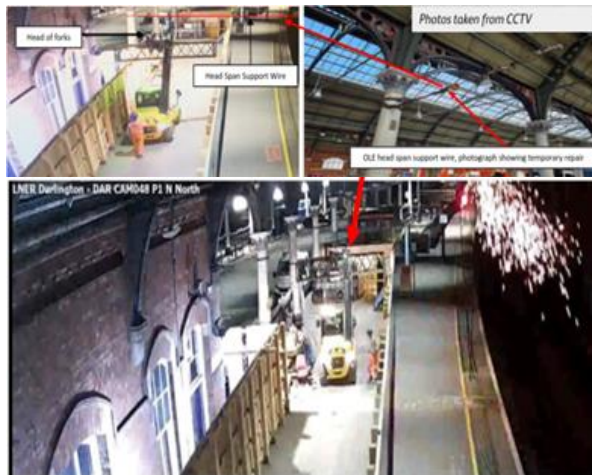
Whilst travelling within the hoarding, the load (3m length of steel) was lifted (boomed) over the hoarding using the telehandler (see photos). The Telehandler's head of the forks contacted the OLE head span support wire and brought the vehicle to a stop. The Plant Marshall checked the tires and then informed the operator that the tires are inflated and therefore couldn't identify any problem. The telehandler driver then continued forward pushing against the OLE head span support wire (see photo) which caused it to snap under the tension and likely came into contact with the live contact wire.

The event caused the adjacent circuit breakers to trip and resulted in 570 delay minutes whilst a temporary repair of the OLE head span was undertaken.

- Steel arisings were not planned to be raised above the hoarding.
- Steel arising were not cut into manageable sections to remain within the hoarding when transported.
- Change in methodology to transport materials was not risk assessed in accordance with [NR/L3/ELP/29987](#) module 2.
- Site Supervision never corrected or ensured that zoning arrangements and safe working practices were being adhered to throughout the shift.

- When working in proximity of NR OLE infrastructure (whether deemed live or not), a risk assessment is required to be in place in accordance with [NR/L3/ELP/29987](#) module 2.
- Site walk through with the designers, contractor and site staff must be carried out.
- When changes arise during planned activities, the collaborative consultation process must be revisited to re-view risks and control measures.
- Supervisors and operatives must check and challenge permits that are ambiguous without any control measures being identified or implemented.
- When putting people to work, briefings must be clear and concise with confirmation of understanding asked.
- Capability assessments to be carried out on all operations and personnel involved prior to commencing the task.
- Plant Marshall required to be in a position of safety out 3 meters away from moving plant(s).
