Derailment of freight train at Audenshaw

Ref: NRL25-02

Location: Audenshaw, Manchester

Date of issue: 09/06/2025

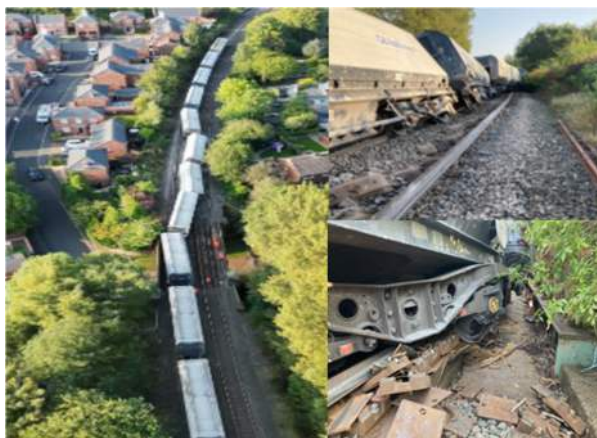
At around 11:25 on 6 September 2024, a freight train travelling between Peak Forest and Salford derailed as it passed over Sidmouth Street bridge in Audenshaw, Manchester. The train was made up of 2 class 66 locomotives and 24 wagons fully loaded with aggregate. The 2 locomotives and the leading 10 wagons passed safely over the bridge, but the following 9 wagons derailed, with the remaining wagons coming to a stand on the bridge itself. No injuries were caused as a result of the derailment but substantial damage was caused to railway infrastructure and some of the wagons.

The track over Sidmouth Street underbridge No. 3 is supported by a Longitudinal Timber Bearer System (LBS) and has a sub 800m radius curve.

Investigations to date suggest that the derailment was caused by gauge spread of the track which occurred when the baseplate chair screws sheared and broke.

- The chair screws in the baseplates were the wrong type. For hardwood timbers they should have been high tensile screws (marked as HT) as per NR/L2/TRK/3038.

- The chair screws used were too short for the depth of packing between the baseplate and the timbers. Screws marked AS had been fitted which are 160mm long (6 5/16 inch). They should have been LSA screws as these are 206mm long (8 3/8 inch),

SIN220 “Managing Lateral Forces on Sub 800m Longitudinal Bearer Systems” was issued on 06 December 2024 which requires the inspection of the type of chair screws and depth of packing to ensure any failed, ineffective or non-compliant screws are replaced.
