## Scaffold incident at London Liverpool Street Station

Ref: NRL25-03

Date of issue: 23/07/2025

Location: London Liverpool Street Station

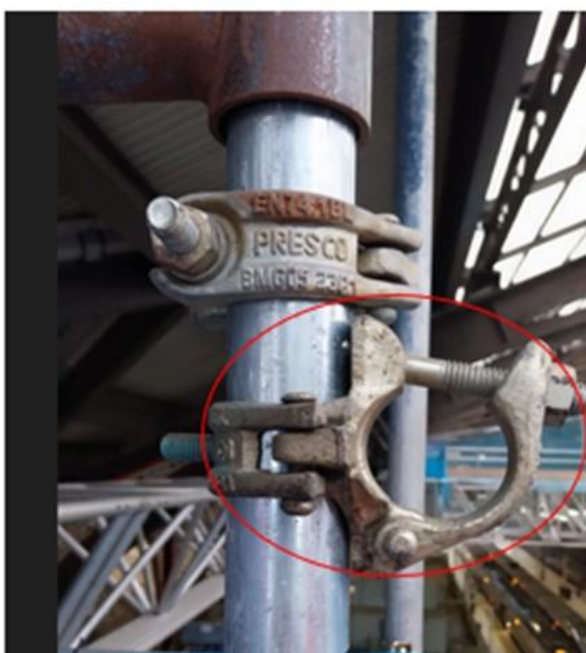
- The check coupler fell because it was not correctly tightened. The orientation of the check coupler prevented the scaffolder having visibility of the bolt head whilst tightening the fixing. This led to the bolt being insecure, and vibrations from ongoing work caused the coupler to loosen and fall.

Bottom fitting was acting as supplementary coupler. Note: Not the actual fitting, this is a similar arrangement.

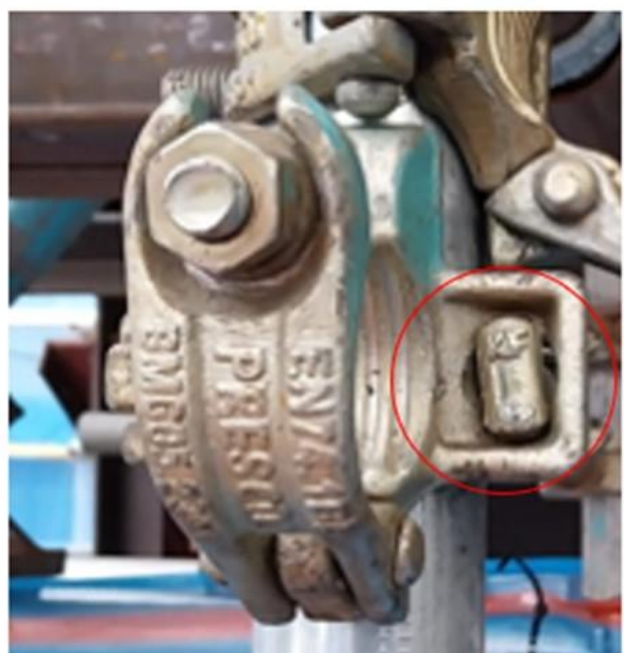
Fitting showing how the bolt head should have been seated in the clip body correctly to prevent fitting becoming loose and falling.

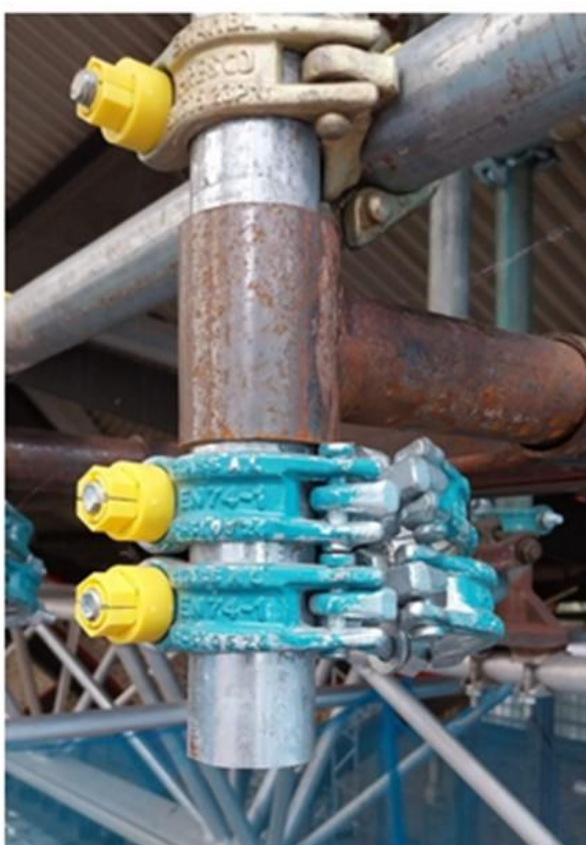
Revised detail with swivel coupler fittings permitting visual inspection of both fittings by erector. Note: Yellow Klikon caps to aid inspection.

- The design of scaffold should take account of installation restrictions and make sure components are selected that suitable for safe installation by those undertaking the works.
- Supervisors in charge of works should be provided with and briefed on the Work Package Plan and Task Briefing contents and ideally involved in their development.
- Specific risk controls detailed in the Work Package Plan should be incorporated into the Task Briefing Sheet to make sure that the correct level of detail is delivered through briefing to those undertaking the works.
- Principal Contractors to review their assurance procedures and processes to assure that Contractors/Sub-Contractors are working in accordance with defined methodology and designs/specifications.

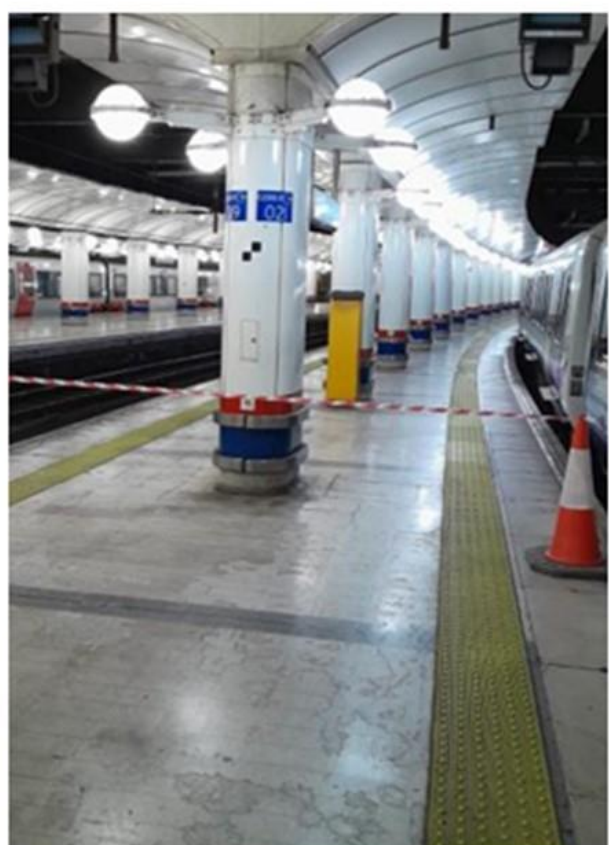
The coupler landed within an exclusion zone that had been established on the station platform, resulting in no injuries or damage.

Exclusion zone in place during the scaffold works.
