## Scaffold incident at London Liverpool Street Station

Ref: NRL25-03

Location: London Liverpool Street Station

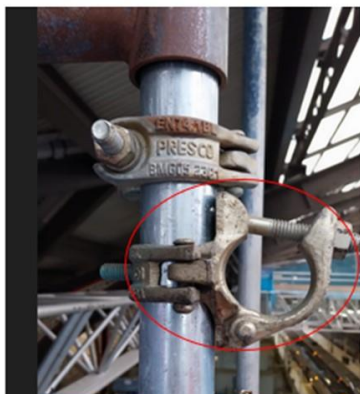
- The check coupler fell because it was not correctly tightened. The orientation of the check coupler prevented the scaffolder having visibility of the bolt head whilst tightening the fixing. This led to the bolt being insecure, and vibrations from ongoing work caused the coupler to loosen and fall.

Bottom fitting was acting as supplementary coupler. Note: Not the actual fitting, this is a similar arrangement.

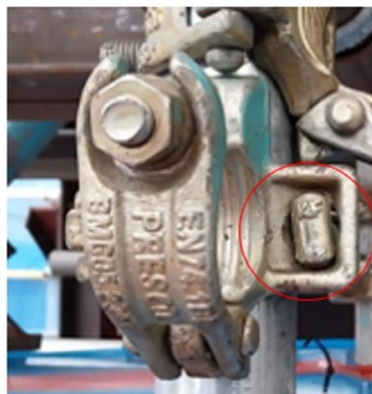
Fitting showing how the bolt head should have been seated in the clip body correctly to prevent fitting becoming loose and falling.

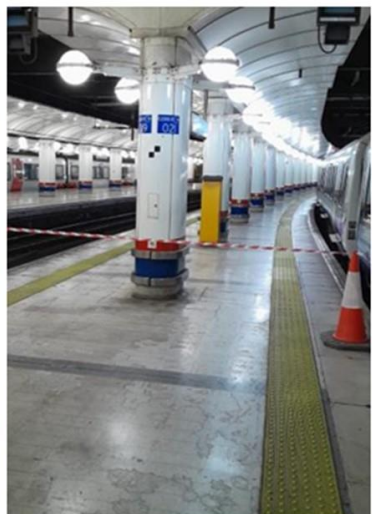
Exclusion zone in place during the scaffold works.
