Scaffold incident at London Liverpool Street Station

Ref: NRL25-03

Date of issue: 23/07/2025

Location: London Liverpool Street Station

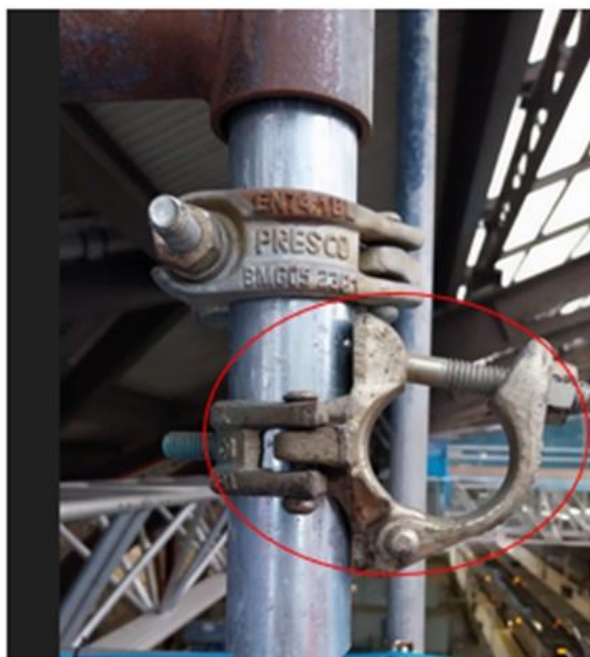
- The check coupler fell because it was not correctly tightened. The orientation of the check coupler prevented the scaffolder having visibility of the bolt head whilst tightening the fixing. This led to the bolt being insecure, and vibrations from ongoing work caused the coupler to loosen and fall.

Bottom fitting was acting as supplementary coupler. Note: Not the actual fitting, this is a similar arrangement.

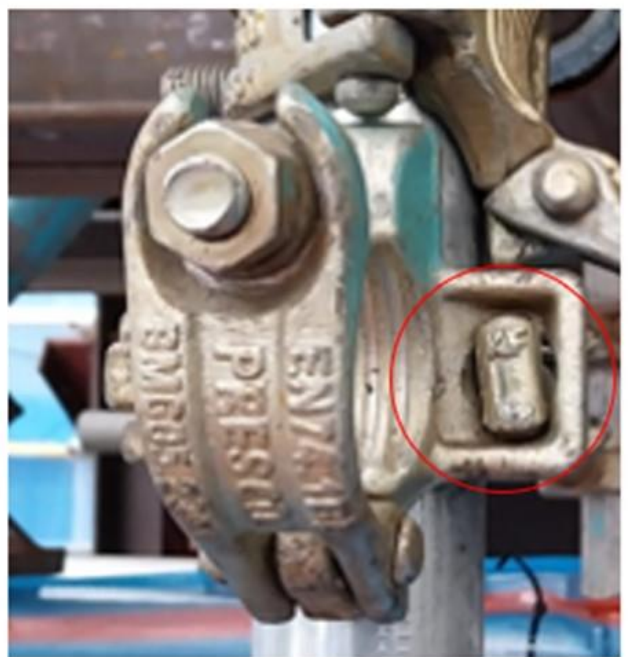
The investigation concluded that the coupler had not been correctly tightened and vibrated loose when the scaffolder was working on an adjacent fitting.

Fitting showing how the bolt head should have been seated in the clip body correctly to prevent fitting becoming loose and falling.

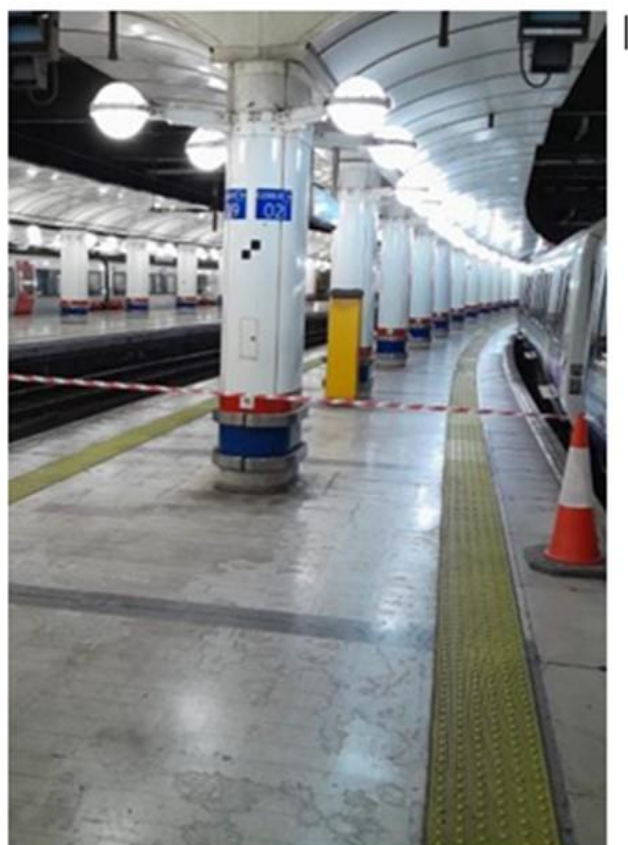
The coupler landed within an exclusion zone that had been established on the station platform, resulting in no injuries or damage.

Exclusion zone in place during the scaffold works.
