# Shared Learning

Key learning following a serious incident

Ref: NRL22-04

Location: Eastleigh Depot, Wessex,

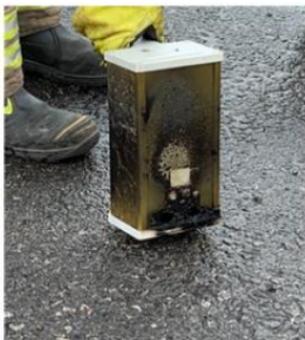
On the 01/08/2022 at 09:25 a thermal runaway of a Robattery 700 portable lithium-ion battery pack occurred at Eastleigh P-way store. The building was evacuated, and the fire brigade called to control the heat and smoke emitted from the battery. The battery was fitted to a Robel tamper unit that had indicated a control unit fault so had been placed in quarantine awaiting repair.

An examination of the units carried out by the manufacturer concluded that the tamper unit fault had caused overheating and damage to the insulation on a cable in the battery causing a short circuit which led to the thermal event.

- Defective equipment must be placed in a clearly defined and marked quarantine area and labelled "not to be used". Staff must be instructed in the arrangements for the reporting and labelling of quarantined equipment.
- Faulty equipment placed in a quarantine area must only be checked or repaired by the approved maintainer and never be removed by staff for operational use.
- The manufacturer has issued updated Service bulletins and operating manuals for the ROBEL 62.20L Tamper and 71.01 Battery. These publications must be made available to users and the instructions they contain followed.
- The equipment retains full Product Acceptance Ref: PA05/05265 & Catalogue number 094/022069. The specific conditions contained within the PA Certificate must always be complied with.
