Share with Pain

SwP001/13

SSI Data Assurance

Background

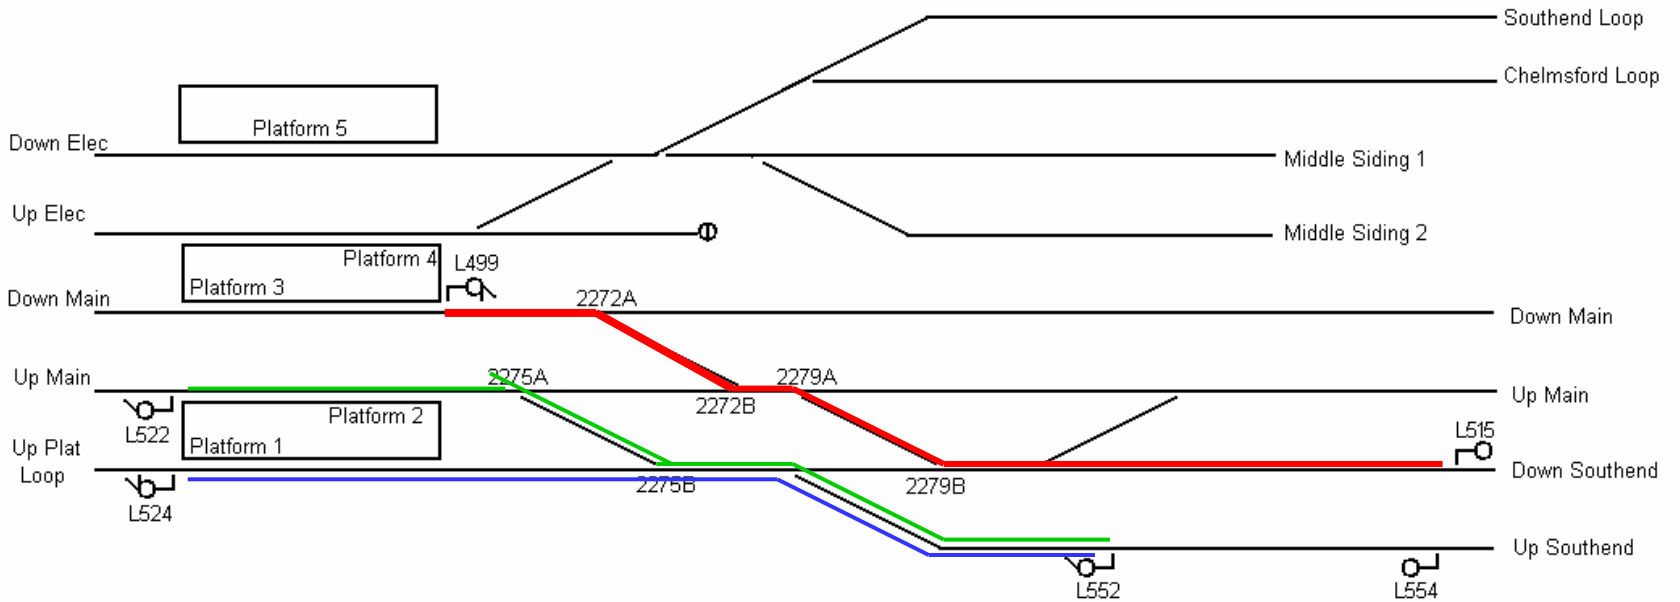
On Sunday 20th April 2008, 2K28 (13:45 Liverpool Street to Southend Victoria) arrived at Platform 3 at Shenfield station on the Down Main. L499 signal at the end of the platform was showing a green aspect with a position 5 junction indicator for the route over 2272 and 2279 crossover onto the Down Southend line (red line). The route was set from L552 signal into platform 2 which the train 2K31 took and arrived in platform 2 (green line). The signaller then set L552 signal into platform 1 (blue line) which required 2275 to go reverse to normal and in doing so irregularly called 2272 reverse to normal even though they were supposed to be locked by the route from L499. Having undertaken his station duties, on closing doors and preparing to move off the driver of 2K28 saw that L499 was now a red aspect and 2272A points immediately ahead were now lying in the normal position for the route to the Down Main.

- Error was in 2272 points call R to N only
- Deficiencies with Control Tables meant data was generated from scheme plan, not from approved control tables and entered straight into the Design Workstation
- Rogue point test used but didn't find the error so swinging overlap rogue point test introduced
- PRR (Panel Route Requests) must be linked to a corresponding PFM (Points Free to Move)

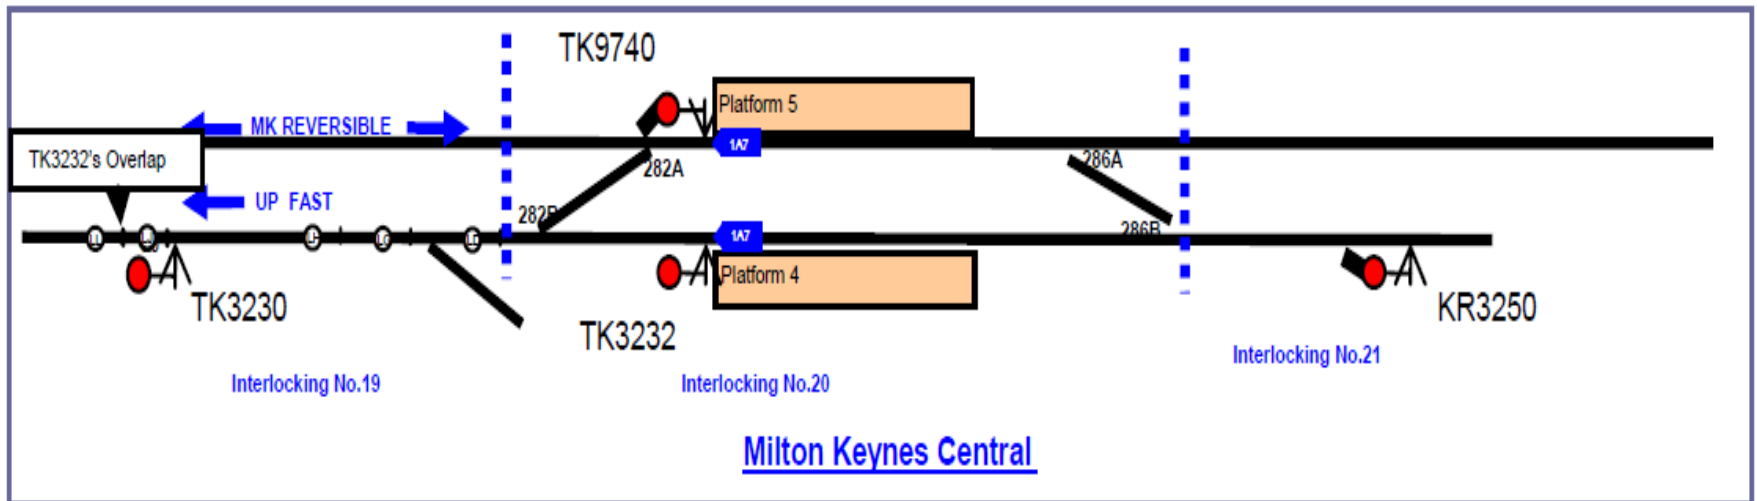
Milton Keynes

For a train from platform 5, Signal TK9740 was set to TK3230 and TK9740 displayed a green aspect to the driver whilst a train was still visible to them on the Up fast line, the aspect in TK9740 then changed to a single yellow aspect.

- **The immediate cause was that the occupation status of all appropriate axle counters was not in the cross boundary telegram associated with the aspect controls for TK9740 signal for the route from TK9740 to TK3230. This was inadvertently removed as part of an update to add conditional double reds**

- **It was extremely difficult to keep track on what test logs had been answered in each new CISR as the test logs were not noted on the CISR (Part 2) and the logs themselves were not returned with the new CISR**

- **A need for communication ‘rules’ between designers and testers to enable discussions on the changes that have/are occurring**
- **If marked up control tables had been produced it would have highlighted the fact that the axle counters had been altered and the testers would have tested the affected control tables. The designers producing the control tables would in producing the control tables have highlighted to themselves the fact that axle counters were affected in the TK9740 to TK3230 route and thus updated that route’s data as well**

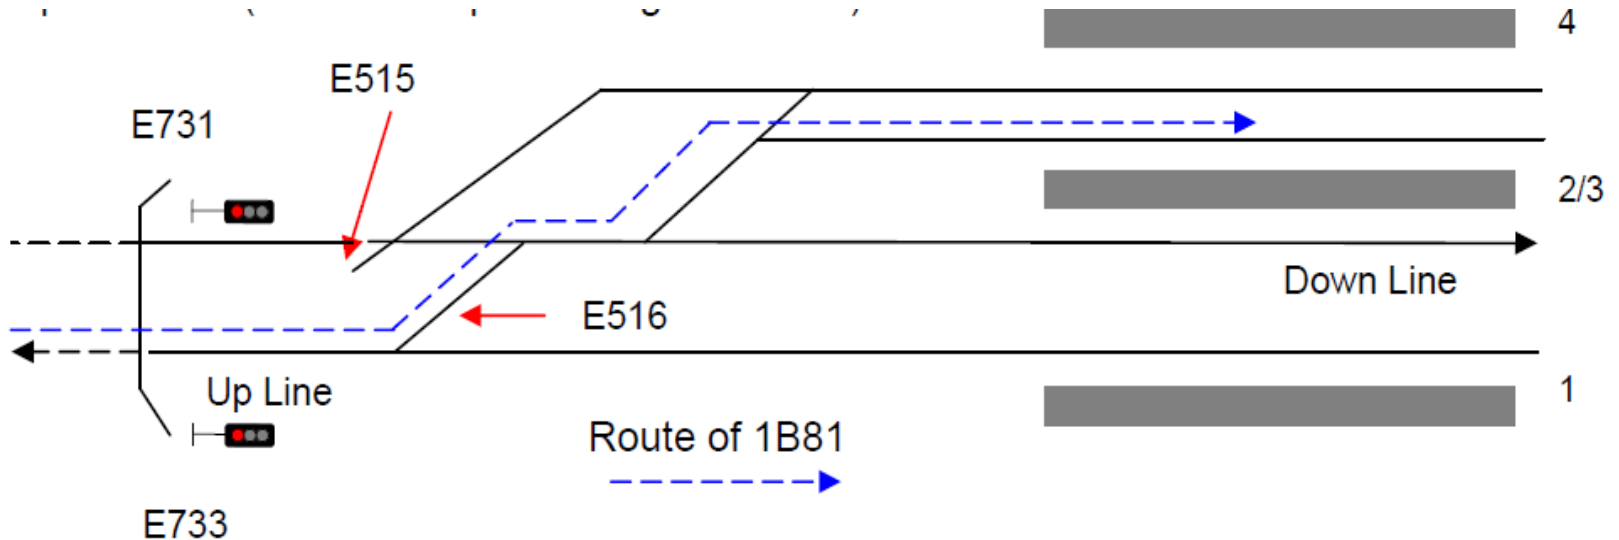
Southampton

Route set from E733 over E516 points reverse in to platform 3. Trying to replicate a permitted move under the old RRI interlocking, the signaller turned E515 points N to R on the point key. E516 points moved R to N even though E733 route was set over them.

- Error was in E516 point call
- PRR must be linked to a corresponding PFM
- Data designed and checked by file rather than by complete route
- Points tested with route set up to signal and then with route beyond signal, but not tested with route up to signal set and route beyond signal set
