Share With Pain

IR87 Immingham

SwP003/13

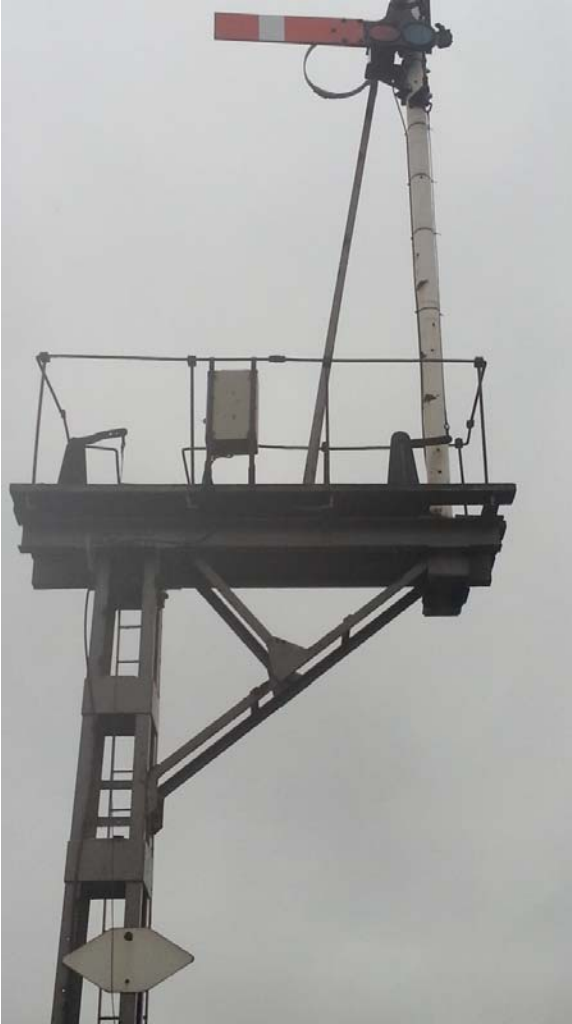
Signals and Signal Box involved

- IR87 semaphore signal is a bracket signal, situated just beyond Immingham Reception Sidings signal box on the double line towards Immingham East Junction.
- IR213 signal is a colour light signal at Humber Road Junction with a route leading towards IR87
- Immingham Reception Sidings Signal Box and the lineside equipment are controlled from a combination of slide lever frame and two (NX) panels. The asset owner is not Network Rail but the infrastructure is operated by Network Rail signallers.

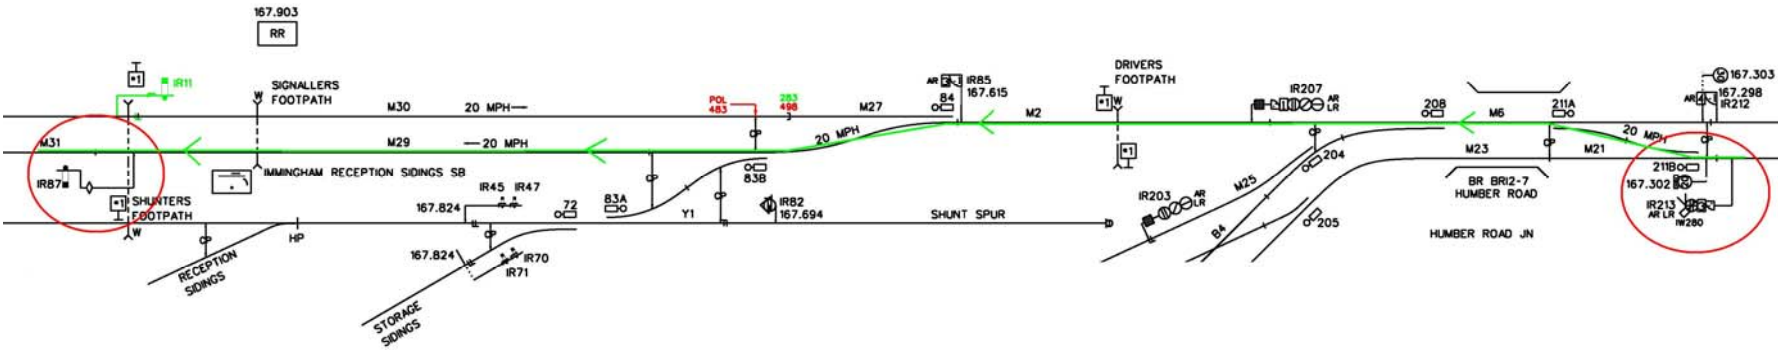
Scheme Plan extract

- On Wednesday 19th December 2012, the driver of 0D54 train reported IR213 (colour light signal) showing a green aspect leading up to IR87 signal (semaphore signal) with the arm in the ON position.
- On the same day, Network Rail Maintenance attended the scene and restricted IR213 to a yellow aspect for routes towards IR87 signal.
- Following investigations on the cause of this wrong side failure and discussions on the best way to implement the changes to the semaphore signal, the necessary equipment and circuits were installed on Sunday 3rd March 2013 and the aspect restriction removed.

- After several options were considered, the final option chosen was to install an arm repeater and associated circuit alterations in line with the Railway Group Standard GK/RT0039.
- An issue affecting the installation of an arm repeater was the poor condition of IR87 structure. An initial structural assessment was undertaken, resulting in the structure being deemed unsafe to access, so an external platform was necessary to install the repeater (and for subsequent maintenance).

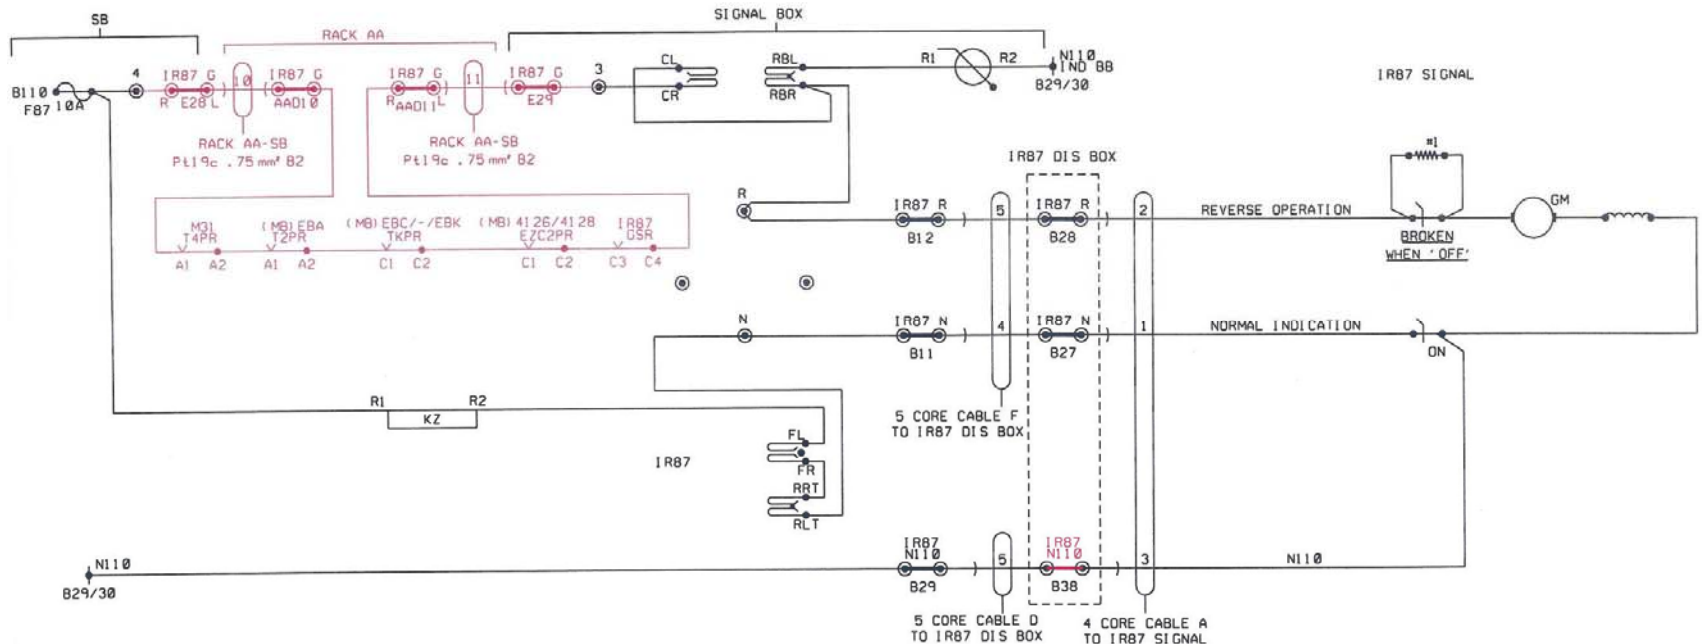
- As part of the circuit changes, relay contacts were included in the IR87 signal motor circuits to return the arm to, or keep the arm in, the ON position while track circuits from the signal to the next signal (MB4126) at Immingham East Junction were occupied.

- Design & Testing failed to identify that 87DGPR relay was directly driven off the lever (via a circuit controller connected to the lever frame). This relay in turn provided the circuits to IR213 signal to show either Yellow or Green depending on the position of 87 lever.

- This resulted in the possibility to have a train in section, with IR87 lever not (yet) normalised but the track circuits returning IR87 signal to danger, while IR213 would show a green aspect because 87 lever was still reversed (energising 87DGPR relay) when a route for a second train would be set from IR213 to IR87.

- No arm proving had ever been installed for IR87 signal, despite this being a motor operated semaphore signal. This is not in accordance with Group Standard GK/RT0039, Section 6.3: “Arm repeating shall be provided for all power-operated semaphore signals”.
