# *Share with Pain*

# *SwP004/13*

*Bromfield Level Crossing*

*Infrastructure Projects*

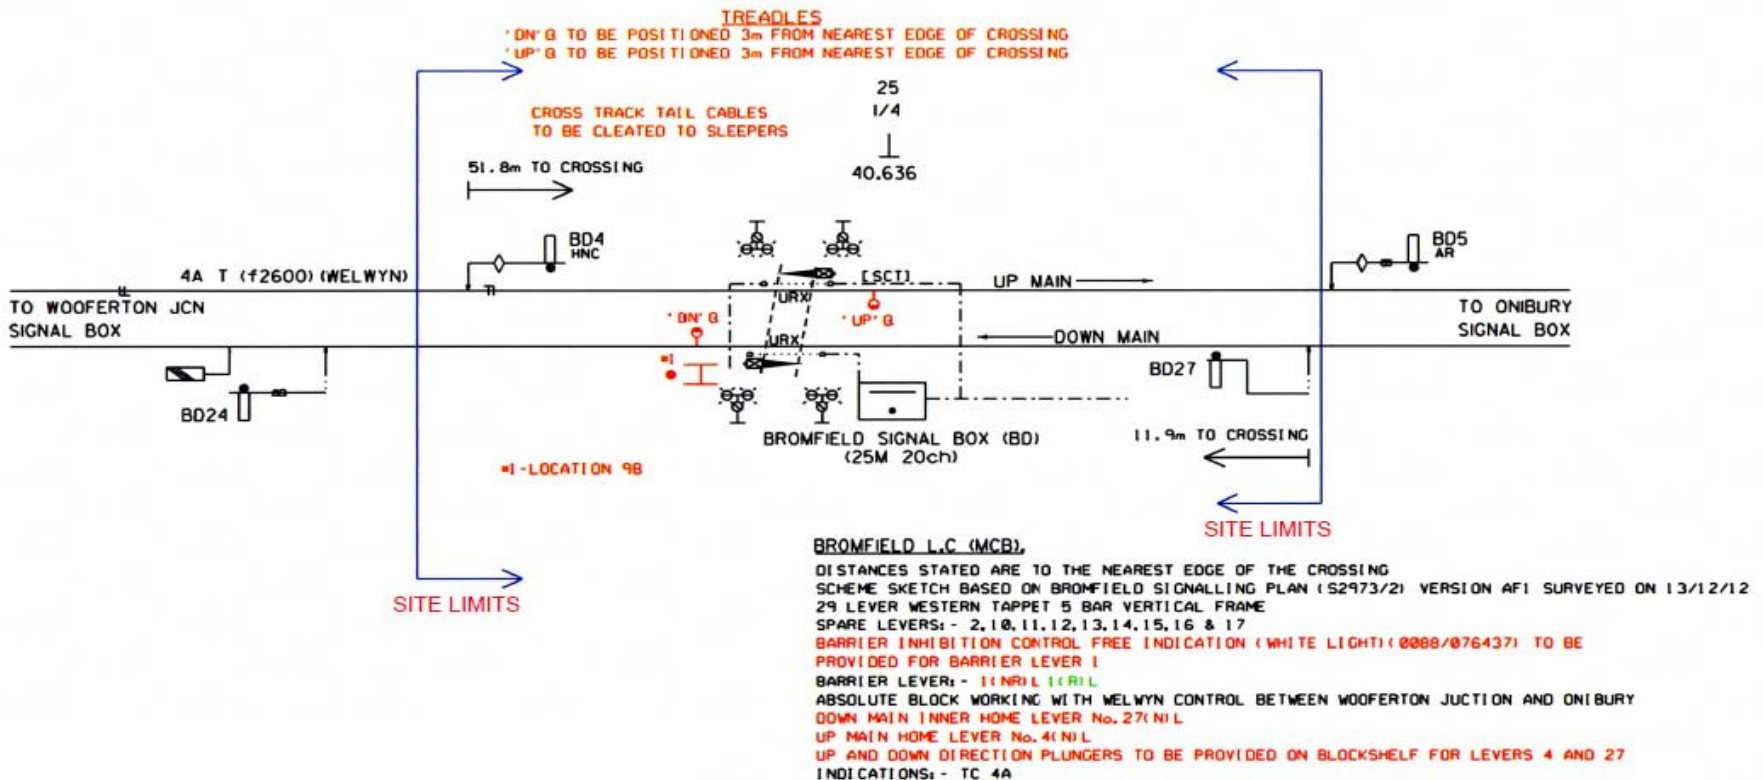
# Site Configuration

Bromfield Signal Box / MCB crossing is located at 25 ¼ miles on the line from Wooferton Junction to Onibury. It is an Electro-mechanical signal box with a Western Tappet 5 Bar Vertical frame.

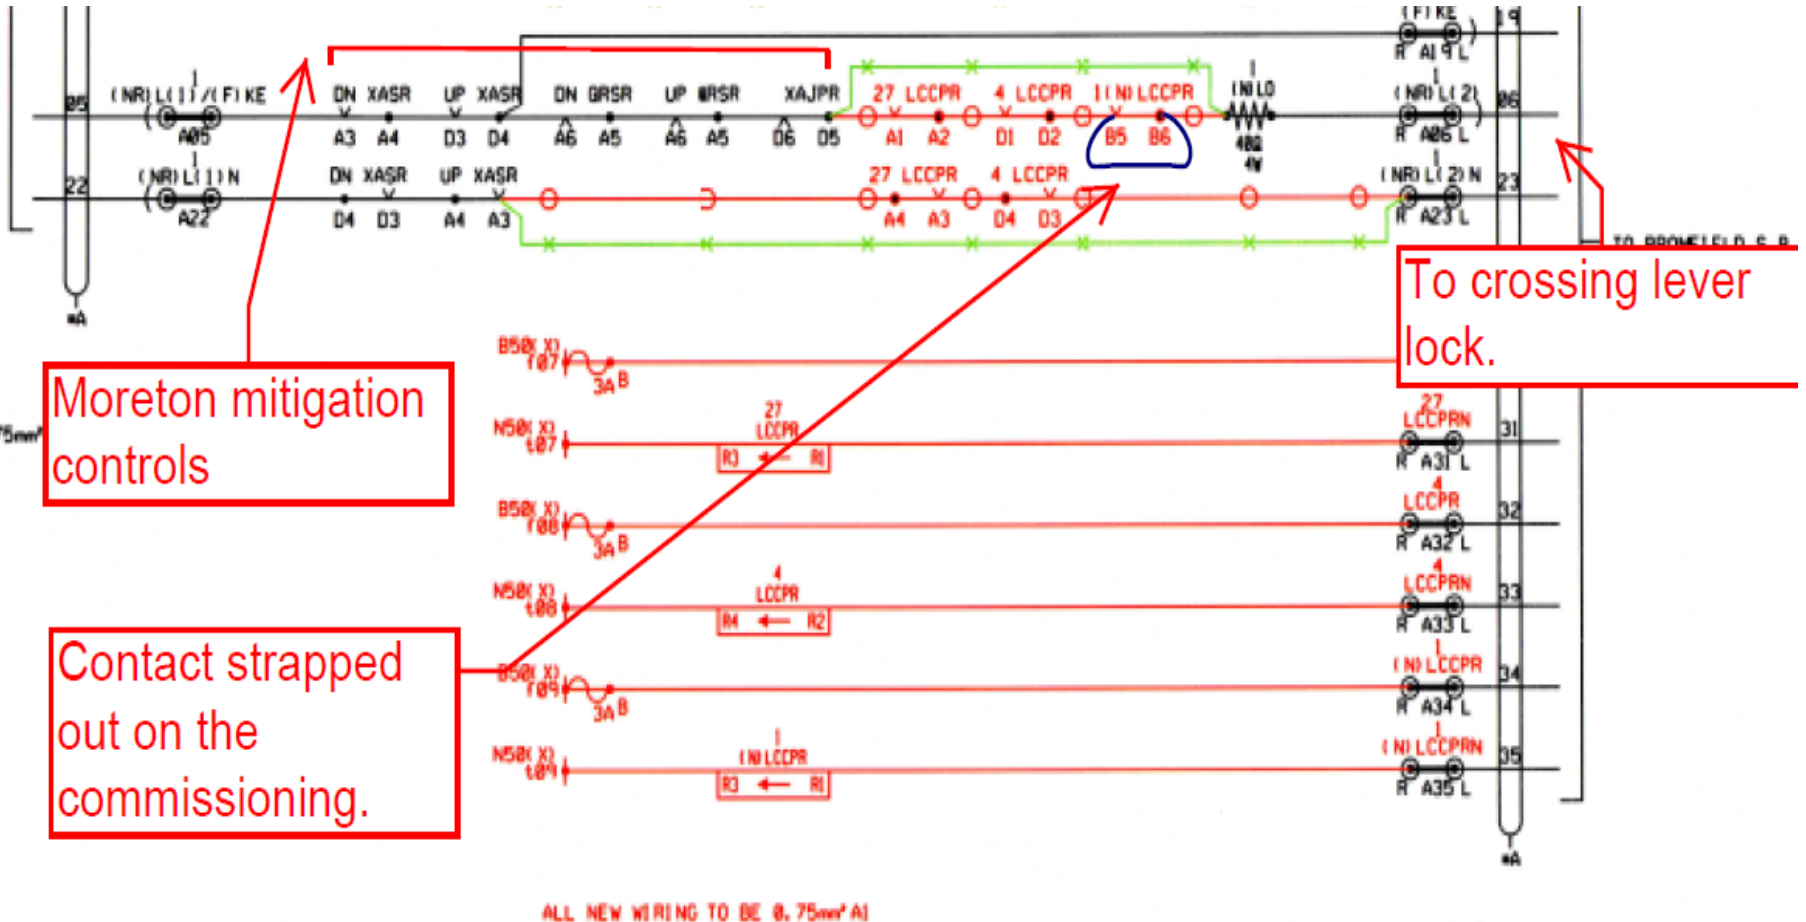
# Circuitry affected, lock 'throw down' modification and strapped out contact

- Following commissioning, whilst reviewing the test copy returns, the designers identified a latent wrong side failure in the tester altered circuitry
- The testers had strapped out 1 (N) LCCPR contact from level crossing number 1 lever lock, which meant that the crossing lever could be moved from the reverse position and put back in the frame. The protecting signals were then released and could be cleared with the crossing barriers raised
- An incident did not occur and the project team reported immediately the risk to the Local Operations Staff who were able to mitigate with instructions

- The original issued circuitry had an emailed design office modification issued to include a 'throw down' feature and this didn't operate as expected
- No test log was written to the design office during the commissioning period for this unexpected operation, and subsequently no design modification was issued to remove 1 (N) LCCPR contact, or alter the circuitry. On that basis independence between design alteration and testing was compromised
- The Principles Tester did not adequately re-test the affected area post alteration. A test of the reverse lock had been undertaken earlier in the shift. The Principles Tester did not think the alteration affected the reverse lock so no further testing was undertaken on the 'reverse side'

- All staff involved were restricted and have been re-briefed on the requirement to follow the correct process when errors are indentified during commissioning including production of test logs and design modifications if required.
- Where email is used to issue design office modifications, the tester-in-charge shall ensure that copies are issued to principles and functional testers
- All alterations to controls shall be identified by the design office on the issued control tables. Existing deficiencies shall be identified to project teams
- Appropriate non changeover critical mechanical installation works shall be completed prior to commissioning shift
